**ATSB TRANSPORT SAFETY INVESTIGATION REPORT**

Aviation Occurrence Report – 200601663

**Wirestrike – St Albans, NSW**

**Bell Helicopter Company 206B III, VH-JIV**

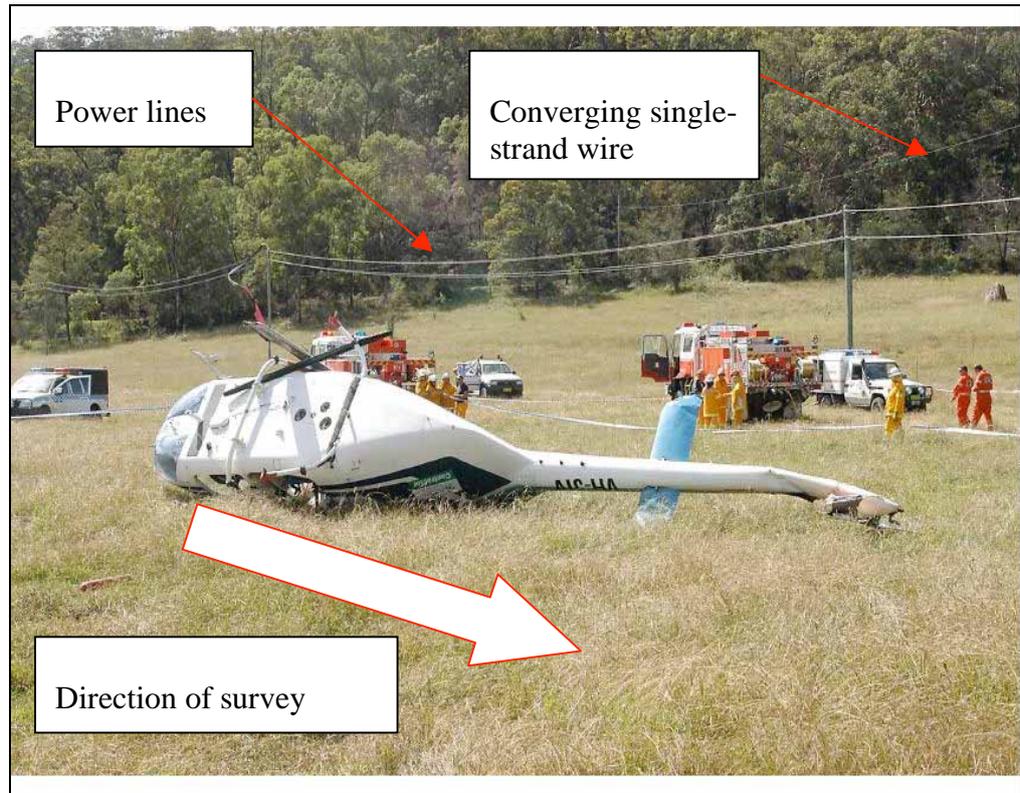
**Figure 1: Helicopter adjacent to survey wires**

The pilot reported being 'boxed in' between the powerlines on his right, and the single-strand wire on his left. In response, he attempted to clear the single-strand wire. However, the tail rotor came into contact with the single-strand wire and the helicopter began rotating as it lost directional control.

The pilot climbed the helicopter clear of both sets of wires before attempting to land the helicopter in an upright position in an adjacent paddock. However, on contact with the ground, the helicopter rolled onto its right side, resulting in severe damage to the helicopter's skid landing gear, main and tail rotors and cabin structure (figure 1).
