Aviation Occurrence Report – 200602199

Runway Excursion – Mabuiag Island, Torres Strait

27 April 2006

Cessna Aircraft Company U206G

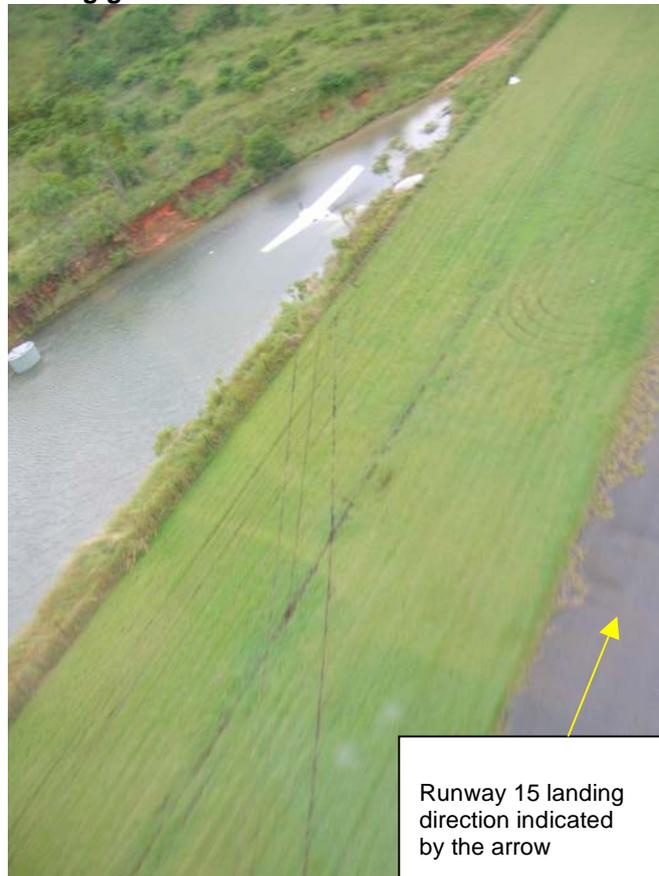
Figure 1: Landing gear tracks and location of aircraft

The pilot reported that the aircraft was configured with full flap for the approach and that the aircraft touched down at about 65 kts near the runway threshold. He retracted the flaps on touchdown and as he applied maximum braking the aircraft turned to the left and started to skid. He applied gentle right rudder in an attempt to straighten the aircraft but it continued to slide left. The aircraft ran off the sealed runway surface and it continued to slide on the grass verge.

The pilot reported that he probably did not apply equal braking effort to both the left and right main landing gear brakes during the landing. While the braking technique may have been a factor, it is more likely that the pilot's limited experience in crosswind conditions and on the aircraft type were the main factors that led to the runway excursion.
