ATSB TRANSPORT SAFETY INVESTIGATION REPORT

Aviation Occurrence Investigation – 200605274

**Engine in-flight shutdown
185 km south of Karratha, WA
6 September 2006
VH-NXI
Boeing Co 717-200**

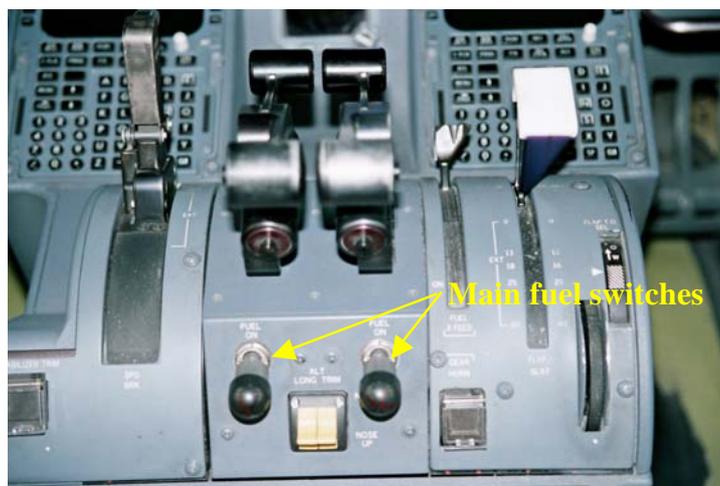
Figure 1: Boeing 717 throttle module (fuel switches indicated)

In the 717, LEFT and RIGHT main fuel switches allow the flow of fuel to their respective engine. The switches are a lever lock toggle design, and are located on the rear face of the throttle quadrant that is located between the pilots' seats (Figure 1).

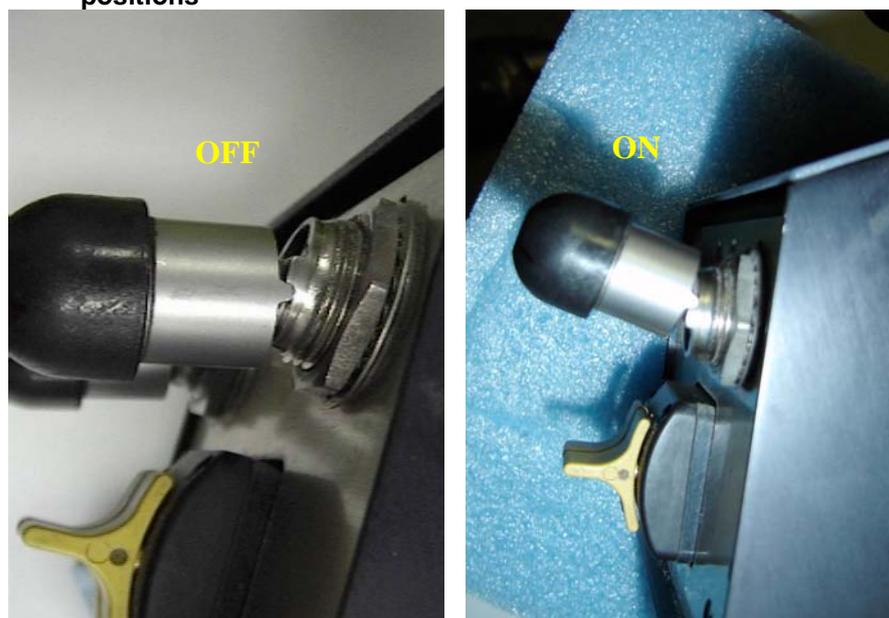
Figure 2: Fuel switch in the locked OFF (left), and locked ON (right) detent positions

An indication of the main fuel switches when selected to the OFF and ON detents is at Figure 2.

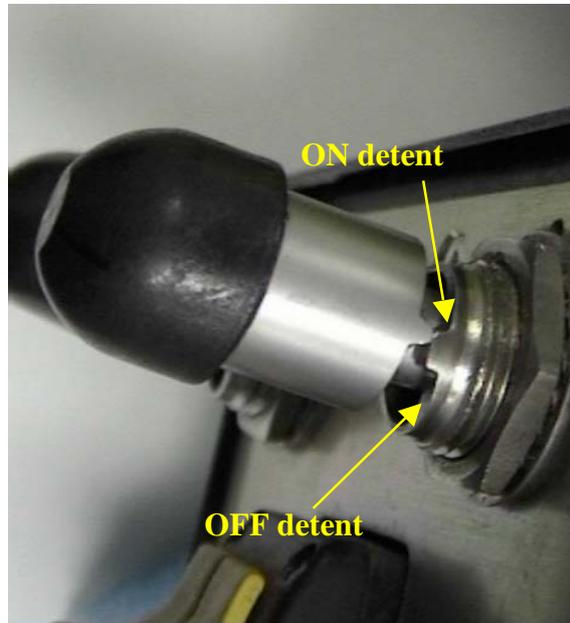
Figure 3: Fuel switch in an out of detent (unlocked), ON position

However, the operator's examination of this incident determined that the aircraft's right main fuel switch could be inadvertently selected to an intermediate position,

including as a result of its being caught by a pilot's wristwatch band (Figure 3). That was, the switch could be moved from the locked ON detent to an unlocked, but still ON, position. The operator also identified that the switches may be vulnerable to being 'snagged' or knocked by flight deck equipment or publications such as ring binders.

- Electrical contact of the main fuel switches to the ON state is possible when the switches are not locked in the ON detent.

The aircraft operator issued a Safety Alert to all of its 717 operating crew advising of the possibility of selecting the aircraft's main fuel switches to ON without their correctly engaging the locking detent. That alert also warned flight crew of the possibility of the inadvertent in-flight selection of the switches to OFF by catching wristbands or long sleeve shirt cuffs. In addition, flight crew were advised to not pass technical manuals or other similar items across the throttle quadrant in the vicinity of the main fuel switches.

The operator is evaluating the possible fitment of a physical guard to protect the main fuel switches against their inadvertent unlock from the ON position.
