ATSB TRANSPORT SAFETY INVESTIGATION REPORT

Aviation Occurrence Report – 200605307

Erratic Airspeed Indications

Boeing 717-200

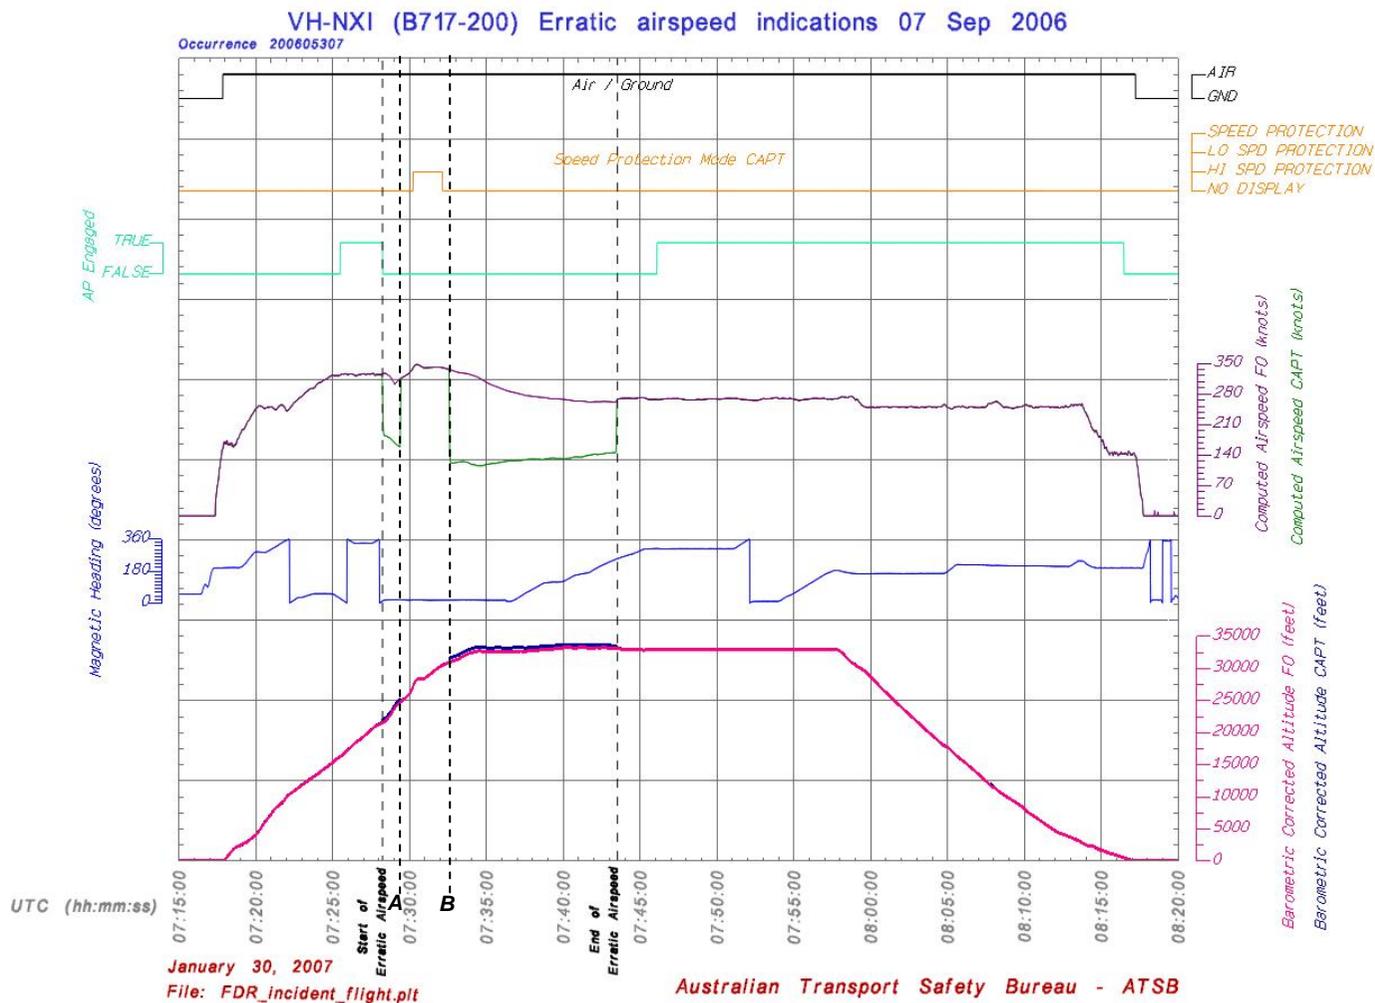
Figure 1: Information from the Flight Data Recorder for the incident flight

A – Pilot in command switched to the copilot’s air data.
B – Pilot in command switched back to his own air data.

The airspeed and altitude that was displayed on the PFD was recorded by the FDR. The FDR did not record the air data that was displayed on the ISIS. When the pilot in command noted that his airspeed was erroneous, he switched to the copilot's air data information. That action was shown on the FDR information (Figure 1).

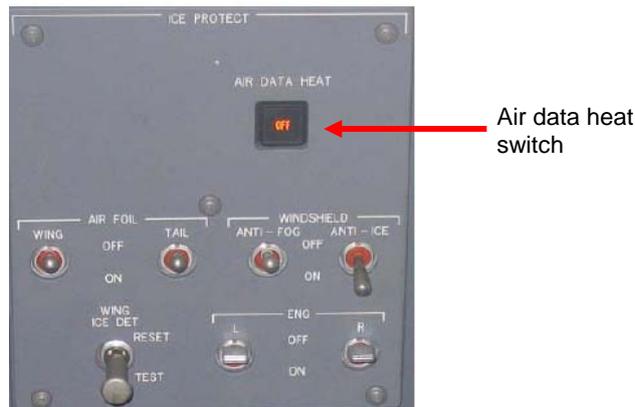
The air data heat switch was located in the forward overhead panel, as part of the ice protection control panel. The air data heat switch was the only push button switch on the ice protection control panel (Figure 4) and the only push button switch in the vicinity.

The switch was an alternate action type switch, containing a latching mechanism. The aircraft manufacturer configured the switch so that when the button was latched (OFF), the probe heaters were off and the switch was illuminated. In that mode, the button would have protruded about 5.5 mm from the panel. When the switch was unlatched (ON), the probe heaters were on and the switch was not illuminated. In that mode, the button would have protruded about 7.6 mm from the panel. No information was found in the maintenance procedures describing how to open the lamp capsule.

Figure 4: Air data heat switch in situ showing the position of the switch in the OFF mode.

The OFF light on the air data heat switch was probably illuminated. However, the crew may not have noticed it due to its location on the overhead panel.

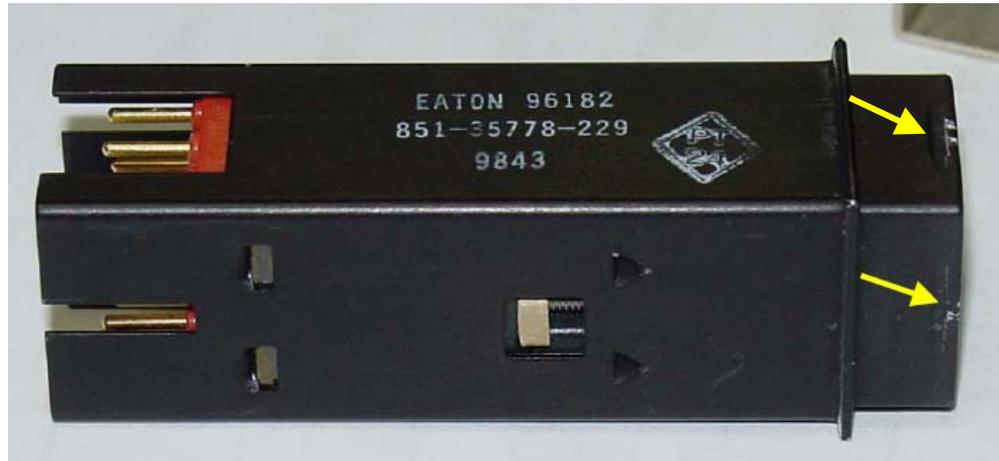
The switch manufacturer, under the supervision of the US, National Transportation Safety Board, carried out further testing. That testing revealed that the latching mechanism within the switch had failed, leading to the switch having a momentary action. The latching mechanism had been torn outwards; abrasions in the fingernail grooves were observed (Figure 5). Previous testing carried out by the switch manufacturer indicated that 17 lbs (7.7 kg) of force would have been required to tear out the latching mechanism. The switch manufacturer concluded that the outward direction of the tear on the latching mechanism, together with the abrasions in the fingernail grooves, indicated that the lamp capsule had been forcibly opened¹⁰ while in the latched (OFF) position.

Figure 5: Abrasions (arrowed) on the fingernail grooves of the air data heat switch

The latching mechanism in the air data heat switch, was most likely damaged when the lamp capsule was forcibly opened while the switch was in the latched position. No information was found in the maintenance documentation on the correct method for opening the air data heat switch lamp capsule. The 2 mm difference in height between the latched and unlatched positions on the switch made it difficult to differentiate between the ON/OFF modes. In addition, the air data heat switch was not located near any similar switches making it difficult to compare the switch ON/OFF position. Consequently, someone replacing a lamp may not have realised that the switch was latched prior to opening the lamp capsule. Provision of information to maintenance personnel on the correct procedure for opening the lamp capsule may avoid damaging the switch.

The operator has also alerted maintenance personnel to the possibility that the air data heat switch may break during its removal.
