ATSB TRANSPORT SAFETY INVESTIGATION REPORT

Aviation Occurrence Investigation – 200606874

Runway incursion
Brisbane Airport, Qld – 15 November 2006
VH-VYK
Boeing Company 737–838
Car 22
Airside operations vehicle

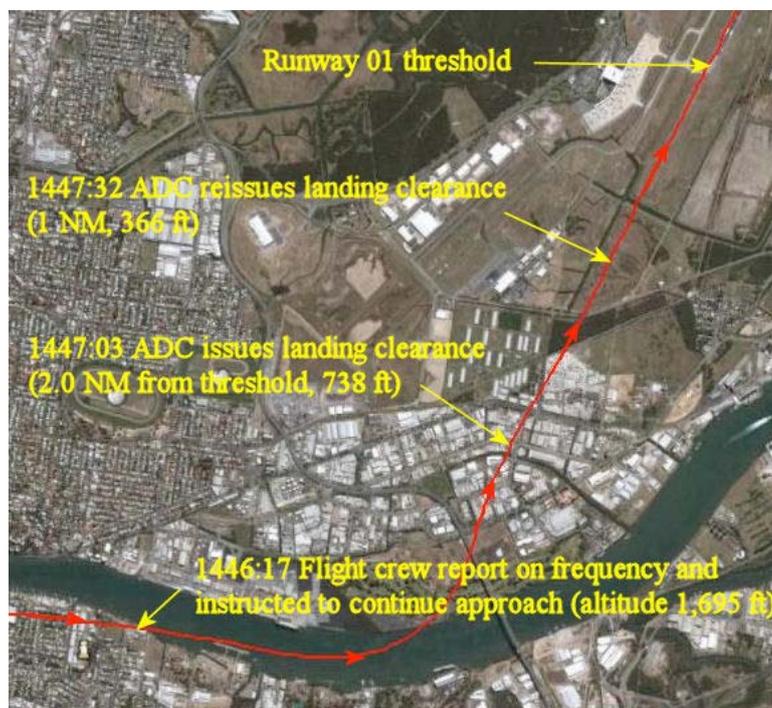
Figure 1: Flight path of 737 on visual approach to runway 01

At 1446 Eastern Standard Time¹ on 15 November 2006, a Boeing Company 737-838 (737) aircraft, registered VH-VYK, on a scheduled passenger service from Cairns, Qld was established on a visual approach to runway 01 at Brisbane, Qld (Figure 1). At 1446:01, the Brisbane aerodrome controller (ADC) issued a clearance for an airside operations vehicle driver (Car 22) to enter runway 01, an active runway, to locate and remove debris (FOD²), which had been observed within the runway strip by a pilot of another aircraft. At 1446:17, after transferring from the approach control frequency, the pilot of the 737 made the first report on the ADC's frequency, and was instructed by the ADC to continue the approach. After attending to a number of other controlling tasks, at 1447:03 the ADC issued the pilot of the 737 with a landing clearance, which was acknowledged. At 1447:20, an unidentified transmission warned the ADC that a vehicle was on the runway. That transmission was thought to have been made by the pilot of another aircraft waiting on an adjacent taxiway for departure. The ADC immediately instructed the driver of Car 22 to vacate the runway. After observing that the vehicle had vacated the runway strip, the ADC reissued the landing clearance to the pilot of the 737. There was a runway incursion.

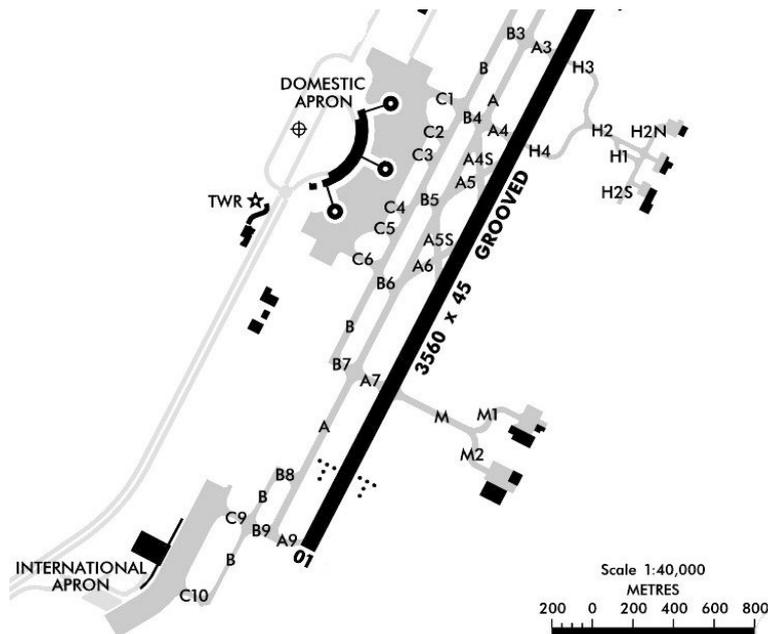
Figure 2: Extract from Aircservices Australia Brisbane Aerodrome Chart

The storm was reported to have caused significant damage around the airport area, including overturning baggage carts and moving cone markers. The reported FOD was thought to have been barrier material that originated from works that were in progress on the international apron near taxiway Charlie 9 (C9) (Figure 2). The reported FOD was not subsequently located by the driver of Car 22.

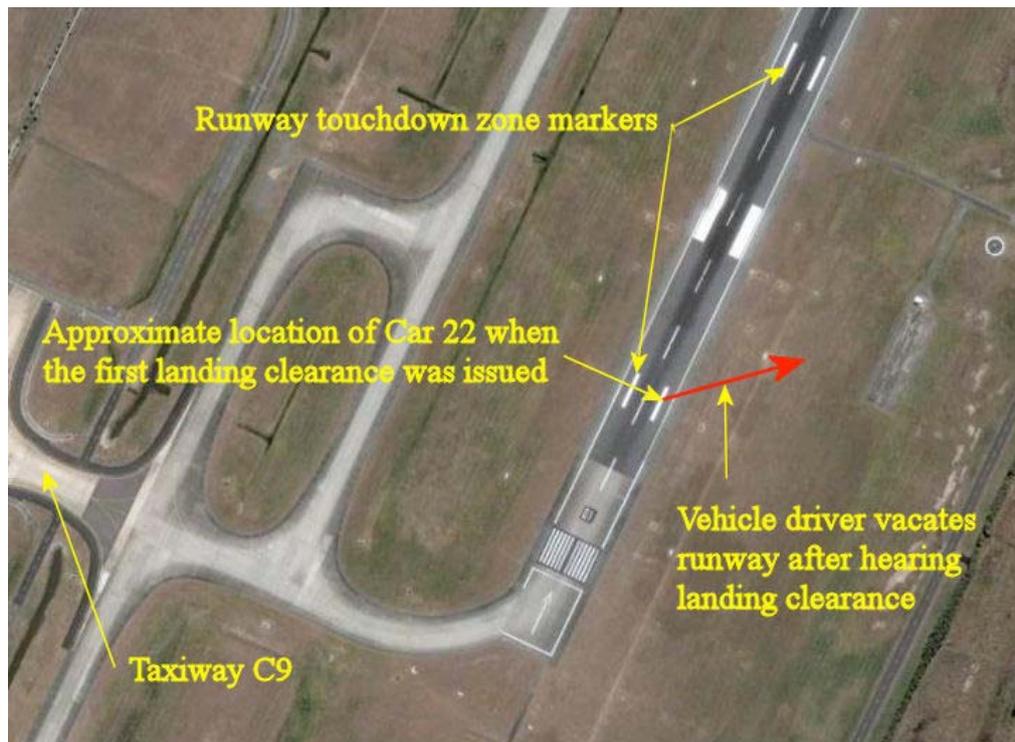
Figure 3: Approximate location of vehicle on runway 01

issue the landing clearance to the pilot of the 737. The driver reported that after hearing that clearance on the vehicle's radio he immediately commenced vacating the runway, prior to the warning to the ADC that there was a vehicle on the runway (Figure 3). He believed that he had vacated the runway strip by the time the ADC issued the instruction for him to vacate.
