**ATSB TRANSPORT SAFETY INVESTIGATION REPORT**

Aviation Occurrence Report - 200505952

**In-flight engine fuel leak**

**Boeing Company 747-438, VH-OJD**

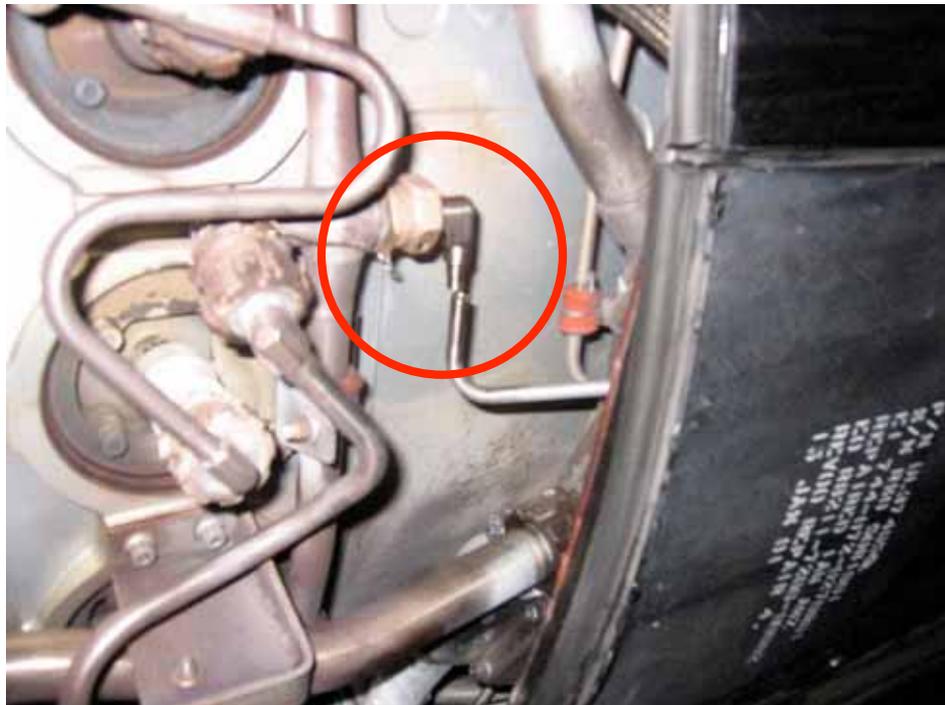
**Figure 1: Fuel manifold drain line<sup>1</sup>**

Subsequent examination of the number-three engine found that the fuel manifold drain line had fractured adjacent to one of the end connectors (Figure 1). The drain line was attached to the engine fuel manifold by a threaded connector which was welded onto the line. The line was then held in position at three locations along its length with 'P' clips.

As a result of this investigation, the engine manufacturer re-designed the fuel manifold drain line for replacement on all applicable engines under a service bulletin (RB211-SB71-F152) released on 4 August 2006. This service bulletin also provides more detailed information to operators regarding fuel line clipping arrangements on these engines.

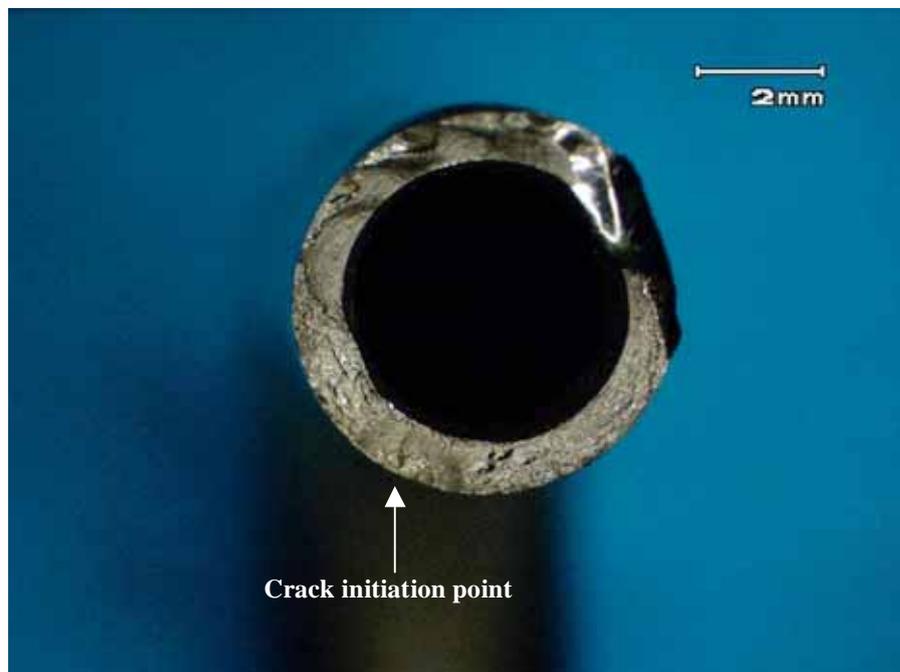
**Figure 2: Fracture surface**

A detailed examination of the drain line's fracture surface revealed it had occurred within the weld heat affected zone (HAZ)<sup>2</sup> between the connector and the drain line (on the connector side). The fracture had been initiated by a fatigue crack on the outside diameter of the drain line, which progressed until it reached sufficient size for a rapid failure to occur (Figure 2).

Scanning Electron Microscopy was used to characterise the fracture surface, revealing closely spaced striations consistent with high cycle fatigue (HCF). The microstructure of the fractured HAZ was also examined and compared with an intact weld from another location on the drain line. The material was typical of a stainless steel weld deposit, and did not exhibit porosity, cracking or inclusions.

The high fuel usage observed on the number-three engine was the result of the fracture of the fuel manifold drain line. Adverse harmonic resonance created by combustor rumble, led to high cycle fatigue and the eventual overload failure of the drain line. The exact origin of the combustor rumble could not be determined.

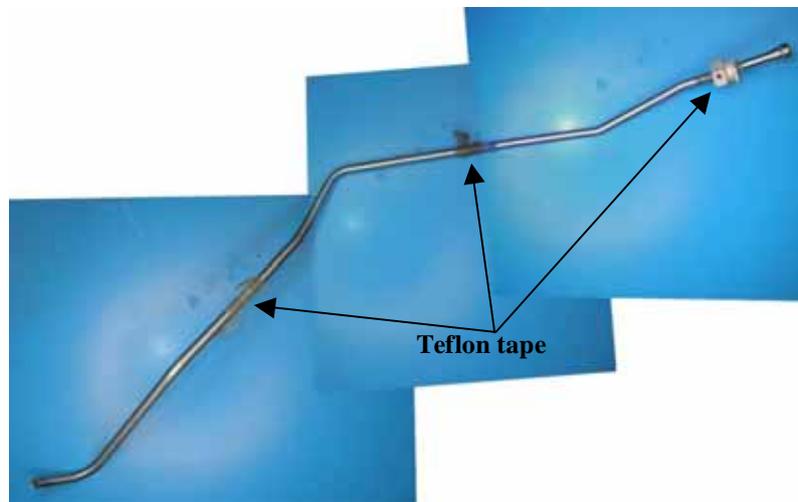
**Figure 3: Drain line showing Teflon tape**

Examination of the drain line found all three Teflon taped areas were worn, with some areas worn through to the drain line surface. The tape edges were frayed and lifting and it was noted that the tape had been wrapped much wider than the clips they were supporting. There was evidence of chafing on the drain line adjacent to two of the taped areas (Figures 3 and 4). The drain line was checked against a build

Examination of the drain line showed evidence of wear to the line's Teflon taped areas, indicating a high level of vibration between the clips and the drain line had occurred, which may have been the result of inadequate tape thickness. The chafing observed adjacent to the taped areas would indicate possible misalignment of the clips or incorrect routing of the drain line on the engine, leading to contact with adjacent parts.
