ATSB TRANSPORT SAFETY INVESTIGATION REPORT

Aviation Occurrence Investigation – 200700356

In-flight engine failure

Boeing Company 747-438, VH-OJM

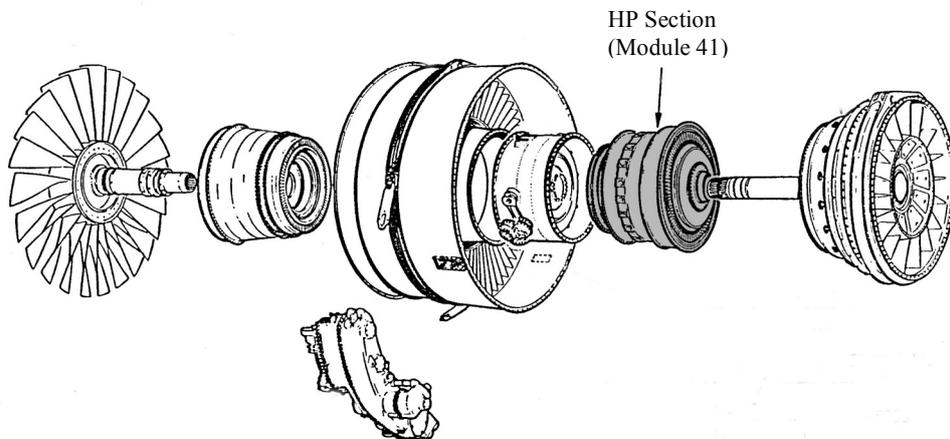
Figure 1 RB211 Engine modules, high pressure (HP) section (module 41)

A subsequent examination of the number-3 engine found that it had sustained a high pressure compressor (HPC), stage 1, blade failure. The blade had failed at its root, and following liberation, had caused considerable damage to the engine high pressure section module 41 (Figure 1). The engine was removed from the aircraft and Module 41 returned to the manufacturer.
