**ATSB TRANSPORT SAFETY INVESTIGATION REPORT**

Aviation Occurrence Report – 200606215

**Smoke event – 65 km NNE Melbourne  
19 October 2006  
VH-TQX  
de Havilland Canada DHC-8-202**

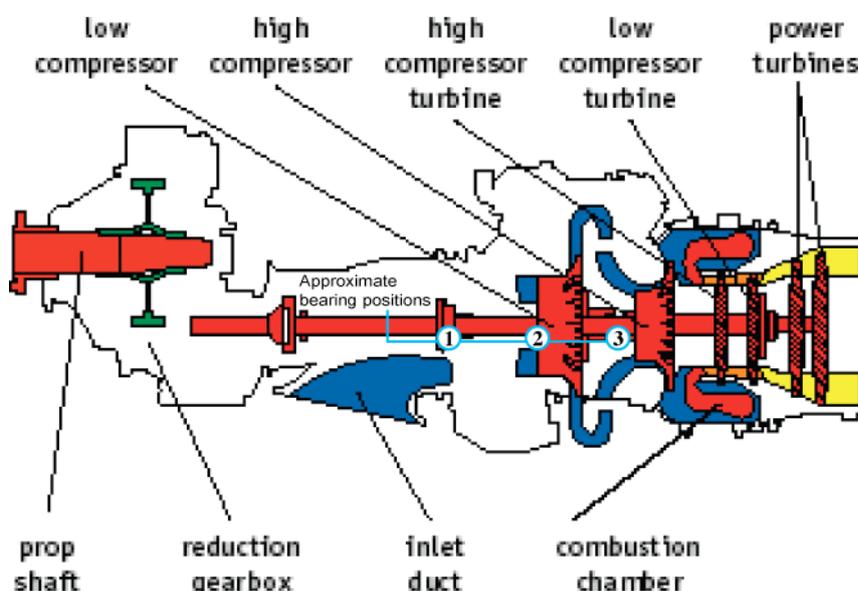
**Figure 1: PW 100 series engine**

A proportion of air from the compressor section (see figure 1) of the engine is extracted (prior to combustion), for the purposes of aircraft pressurisation, cabin ventilation and air conditioning. The manufacturer's examination of the engine showed that oil had leaked from the number-3 bearing, into the low pressure compressor section of the engine (see figure 1). The high temperature of the compressed air and engine components caused that oil to vaporize, thereby contaminating the air extracted from that section of the engine to the aircraft cabin.

The bearings are lubricated and cooled by oil. Bearing seals are of the non-rubbing labyrinth or abradable type. Labyrinth type seals are constructed so that bearing cavities are surrounded by a blanket of cool air, designed to prevent lubricating oil leaking into the main engine air flow. The leakage of oil from the bearings as described above was due to an increase in accessory gear box (AGB) pressure with a corresponding reduction in sealing air pressure across the oil/air bearing seals. The increase in AGB pressure was attributed to worn and damaged carbon seals on the number-1 bearing and deteriorated packing on the P2.5/3 switching valve transfer tube (not depicted). In addition the deteriorated packing between the low pressure diffuser case and the inter-compressor case and the number-4 bearing housing allowed oil to leak into the P2.5/3 air plenum<sup>4</sup> (not depicted) contaminating it with oil, which also contributed to the smoke in the cabin.

The post engine examination report by the engine manufacturer recommended that the operator comply with the content of service bulletins (SBs) 21680; 21546; 21313. These SBs were intended to address the issues of:

- deteriorated packing- by the use of an improved fluorocarbon packing material and
- the effectiveness of the air/oil bearing seals as identified above- by extending the accessory gear box breather tube into the engine exhaust duct to prevent an increase of pressure within the AGB.
