ATSB TRANSPORT SAFETY INVESTIGATION REPORT  
Rail Occurrence Investigation Report 2006002  
Final

Derailment of  
**XPT Passenger Train ST22**

Harden, New South Wales

9 February 2006

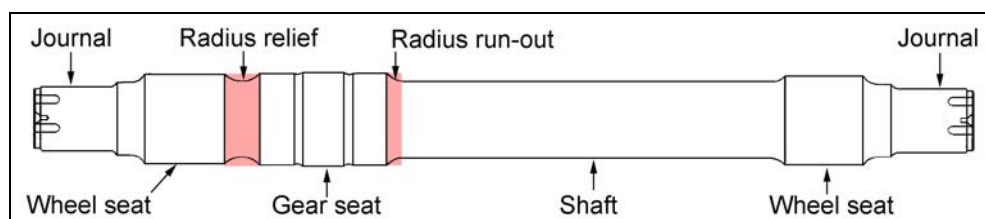
**Figure 3: Schematic of an XPT power car axle**

Note: Crack indications found in shaded areas.

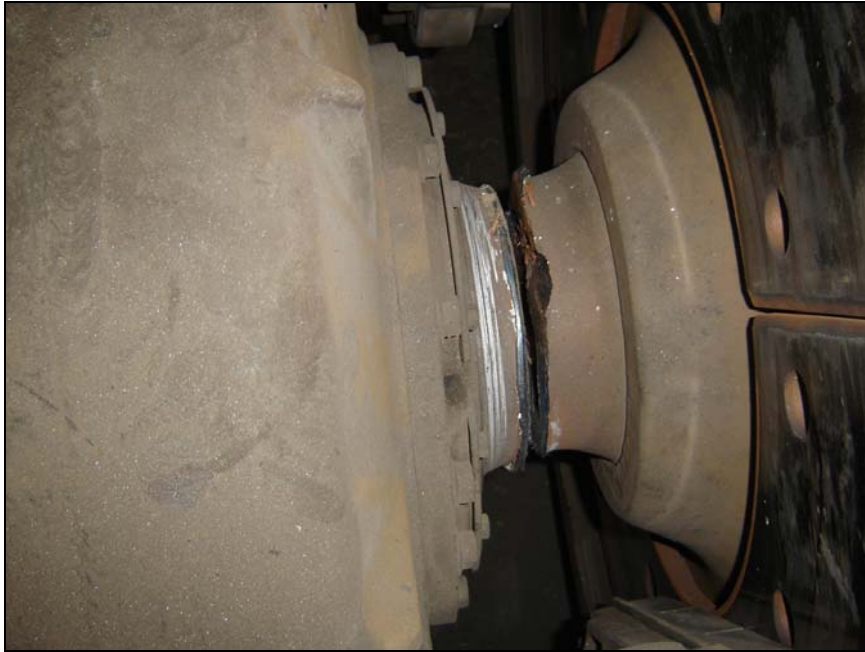
**Figure 5: Axle number 931679 completely fractured in-situ**

At about 0700 hours an emergency breakdown crew arrived to re-rail the derailed wheel. During the re-railing process a further inspection revealed that the axle had completely fractured, shown in Figure 5.

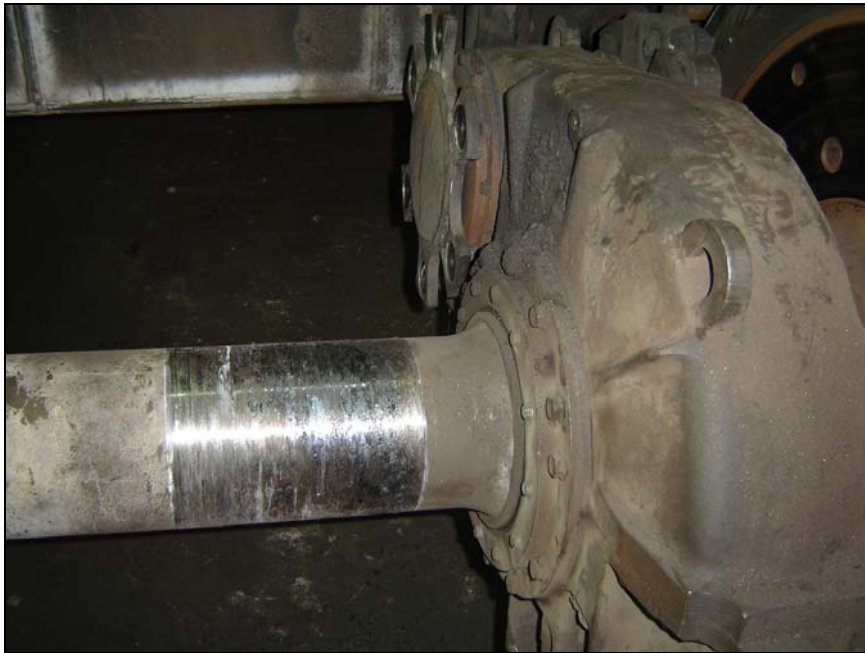
**Figure 7: Axle number 931679**

- Axle number 931679 had wear marks on the axle probably from contact with the traction motor after the axle failed, as shown in Figure 7. The fracture was orientated perpendicularly to the shaft axis. A considerable portion of each fracture surface had been scored from heavy rotating contact. A small portion of the original fracture still remained and showed evidence of rapid crack progression. Extensive discoloration of these fracture surfaces was indicative of a high level of frictional heating, as shown in Figure 8.
- The gear side wheel on axle 931679 had major damage.
- The traction link arrangement on axle 931679 had damage to the bolt heads from being struck after the axle had failed.
- Axle 931679 had completely fractured between the gearbox and the wheelseat on the axle.

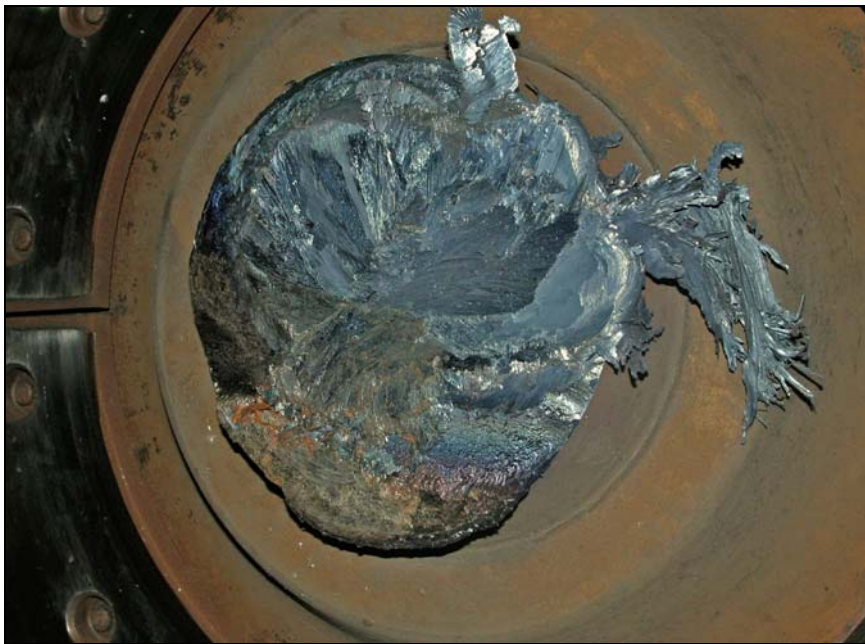
**Figure 8: Fracture surface of axle number 931679**

The ATSB's investigation of the derailment concluded that train ST22 had derailed as a result of the axle completely fracturing. The axle had fractured as a result of the initiation and propagation of a fatigue crack. Once the crack had grown to critical size, the axle was unable to withstand further operational stresses, which resulted in the overload of the remaining net section of the axle. Once the axle had fractured the wheelset became unstable on the rail and eventually derailed one wheel.

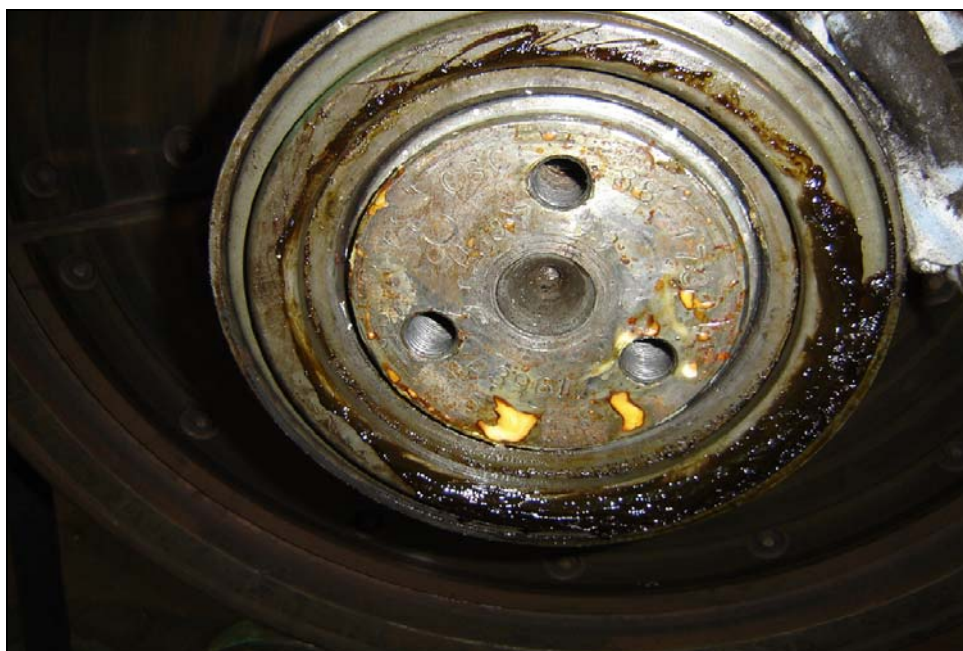
**Figure 9: Axle 881733 showing signs of water ingress**

- All bearings fitted to the inspected axles were manufactured by Timken
- Grease had leaked from the package bearings on all bearings inspected that had operated in service, this was considered normal
- There was some discolouration of the grease possibly due to water ingress on some of the bearings
- Rust and signs of water ingress were noted on bearing number 532482 fitted to axle number 881733 (see Figure 9)
- Bearing number 251374 on axle number 931679 exhibited internal damage when rotated by hand. This was probably as a result of the axle failure and subsequent derailment.

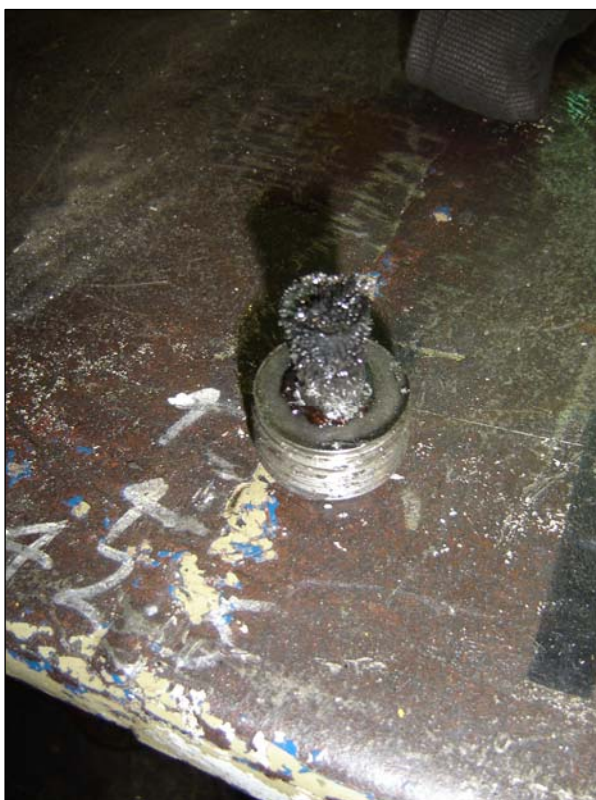
**Figure 10: Oil drain plug from gearbox C17**

A sample of oil from gearbox C17 on failed wheelset 931679 was removed and sent for analysis. Test results for viscosity, density and flash point align with the characteristics of BP Transgear 80W-140 oil, which is the designated lubricant. Contaminants identified in the oil include iron oxide, cellulose and inorganic silicates, though only in trace amounts and would have not contributed to the failure of the axle. When the oil drain plug was removed from the gearbox a quantity of metal particles were attached to the magnet plug, which is considered to be normal, shown in Figure 10. There appeared to be no visual major damage to the teeth or bearings after dismantling the gearbox.

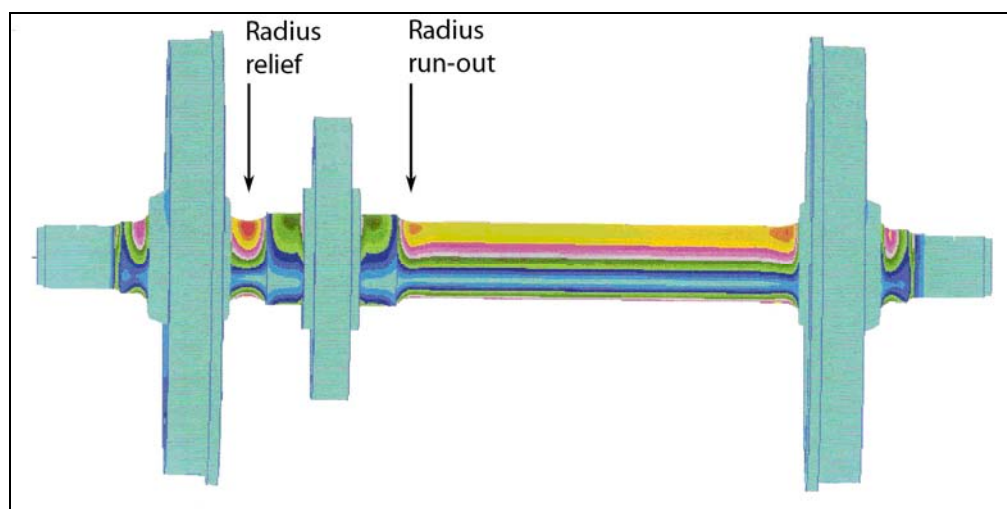
**Figure 15: Finite element model of an XPT power car axle**

Note: Shows the stress distribution when exposed to 1g vertical loading. The stress gradient decreases in magnitude from red (highest), to blue (lowest).

The report concluded that the most vulnerable area to fatigue cracking was the radius relief between the gear drive and bogie wheel.

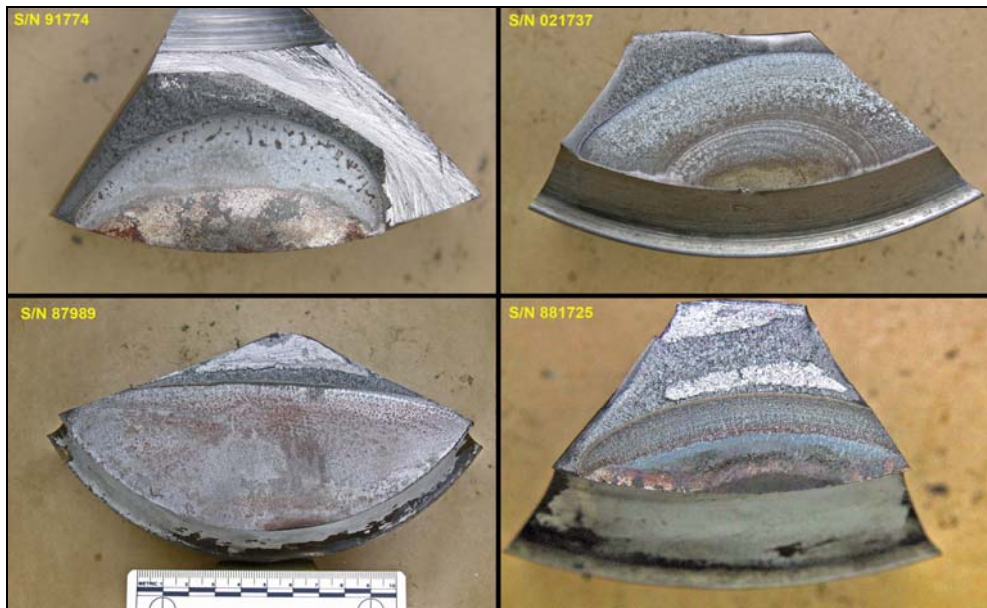
**Figure 17: Composite view showing the axle fatigue crack surfaces**

Destructive sectioning and examination of the four other XPT axles revealed that fatigue cracking had developed within each axle. Beach marks clearly defined the progression of each fatigue crack. The cracks had propagated from the radius relief and run-out areas and grown transversely into a semi-elliptical shape. A general accumulation of corrosion and fretting products was observed on each of the crack surfaces, which was consistent with the cracks growing over a substantial period of time. Figure 17 shows a composite view of the axle fatigue crack surfaces.

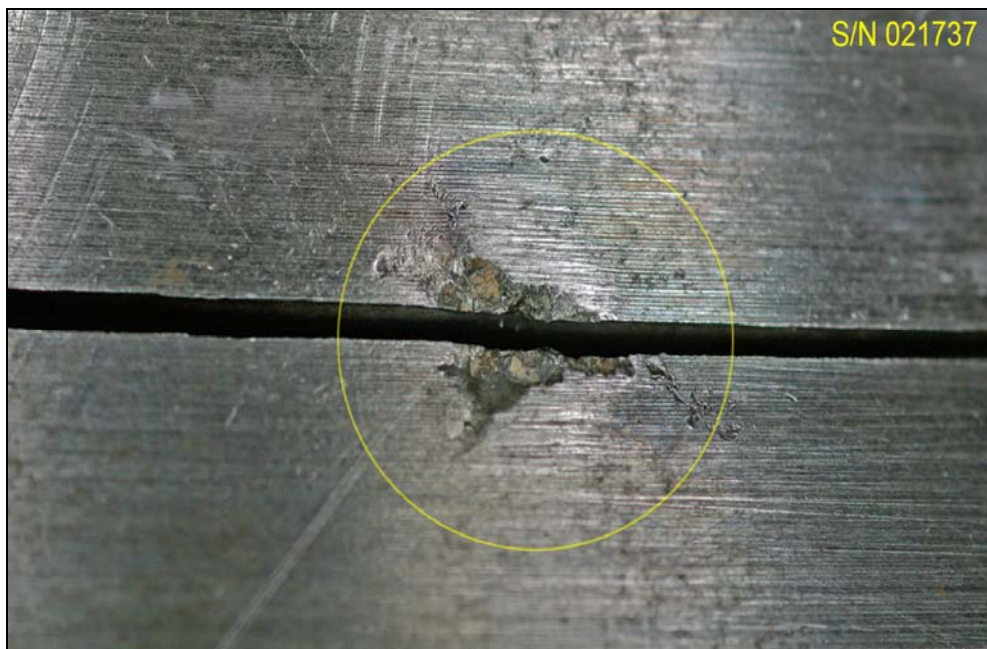
**Figure 18: Indentation damage (circled) on XPT axle 021737**

Of particular note during the examination was the presence of irregular surface damage at each crack origin. The general shape of each indentation suggested that they had been mechanically produced. No evidence was observed in or around the indentations to indicate they had been produced by corrosive processes. Low power optical examination revealed that a crystalline material was still embedded within all of the indentations, see Figure 18 and Figure 19.

The general size and depth of the indentation damage on each axle was quite small. Although the surface damage was relatively minor, it was present in areas where the service stresses were concentrated and the axle was vulnerable to fatigue. Even though the damage was minor, the evidence indicates that these flaws were sufficient to increase the localised stress intensity above the designed fatigue limit, resulting in a reduction in fatigue life.

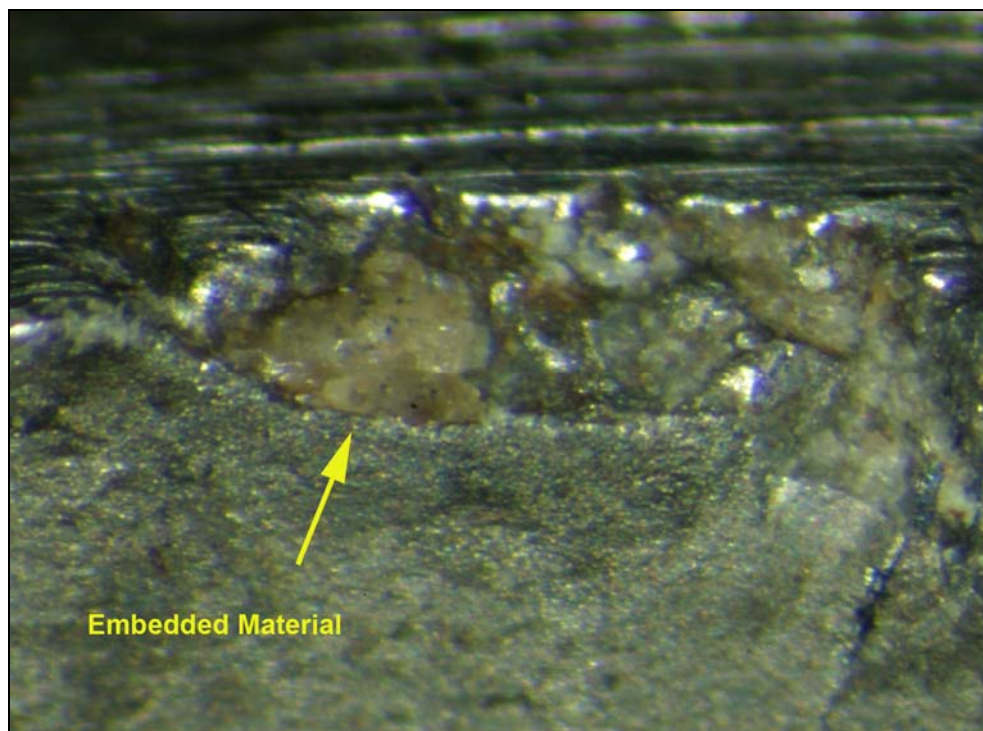
**Figure 19: Close-up of embedded material (arrowed) within the indentation damage from XPT axle 021737**

The analysis revealed the composition of the embedded material to be largely silicon (Si) and oxygen (O). See Figure 20 for a representative EDS chemical spectrum. The chemistry of the embedded material was consistent with a rock or mineral aggregate, such as the type used in track ballast.

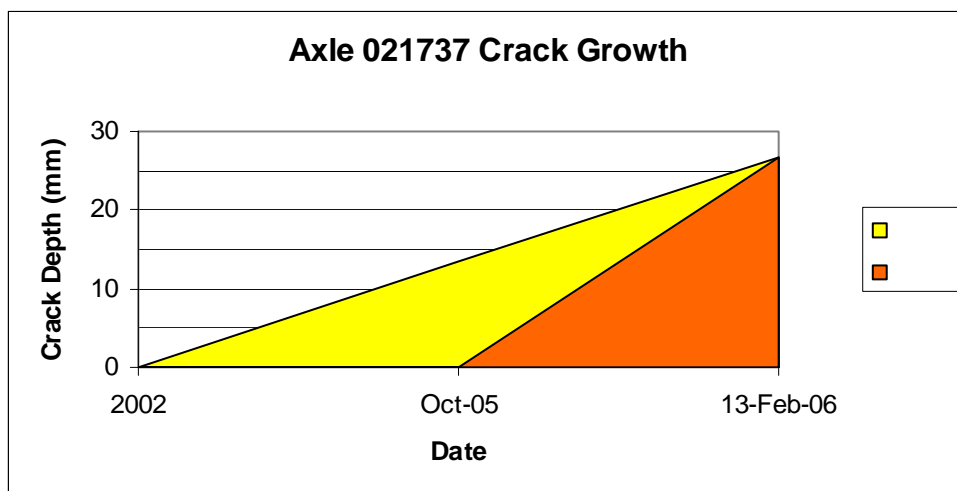
**Figure 23: Axle 021737 Crack Growth Rate**

The date of manufacture (DOM) and date of the last overhaul (OH) are two datum points used for calculating a fatigue crack growth rate. The yellow area in Figure 23 represents a crack growth rate based on a fatigue crack initiating and propagating, from the time of manufacture (DOM) in 2002 until the date of detection. The orange area represents a crack growth rate based on a fatigue crack initiating and propagating, from the time of the last overhaul (OH) until the date of detection. The only reliable datum point is considered to be the DOM. In this example the minimum crack growth rate would be from the DOM, the maximum based on a fatigue crack initiating and propagating rapidly immediately before detection.

Given the characteristics of each fracture surface examined, the cracks had been propagating in each axle for a considerable time period. It is more likely that the actual crack growth rate in each axle is within the yellow area. Exactly how long the cracks had been propagating in each axle could not be accurately determined but the cracks were very likely to have been present during the previous inspections.
