Aviation Safety Investigation Report - Interim Factual

Collision with trees, Cessna U206 VH-UYB at Willowbank, Qld

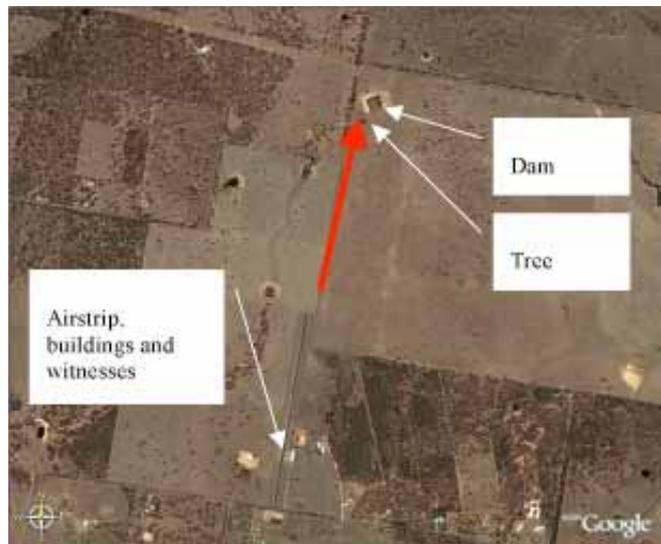
Figure 1: Willowbank airstrip²

The Willowbank airstrip and the dam location is displayed in Figure 1. The estimated flight path is indicated by the red arrow.

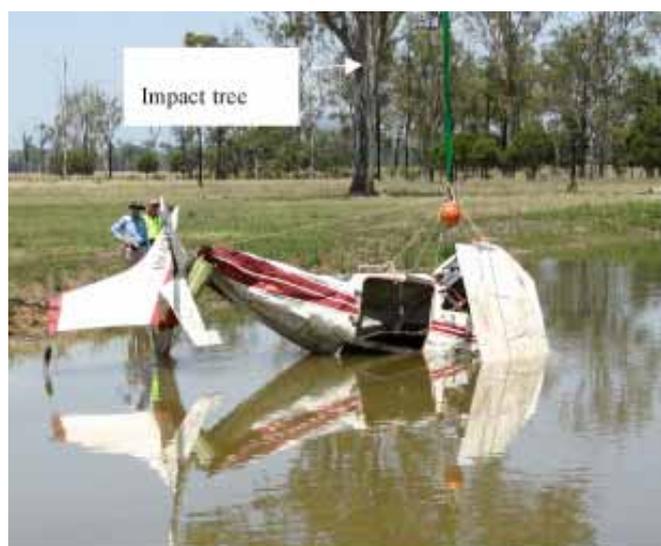
Figure 2: Recovered wreckage

The wreckage was recovered from the dam (see Figure 2) and moved to a secure location for further examination by the Australian Transport Safety Bureau (ATSB). That examination revealed that the aircraft had impacted in a nose-down, left wing-low attitude. The forward section of the cabin was extensively damaged by impact forces, but the aft cabin section remained relatively intact. The right wingtip was separated by the initial impact with the tree and was located nearby. The right wing outboard spar was heavily damaged. A number of components from the aircraft, including the propeller and engine, were removed for further technical examination.
