ATSB TRANSPORT SAFETY INVESTIGATION REPORT
Rail Occurrence Investigation 2006/014
Final

Collision between
Rigid Tipper Truck/Tri-axle Trailer
and
The Overland Passenger Train, 4AM8

Wingeeel, Victoria

15 November 2006

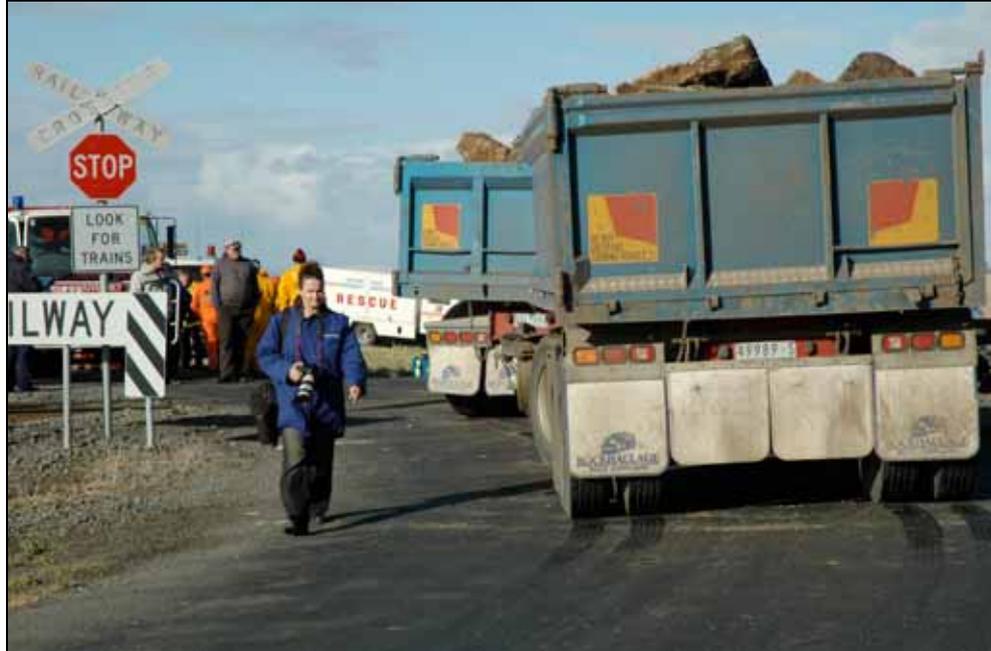
Figure 4: View of 'Stop' sign , approaching level crossing from south-west.

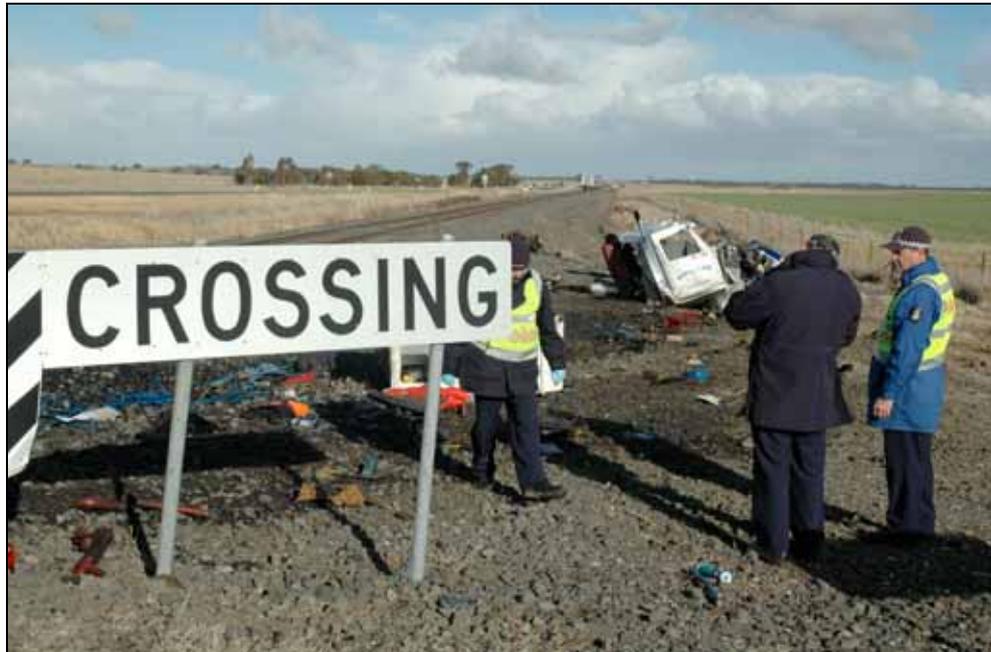
Figure 6: Photo of accident site, taken at approximately 1700. Train 4AM8 can be seen in the background.

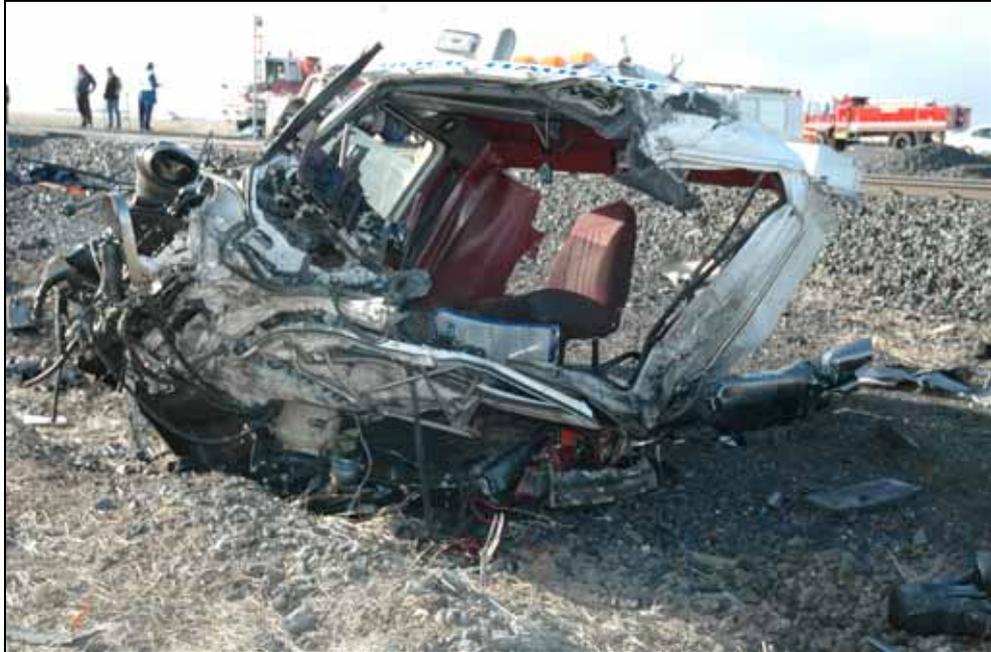
Rock Haulage Pty Ltd incurred significant losses with the truck being written off.

Figure 7: Photo of truck cabin wreckage.

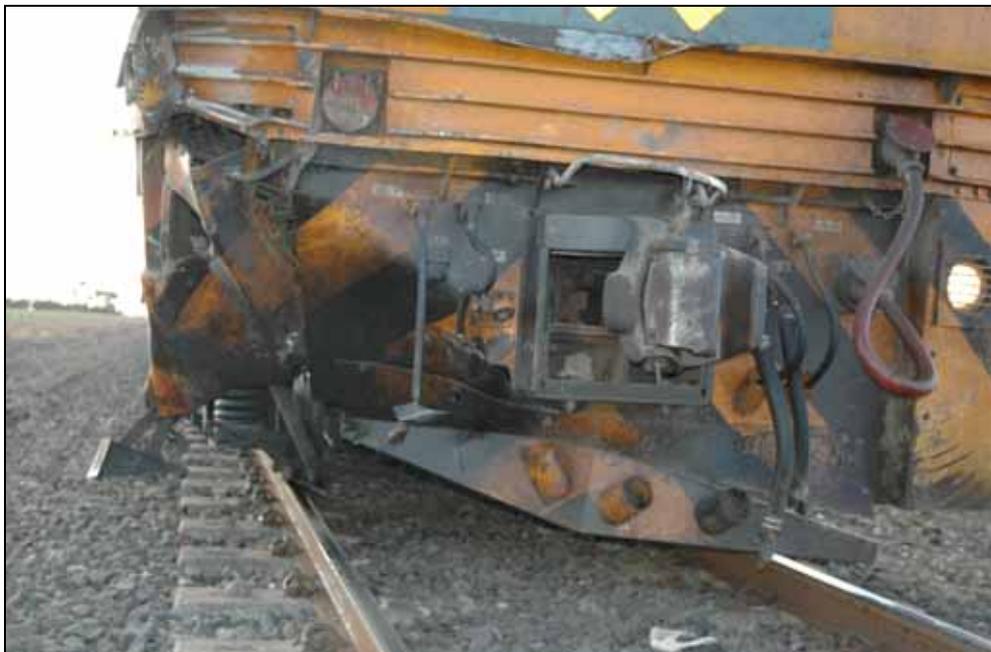
There was only minor damage to the lead locomotive of the train, however the locomotive air-compressor was destroyed. This meant the train could not be moved and as delays were expected to be significant, alternative road bus transport was arranged to convey passengers to Melbourne. The buses arrived at approximately 1846 with passengers transferring thereafter.

Pacific National incurred minor damage to the drag box, air-compressor and various brake fittings on its locomotive.

Figure 8: Photo of locomotive, NR118, showing extent of damage.

A relief train⁵ was arranged and despatched from Melbourne at 1622. On arrival at the site (temporary repairs were made to the compressor and air line of 4AM8) 4AM8 was moved into the Wingeel crossing loop. After undertaking further repairs 4AM8 departed for Melbourne at approximately 0050 on 16 November 2006.

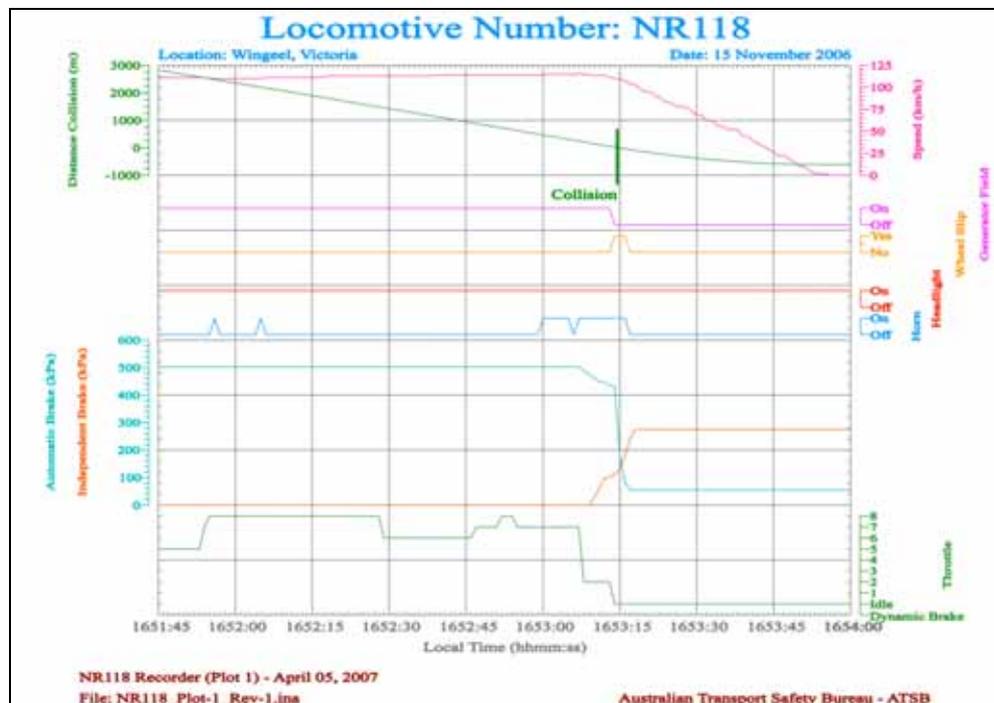
- The train brakes were applied 243 metres in advance of the level crossing when it became apparent to the train driver that a collision may be imminent. This is corroborated by the train driver who stated that he applied the brakes approximately 200 m in advance of the level crossing.
- The collision occurred at 1653:14.
- The speed of the train at the time of collision was 110 km/h; this was 5 km/h below the track speed for this class of train. The speed reduction is reflective of achievable braking effort from when the train driver reacted to the risk of a collision.

Figure 9: Locomotive NR118 'loco log data' extract

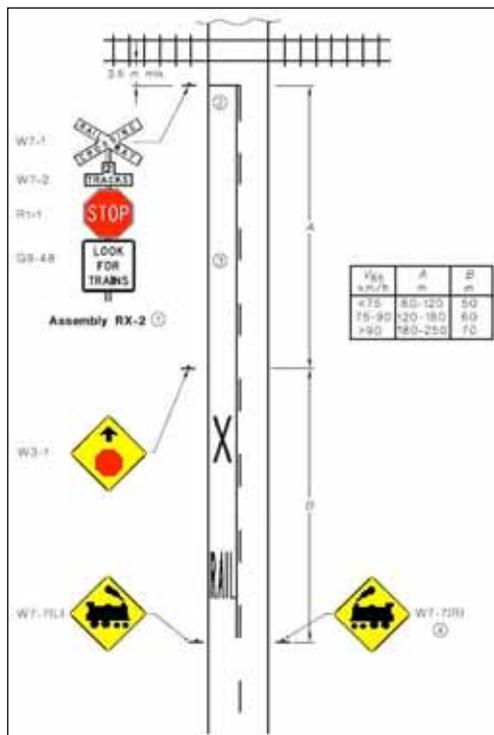
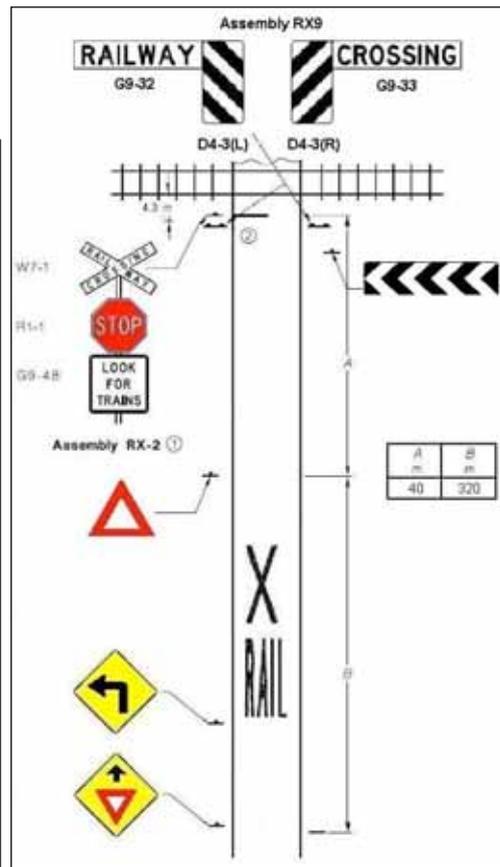
Figure 11: Signage as observed approaching the Barpinba-Poorneet Road level crossing from the south west. Note 'Give Way' approach signs.

- The W3-1 ‘Stop sign ahead’ was not in place as prescribed. A position marker/inverted triangle, peak facing upwards was located at a distance of approximately 40 m from the ‘Stop’ sign. There was some evidence of a sign below the triangle, it was probably vandalised and had not been replaced.
- Road markings were not as prescribed, in particular there was no evidence of a ‘barrier line’⁸ and the ‘Stop line’ at the south west approach was heavily faded.
- The inner approach warning sign was in a poor condition.

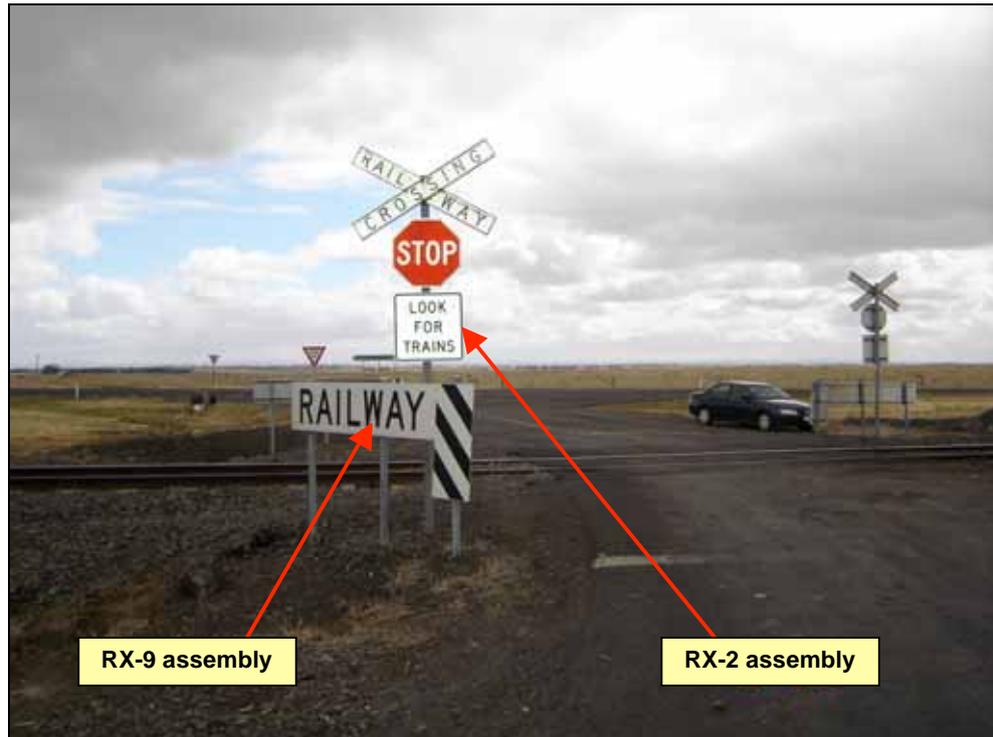
Although the RX-2 and RX9 assemblies (Fig. 12) on the south-west side of the Barpinba-Poorneet Road level crossing were compliant and in good condition the approach warning signage (Fig. 13) and road pavement markings, maintained by the Colac Otway Shire Council (COSC) did not comply with AS1742.7-1993 and were in poor condition. A motorist who was unfamiliar with the local topography would have been unaware of the presence of the level crossing until almost upon it.

Figure 12: Photograph of RX-2 and left hand side of RX9 assembly at the Barpinba-Poorneet Road level crossing.

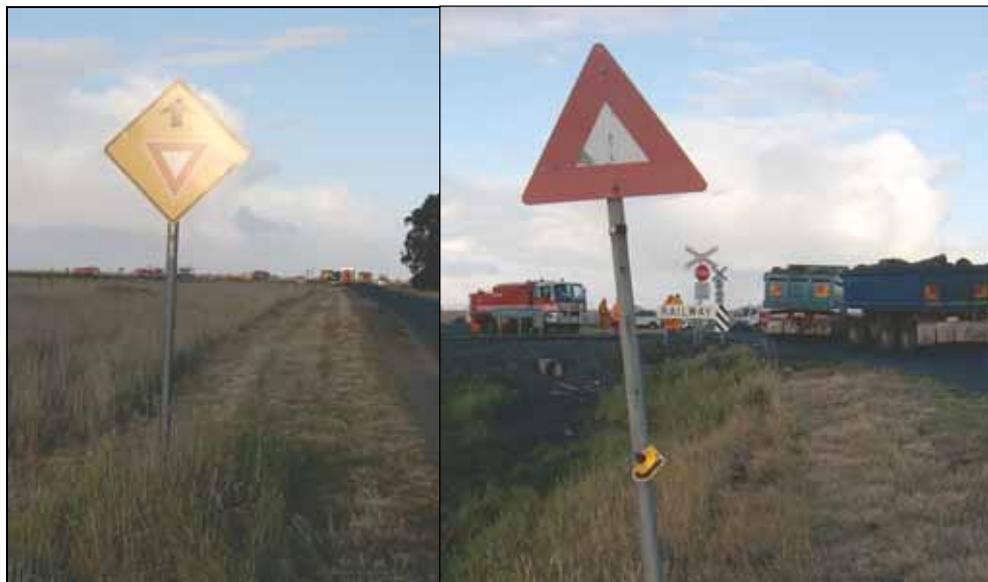
Figure 13: Left photograph shows a non compliant 'Give Way Sign Ahead'. Right photograph shows a position marker with an indication of a missing sign below.

1. The approach warning signage on the south west approach of the Barpinba-Poorneet Road level crossing was not compliant with AS1742.7-1993 and in poor repair. A motorist unfamiliar with the road would probably be unaware of the level crossing until they could directly sight it. *[Safety issue]*

Following the accident the Victoria Police directed that the Colac Otway Shire Council upgrade the Barpinba-Poorneet Road level crossing south-west approach warning signs before they would allow the level crossing to be re-opened. This work was completed on 16 November 2006, however it was observed that the signage was still not in compliance with AS1742.7-1993 and/or AS1742.7-2007.

The approach warning signage on the south west approach of the Barpinba-Poorneet Road level crossing was not compliant with AS1742.7-1993 and in poor repair. A motorist unfamiliar with the road would probably be unaware of the level crossing until they could directly sight it.

The Australian Transport Safety Bureau recommends that the Colac Otway Shire Council take action to address this safety issue.

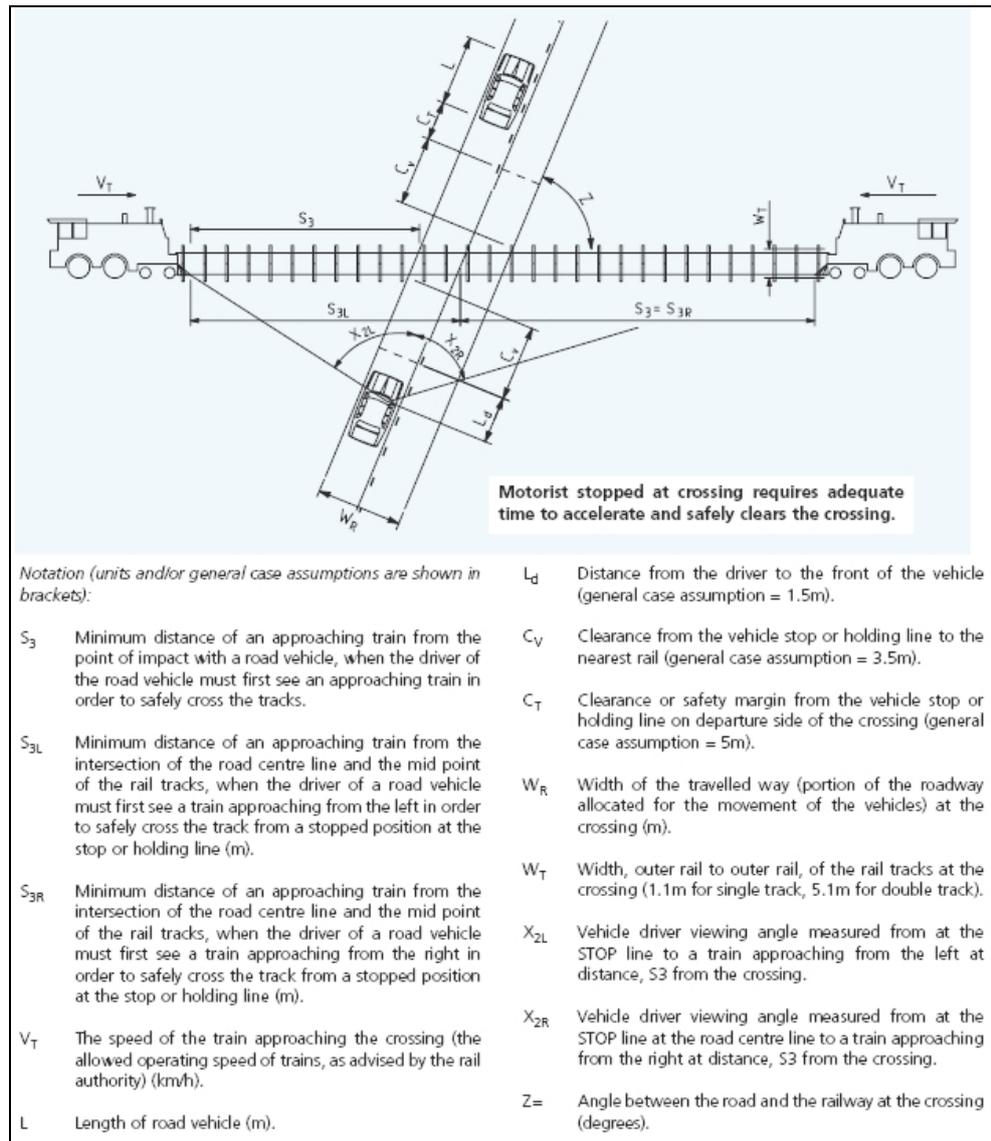
Figure 14: Approach distances and viewing angles

Based on a train speed of 115 km/h approximately 580 m available sighting is required for a loaded truck (19 m in length) when stopped at the Barpinba-Poorneet Road level crossing to see a train, safely accelerate and then clear the crossing. An examination of the Barpinba-Poorneet Road level crossing established that there was adequate sighting distance along the track in a north-westerly direction.

AP-G1 03 also prescribes that the maximum viewing angle measured at the ‘Stop’ sign when looking for an approaching train. This angle should not exceed 110 degrees, when looking to the left. Using the guidelines within AP-G1 03 revealed that a viewing angle as large as 141 degrees was possible dependent on the final position of the truck when stopped.

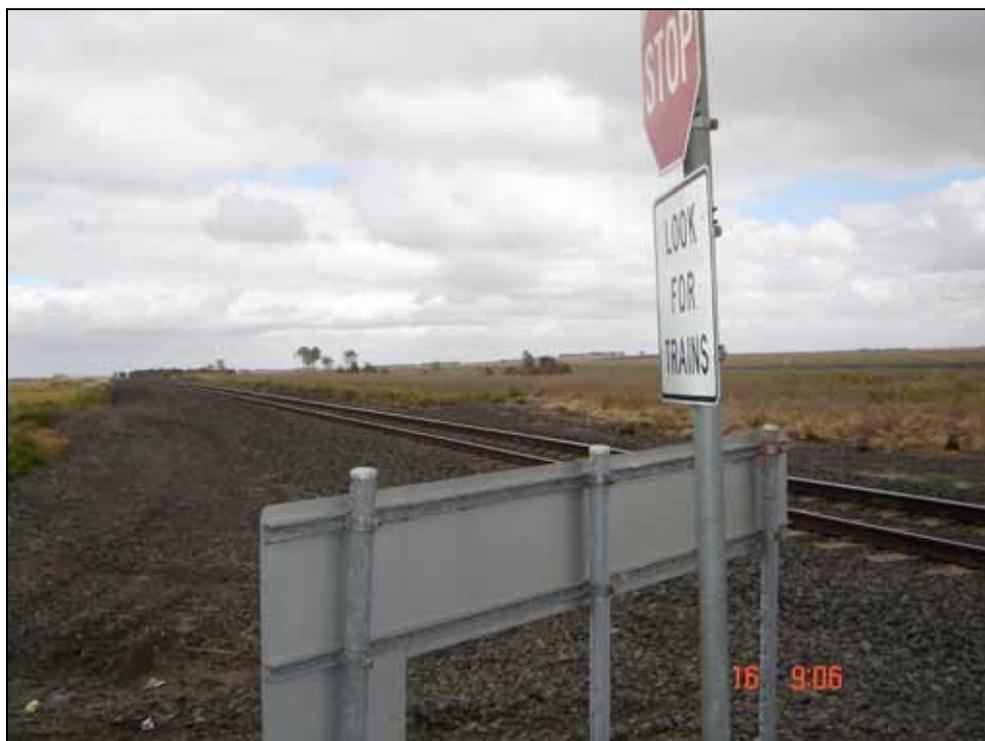
Figure 15: View of track from the level crossing looking north-west, the direction from which *The Overland* approached.

This indicates that the amount of head twist required of the truck driver was excessive. This coupled with the sighting constraints imposed by the 'B' pillar of the truck involved in the collision, would have made it very difficult for the truck driver to see and appreciate the presence of the train without coming to a halt at the 'Stop' sign. All available evidence indicates that the truck did not come to a halt at the 'Stop' sign and did not intend to stop until he saw/detected a train, he was probably unaware of the presence of the train until the last few seconds before the collision.
