Aviation Occurrence Report – 200600633

**Runway separation event – Perth Airport – 24 January
2006**

VH-VXR

VH-NJN

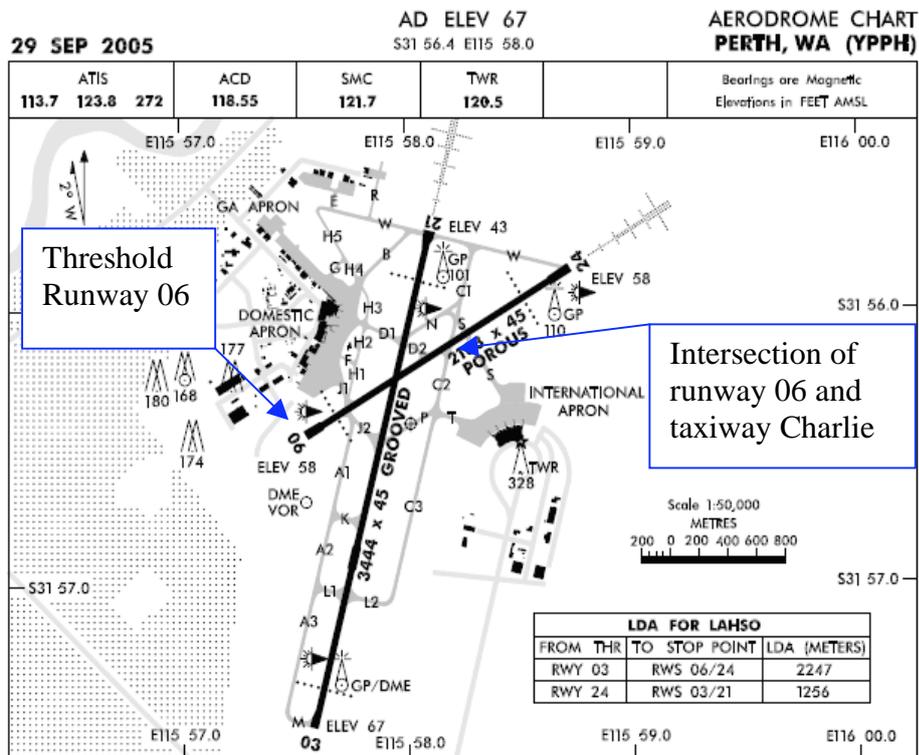
Figure 1: Perth Aerodrome chart

The bearing of runway 06 is 061 degrees M. The intersection of taxiway Charlie and runway 06 is midway along that runway, about 1100 m from the runway threshold.
