Aviation Occurrence Investigation – AO-2007-017

Interim Factual

Fuel starvation – Jundee Airstrip, WA – 26 June 2007
VH-XUE
Empresa Brasileira de Aeronáutica S.A., EMB-120ER

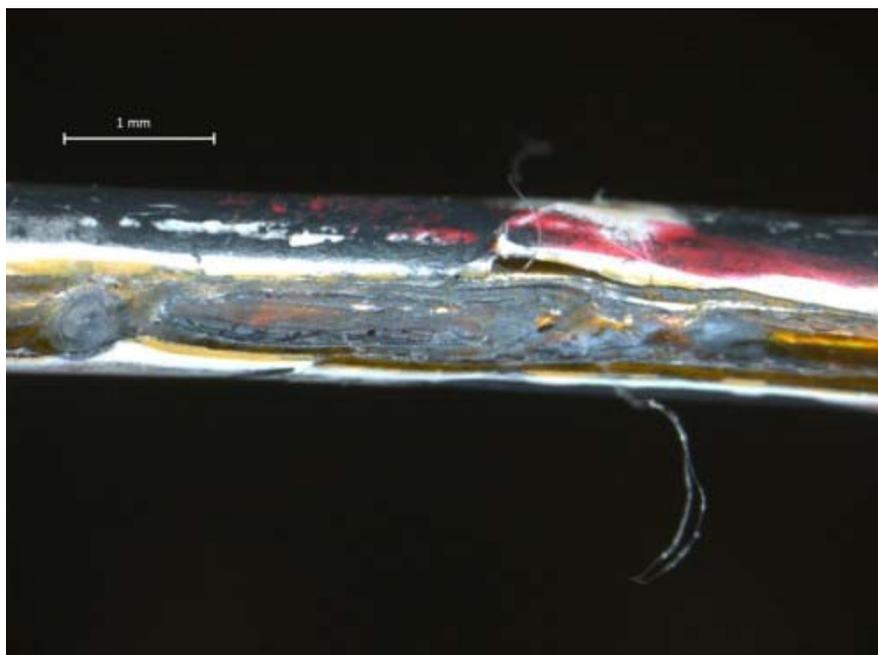
When the aircraft was examined after the incident, the left tank was empty, while the left gauge indicated 350 kg. A check of the overall capacitance of the left fuel quantity indicating system revealed that it was out of limits on the low side. The capacitances of all probes (while still installed) were also out of limits on the low side. When the probes were removed and bench tested, all tested correctly except probe number-6 (the outboard probe) which showed similar below limits capacitance as it did while installed. After a replacement probe was fitted in the number-6 position, the system capacitance returned to the correct value.

A visual inspection of the left FQIS wiring harness did not reveal any abnormality. The loom was subsequently removed from the aircraft and was inspected under magnification. That inspection revealed several areas of damage on the loom, particularly on the wires in the loom relating to the number-6 probe (Figure 5). Those wires were short circuiting to the metal structure inside the wing tank and also between the AC supply, DC positive and DC negative wires causing intermittent and hard short circuits and arcing, leading to the failure of two diodes on the number-6 probe.

Figure 5: Example of damage to wiring loom showing exposed wire and abraded insulation layers.
