Aviation Occurrence Investigation – AO-2007-044

Preliminary

**Missed Approach**

**Airbus A320-232, VH-VQT**

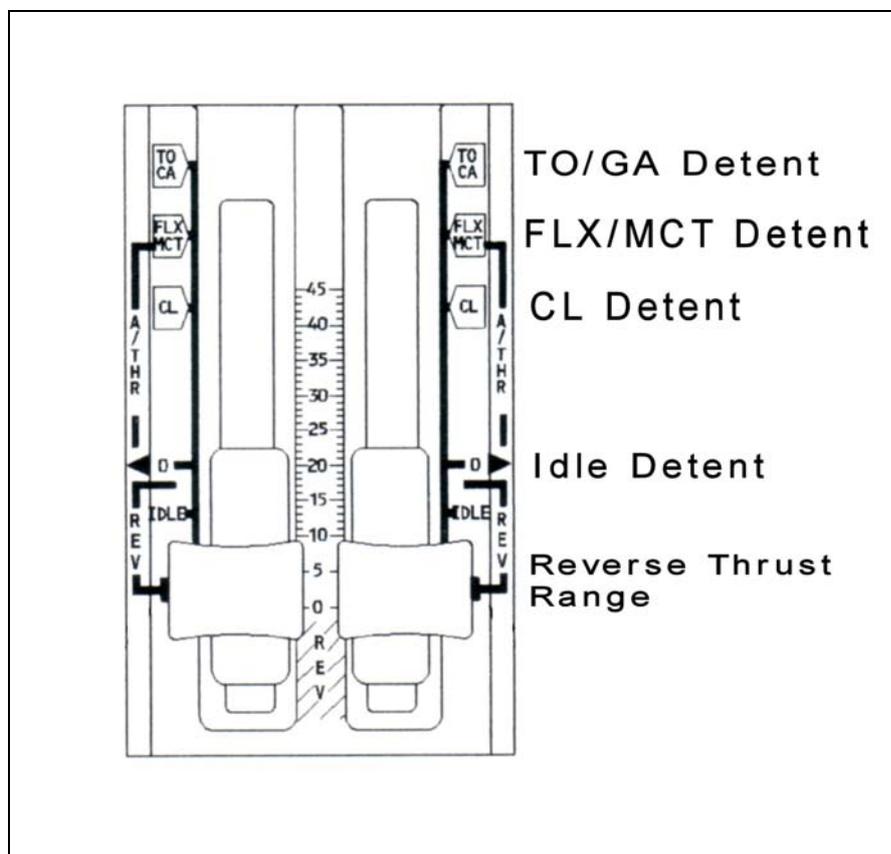
Figure 1: A320 thrust lever positions

Engine power can be controlled by the auto-thrust system, which the crew reported was active at the time. The thrust levers can be placed in any one of four detents on the thrust lever quadrant according to the phase of flight.<sup>2</sup> During a normal instrument approach, the levers are in the climb (CL)<sup>3</sup> detent. If auto-thrust is active, then the aircraft's speed is controlled by the thrust commanded by that system. The two detents forward of the CL detent are the flexible takeoff/maximum continuous thrust (FLX/MCT)<sup>4</sup> detent and the takeoff/go around (TO/GA)<sup>5</sup> detent. (Figure 1.)

At the decision height for the approach<sup>6</sup>, if the crew are not visual with the runway environment, they are required to conduct a missed approach. This involves the handling pilot advancing the thrust levers from the CL detent<sup>7</sup> to the TO/GA position and positively rotating the aircraft to a climb attitude. It also involves a number of callouts from the crew in response to the manoeuvre, and subsequent actions to reconfigure the aircraft to a climb configuration.

Movement of the thrust levers to the TO/GA position provides inputs to the flight control computers to initiate a change to the flight guidance modes. In a missed approach, the applicable modes are speed-reference-system (SRS) and go-around track (GA TRK). In the go-around manoeuvre, the SRS system provides guidance to maintain the speed which existed at the commencement of the missed approach procedure, while GA TRK provides lateral tracking guidance. The engines had already been commanded to provide thrust to allow the aircraft to climb away in the missed approach in response to the pilot advancing the thrust levers.

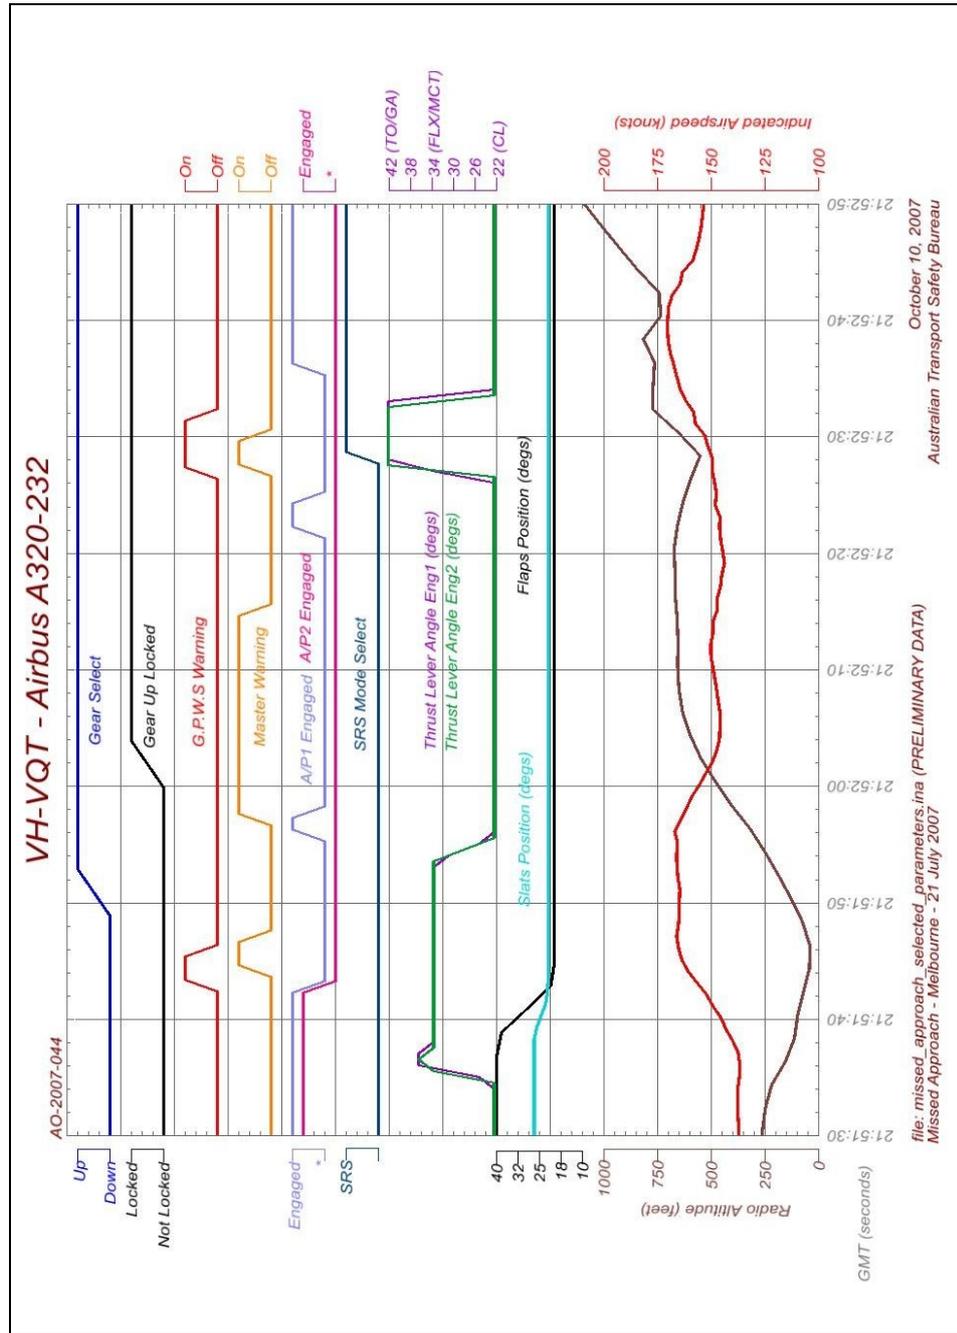
**Figure 2: Graphical representation of selected recorded parameters during initial missed approach**

Recorded flight data from the flight had been retrieved from the onboard flight data interface management unit (FDIMU) by the operator and was provided to the ATSB. Examination of the recovered flight data indicated that at the commencement of the first missed approach, at approximately 200 ft above ground level (AGL), the thrust lever positions were moved forward of the FLX/MCT detent<sup>8</sup> for a short period before being retarded to that position. Simultaneously, the flaps and slats were retracted to the FLAP 3 position from the FULL position.<sup>9</sup> The autopilot remained engaged during the commencement of the missed approach and was disengaged shortly after the flaps had been retracted. The recorded radio altimeter height at this time was between 58 and 72 feet. Selected recorded parameters are shown at Figure 2.

Shortly after the flaps had been retracted, the data indicated that an EGPWS ‘don’t sink’ warning activated. The aircraft continued to descend on the glideslope and the speed initially remained at approximately 140 knots before increasing. The aircraft descended to a minimum recorded radio altimeter height of 43 feet AGL. The landing gear was down at this time.

Shortly after reaching that height, the aircraft commenced a positive rate of climb, the landing gear was retracted and the aircraft commenced to climb away. Coincident with the gear retraction was a ‘master warning’ indicating a configuration warning.

The aircraft was climbed to approximately 650 ft AGL and remained at that altitude for approximately 17 seconds, before it commenced a shallow descent. Shortly after commencing this descent, the thrust levers were moved to the TO/GA detent<sup>10</sup> and coincident with that movement, another EGPWS 'don't sink' warning activated. After the thrust levers were moved to the TO/GA detent, the aircraft continued to climb and no further warnings or alerts were recorded.

1. An internal message to all crews was issued, requiring the use of full take-off thrust to be used for all missed approaches. Engine thrust was not to be reduced until commanded by the flight mode annunciator.
2. A flight standing order was published, which revised the missed approach procedure and associated crew actions.
