Aviation Occurrence Investigation – AO-2007-055

Procedures related event – Melbourne Airport, VIC

4 November 2007

Boeing Company 777 - 2D7

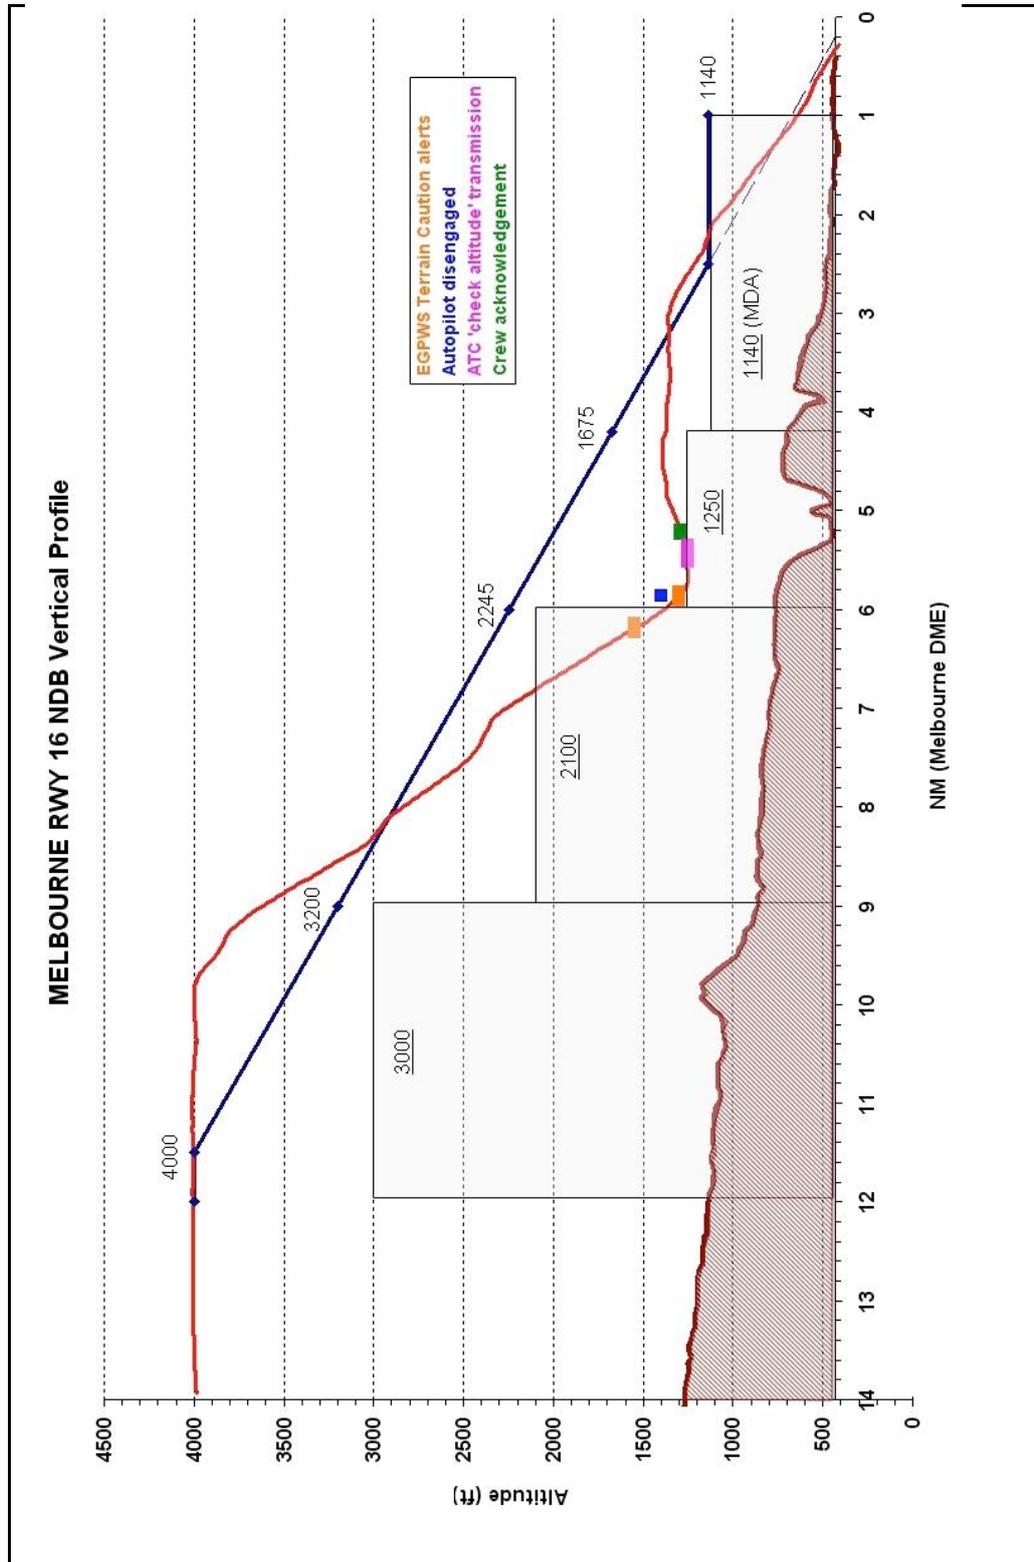
Figure 2: Approach profile (in red) derived from FDR data, published constant angle descent path (in blue), segment minimum altitude limiting steps (in grey) and terrain profile (in brown).

Soon after commencing the approach, the crew configured the aircraft for landing and at 1308:21 they selected the landing reference speed of 142 kts on the MCP. The FDR indicated that the rate of descent averaged 1,500 ft/min during the 114 second descent, with a maximum of 1,808 ft/min when the aircraft was 8.5 DME. The aircraft descended below the 2,100 ft segment minimum safe altitude step at 6.8 DME (Figure 2).

At 1309:08 the aircraft was about 6.25 DME descending through 1,544 ft, which was below the 2,100 ft segment minimum safe altitude. At this time, the enhanced ground proximity warning system (EGPWS) annunciated 'caution terrain' for 4 seconds and the terrain display and terrain caution message appeared on the navigation displays on the forward instrument panel for 15 seconds. At 1309:18, a second EGPWS 'caution terrain' was annunciated for 4 seconds.
