ATSB TRANSPORT SAFETY INVESTIGATION REPORT

Aviation Occurrence Investigation – 200701033

**Loss of Control
Clyde North, Victoria
23 February 2007**

Van's Aircraft Inc. RV-4, VH-ZGH

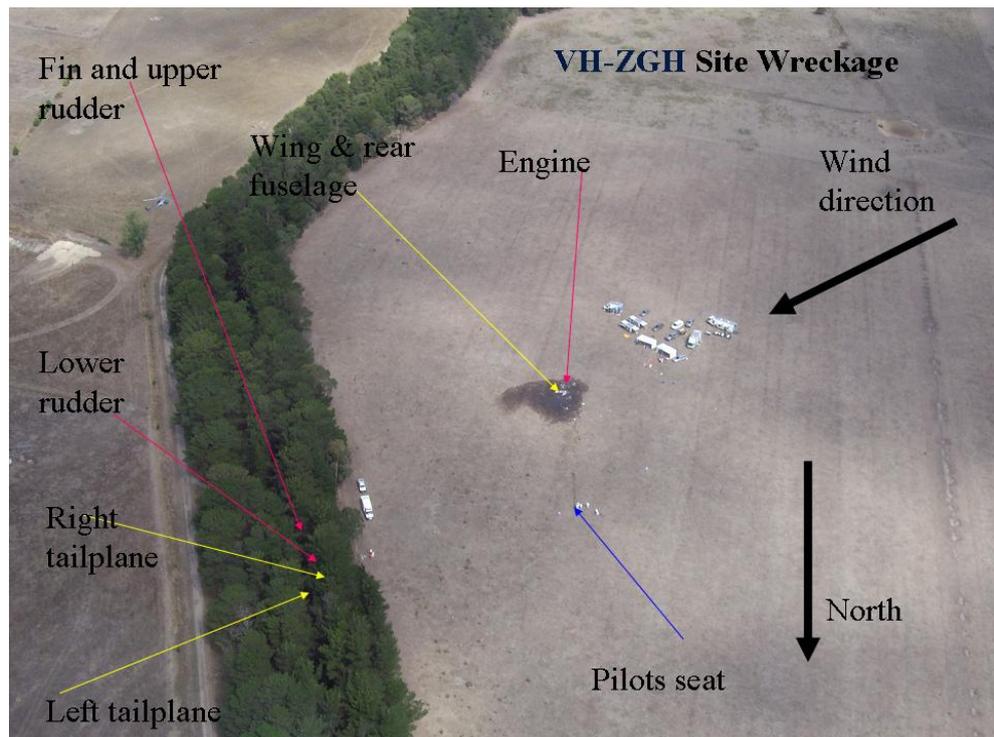
Figure 2: Accident site

The terrain at the accident site was flat and open. An examination of the site revealed the aircraft had impacted the ground in a very steep, nose-down attitude at high speed.

Both right and left tailplanes, the fin and rudder were recovered in trees approximately 117 metres from the main aircraft impact point (Figure 2). The left and right elevator balance weights were recovered either side of the burnt area of the accident site.

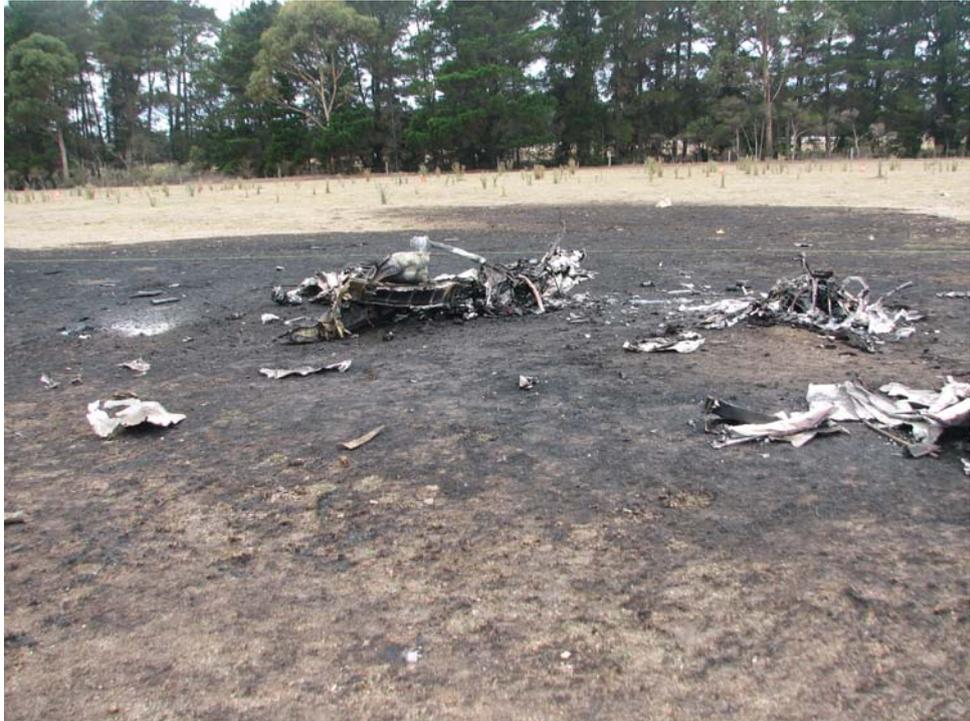
Figure 3: View of wreckage

The force of the impact and the subsequent fire resulted in disintegration of the aircraft (Figure 3). As a result, no instrumentation was able to be recovered from the wreckage. An examination of the engine and propeller showed that the engine was developing significant power at the time of impact.

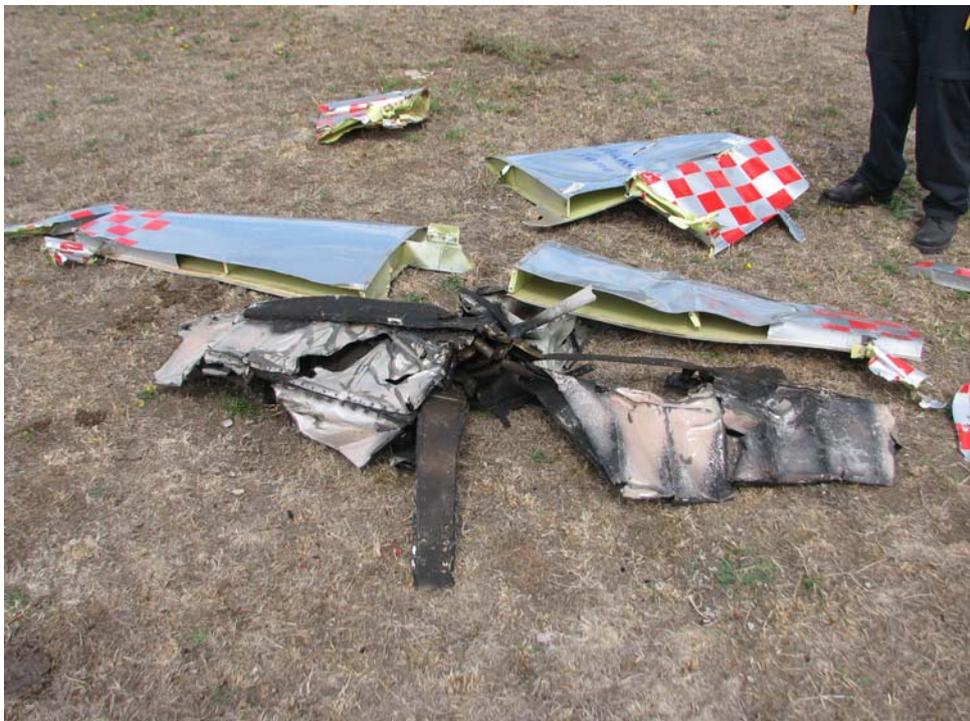
Figure 4: Fin, rudder, and tailplanes with the spars and elevators loosely assembled after recovery.

The ground marks and twisting of the tailplane rear spar indicated the aircraft had been rotating in a clockwise direction at the time of impact. Examination of the separated tail structures (Figure 4) showed twisting and tearing of the attachment fittings.

The structural integrity of the separated tail aerofoil sections (Figure 4) was assessed against the original approved construction drawings. This showed that the tailplanes and the fin and their attachments were compliant with the design specifications.

- The pilot performed manoeuvres in an aircraft that was loaded above the maximum weight limit for aerobatic flight and with the centre of gravity outside the rear limit.
- The pilot probably lost control of the aircraft performing an aerobatic manoeuvre and entered a spin from which he was unable to recover.
- The aircraft structure failed as the result of the aircraft exceeding its design limits during aerobatic manoeuvres.

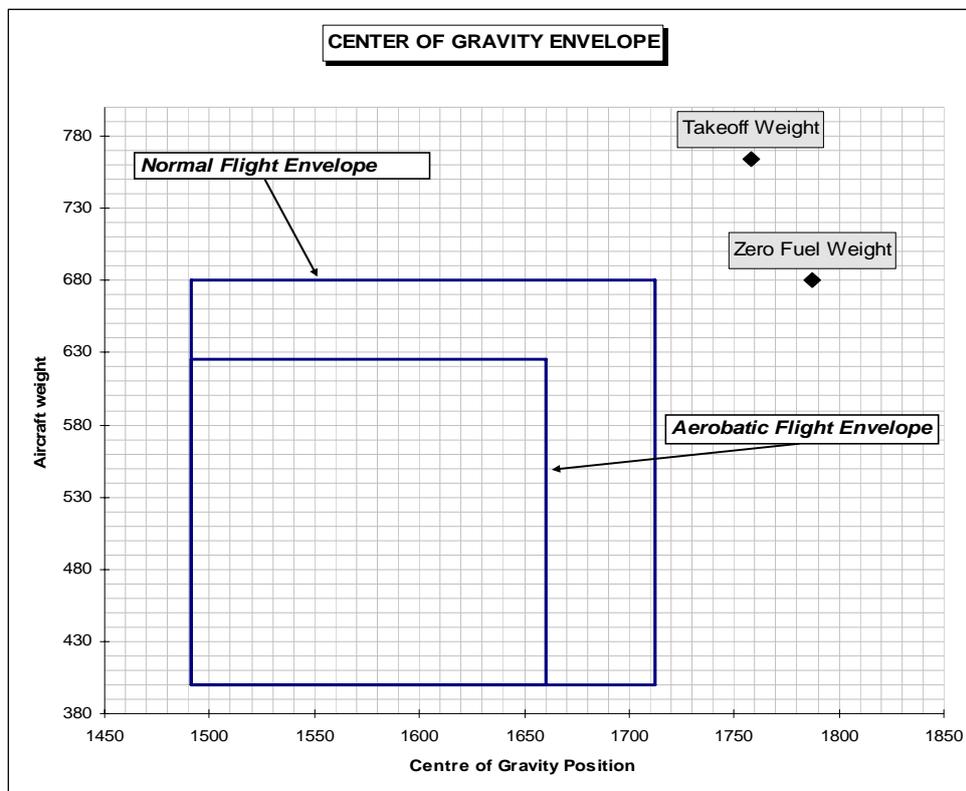
Figure 6: Centre of gravity envelope for VH-ZGH

Based on the above weights, the take-off weight of VH-ZGH on its final flight was calculated to be 764.5 kg. This exceeded the maximum allowable weight for normal flight operations by 84.5 kg and for aerobatic operations by 139.5 kg. In addition, the centre of gravity at this weight was determined to be at 1757.9 mm, which was 97.9 mm outside the limit permitted for aerobatic manoeuvres.

Figure 6 shows the C of G envelope for normal and aerobatic flight in VH-ZGH. Also plotted for the accident flight is the zero fuel weight (aircraft fully laden but without fuel) and the take-off weight (aircraft fully laden with fuel added). The diagram indicates that both the zero fuel weight and the weight of the fuelled aircraft on the accident flight were well outside the envelope for safe flight.

With the rear centre of gravity (C of G) calculated to be 97.9 mm outside the limit permitted for aerobatic manoeuvres, positive control about the pitch and yaw axis of VH-ZGH was diminished.

With the C of G behind the rear limit, the moment arm of the rudder would be reduced, making the rudder less effective at stopping the aircraft from spinning. This would be further compounded because the aircraft was overweight, resulting in a higher stalling speed. Recovery from a spin with the C of G so far to the rear of the approved limits (Figure 6) was untested and likely to be difficult or impossible.
