RAIL SAFETY INVESTIGATION
2003/002

Derailment of Pacific National Freight Train 1SP2N and the Subsequent Collision of V/Line Passenger Train 8318

near Chiltern, Victoria
16 March 2003

June 2004

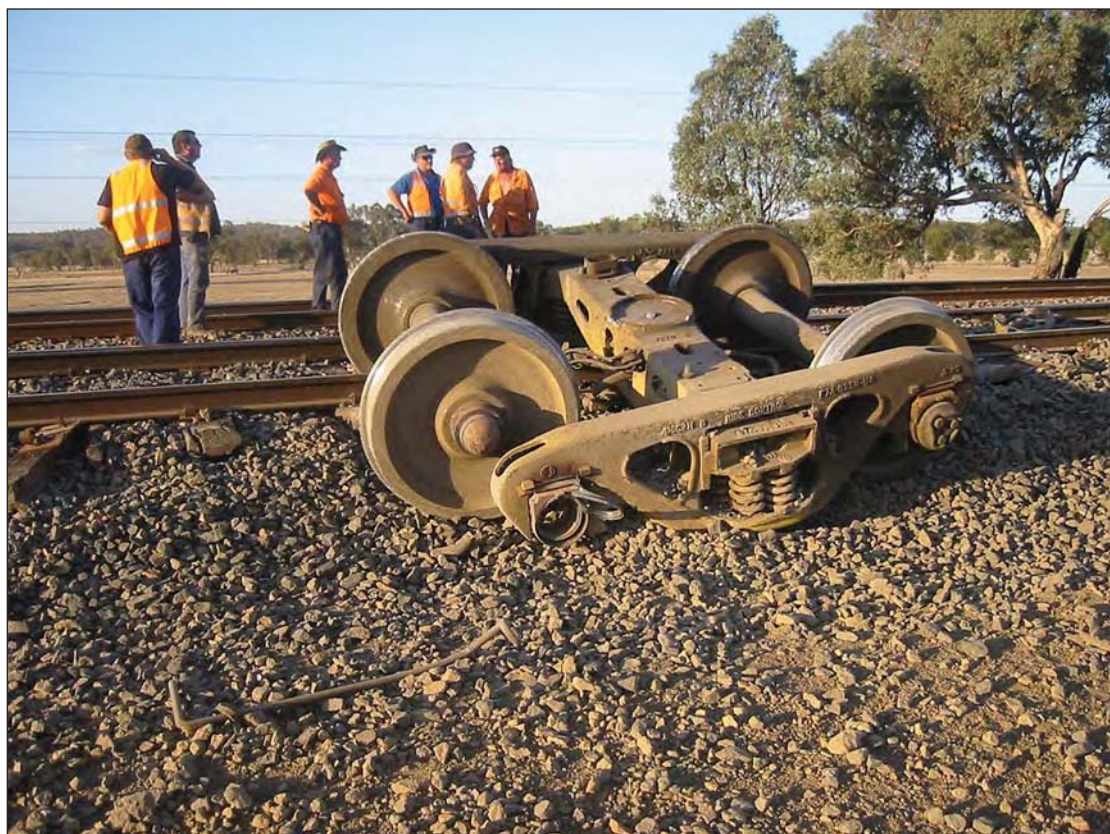
FIGURE 1:
Screwed journal within bogie

The derailment of train 1SP2N was caused by a 'screwed journal' on a wagon located in the 15th position of the train consist. The wagon had reportedly been in storage for several years and had been re-introduced into service. The screwed journal was the result of a failed wheel bearing due to a loss of interference fit on the axle journal. Heat (from friction) built up to a point at which the bearing seized and the journal detached from the axle. The wheelset then became unstable causing the derailment.

A damaged axle journal from a wagon off train 1SP2N was found adjacent to the track in a position close to, but on the Albury side of where the train started to derail. The separated axle journal was sufficiently hot to ignite a grass fire in the adjacent field. The axle journal had screwed off⁴ the axle causing instability within the wheelset, leading to the derailment.

⁴ Progressive failure of the bearing unit resulted in heating (from friction) of the axle journal. Seizure of the bearing then resulted in the journal 'screwing off' the axle.

The failed railway bearing unit (RBU) had experienced a loss of interference fit on the axle journal. The RBU failure led to the axle journal failure and subsequent derailment. There are a number of potential contributing factors to loss of interference fit for RBUs. These are discussed in the body of the report in Section 5.4. Considering all of the investigation evidence the most likely cause of the RBU failure was outboard roller assembly inner ring loss of interference fit on the axle journal.

The axle journal had screwed off the axle due to bearing failure. The loss of bogie stability combined with the weight of the vehicle and load caused instability within the wheelset, loss of tracking ability and subsequent derailment of the vehicle.

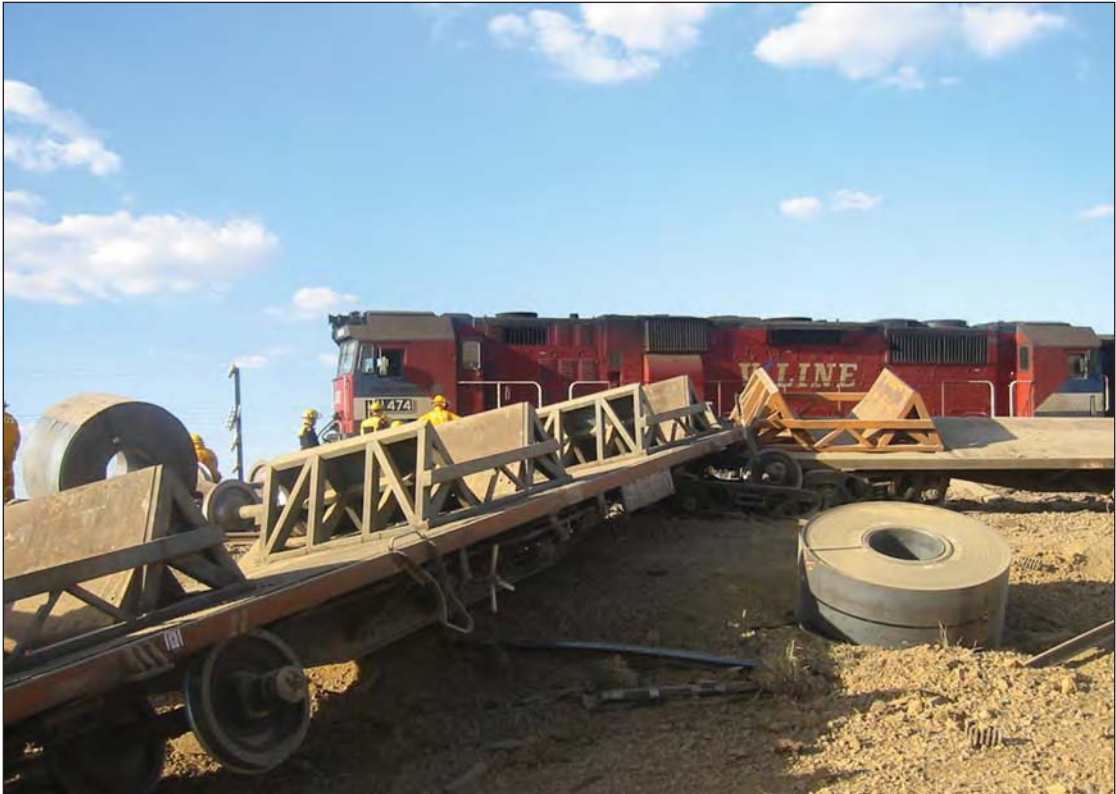
FIGURE 2:
Derailed site

Damage to the rolling stock was extensive as a result of the derailment. Twenty one wagons, from the 14th to 34th position, were derailed. Wheelsets and bogies were dislodged from their position on a number of wagons. Train 1SP2N was transporting various goods including steel coil, steel pipes, steel slab, and sugar hoppers. The derailment dislodged steel pipes and coils, which were thrown from their loaded position within the wagons and scattered throughout the derailment site. A number of wagons were damaged beyond repair.

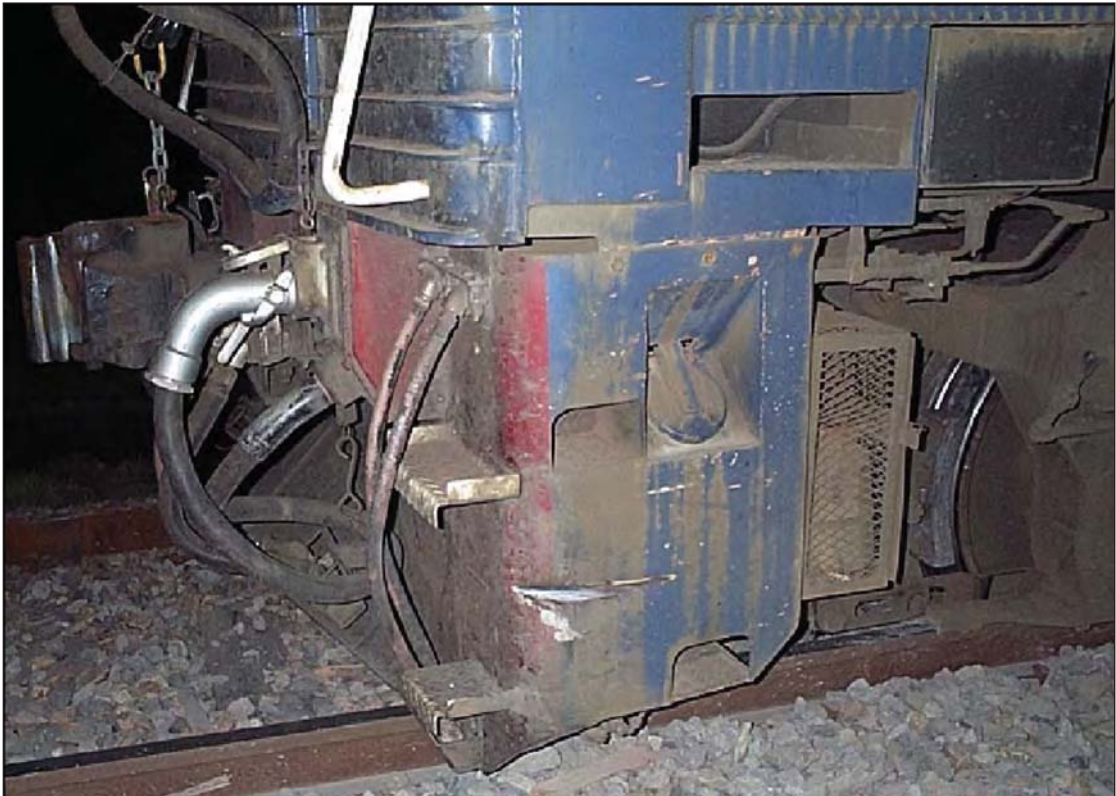
FIGURE 3:
Damaged locomotive N474

V/Line passenger train 8318 struck wreckage from train 1SP2N. The locomotive, N474, showed strike mark evidence on the front 'cow catcher' and along both bogies. The locomotive and first two passenger carriages also had minor damage to wheel sets as a result of derailing. The locomotive fuel tank, containing diesel fuel, was punctured allowing fuel to leak onto the track.

The fuel tank on of the V/Line N Class locomotive had been punctured by the impact and fuel had spilt at the site. The driver of the V/Line train had used rags from the locomotive to initially plug up the hole, the CFA affixed temporary plugs until decanting of the fuel could take place. An amount of diesel fuel had leaked onto the track ballast.

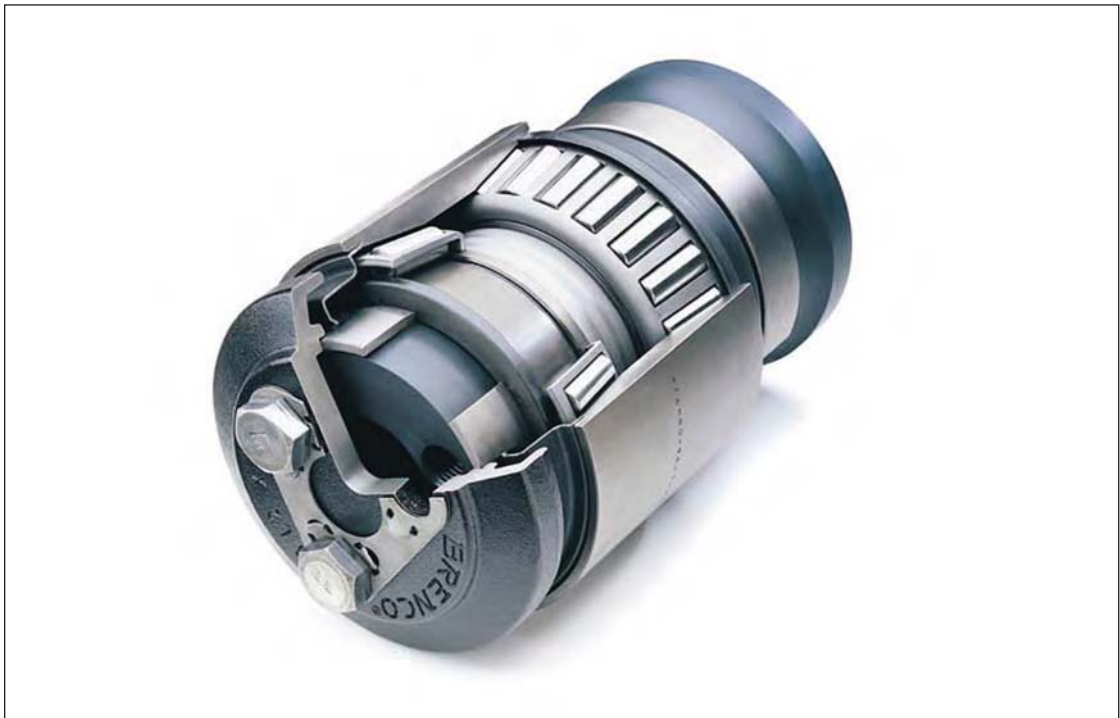
FIGURE 5:
Brenco sealed roller bearing unit (cut out)

The Pacific National wagon, RKTF2955X, was classified as an open goods wagon. It had entered service in 1975. In 1992 the wagon underwent maintenance at Islington (South Australia) which included sealed roller bearing unit (SRBU) replacement. The wheelset that failed was fitted with two different brands of SRBU's, (Timken and Brenco) one on each axle journal, although this is generally not recommended by bearing manufacturers. The failed bearing was manufactured by Brenco.

For bearings already mounted and out in storage or under wagons, the situation is different. Although the bearing is sealed, hot and cold, dry and wet weather cycles cause the bearing to 'breathe'. The air that passes in and out of the bearing over time includes moisture from the air. Over time, the lubricant film on the internal bearing surfaces may thin and allow moisture to react with the surfaces. Moisture condenses out into the bearing and collects where the rollers meet the inner and outer races. If left too long, this can lead to lines of water etch across the raceways.

Rotating the bearings by hand or moving the wagon allows the grease that is slumped in the bottom of the bearing to replenish the raceway surfaces. While there is no 'official' Brenco position, Brenco Service Engineers normally recommend turning all bearings at least two revolutions and moving all cars at least one car-length every 30 days of storage. For non-severe weather conditions, performing this task every 60 days should be adequate. For any bearing that has remained stationary in the field for a period exceeding six months, bearing removal and reconditioning should be considered.

The '30 to 60 day turn' recommendation will significantly decrease the potential for corrosion thus assuring maximum bearing performance and protecting a customer's investment.

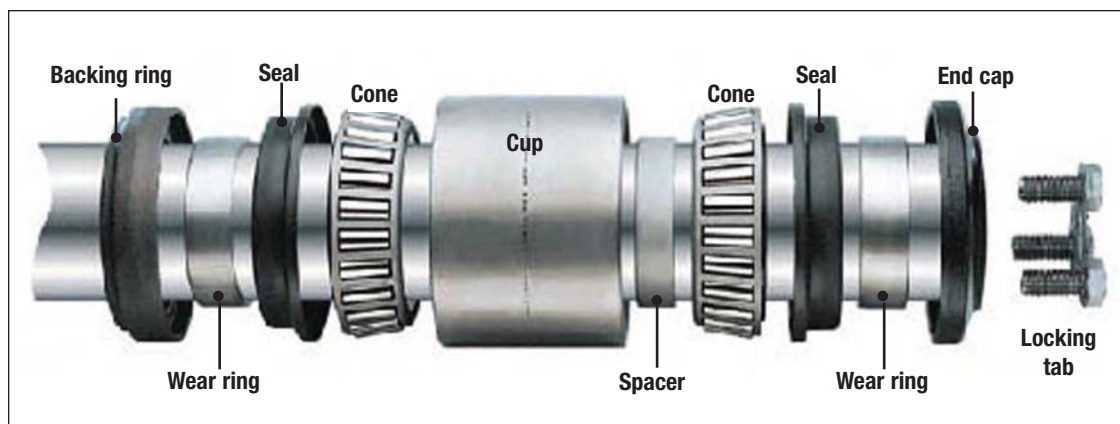
FIGURE 6:
Sealed roller bearing unit assembly

The maintenance records for the wagon and bogie were incomplete with no record covering the period from 1975 to June 2000. For this reason it is unclear if the failed bearing was new or requalified (reconditioned). At that time (October 1992) the wagon was owned by Australian National (AN). Over the following years ownership of the wagon transferred from AN to National Rail (NR) then recently to Pacific National in February 2002. During this time the wagon had sporadic use and was (reportedly) mostly kept in storage.

The lack of historical information for wagon RKTf2955X from previous owners/maintainers is considered to be a system deficiency. It does not allow an effective analysis of the history of a critical unit.

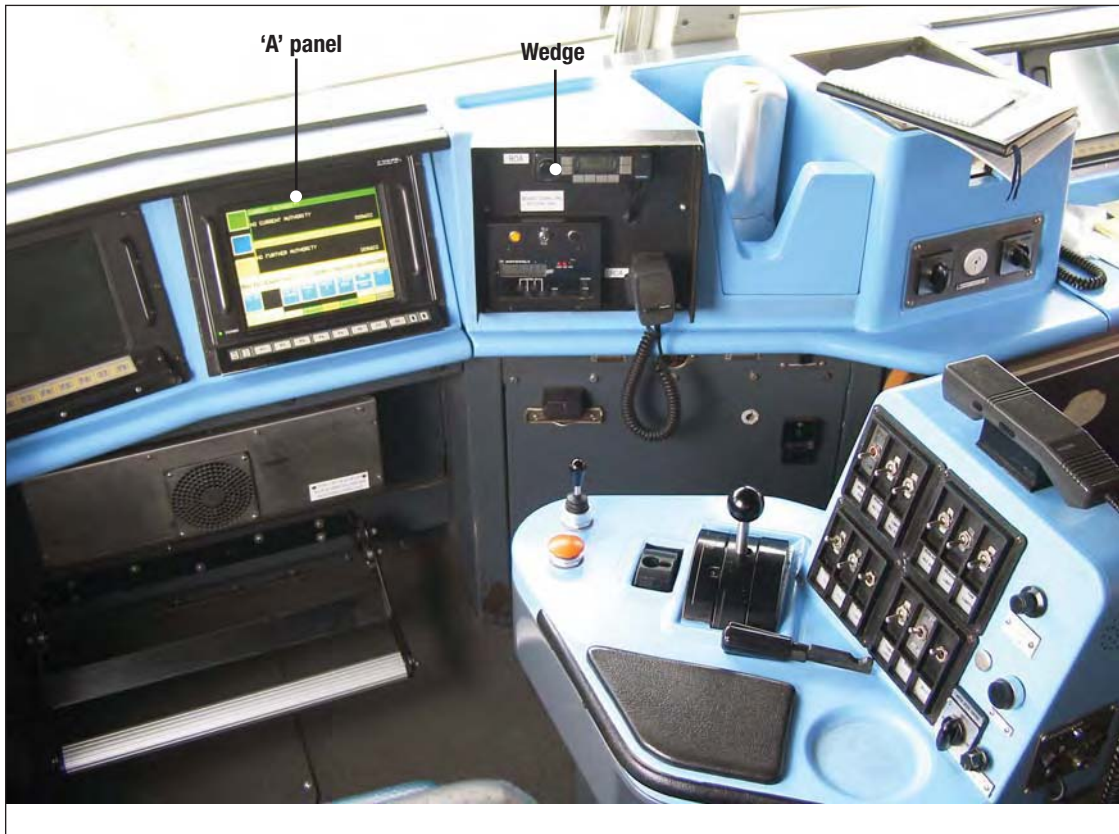
FIGURE 7:
Driver's work area showing 'A' panel and wedge radio system

The Pacific National drivers knowledge of operating the AWARE ‘B’ panel during emergencies was not comprehensive.

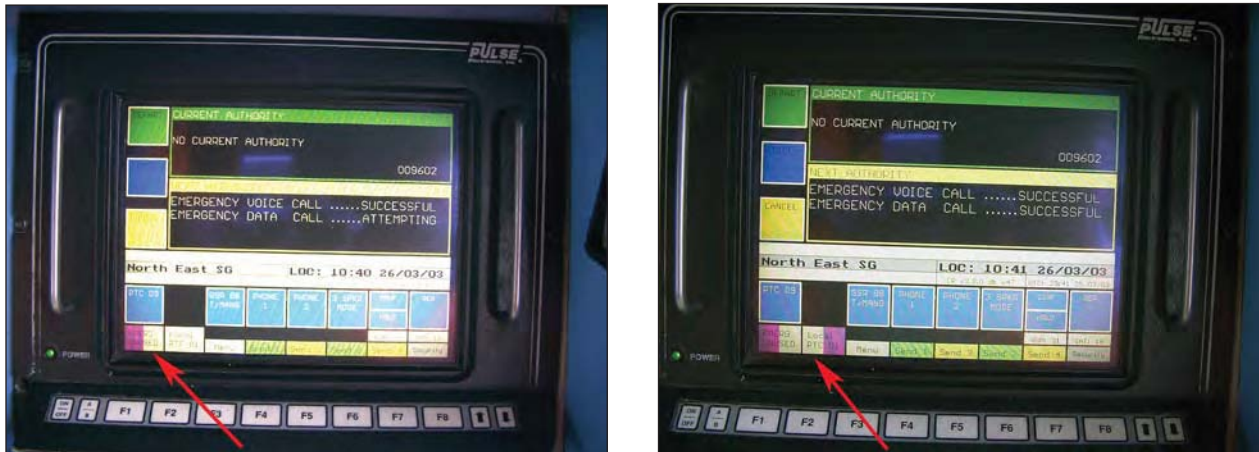
FIGURE 9:

On 26 March 2003 the investigation team tested the function of the radio system on locomotive NR66 in the Pacific National depot at Dynon Victoria. An emergency call was initiated from the 'A' panel while the end – to – end radio was activated on the 'B' panel, both calls were initiated successfully.

'A' panel showing emergency call, 'B' panel showing emergency call and simultaneous end – to – end radio call
