**Piper PA-23-250 Aztec, VH-WAC  
1 km WSW Mareeba Aerodrome, Qld.  
1 October 2003**

**INVESTIGATION REPORT  
BO/200304091**

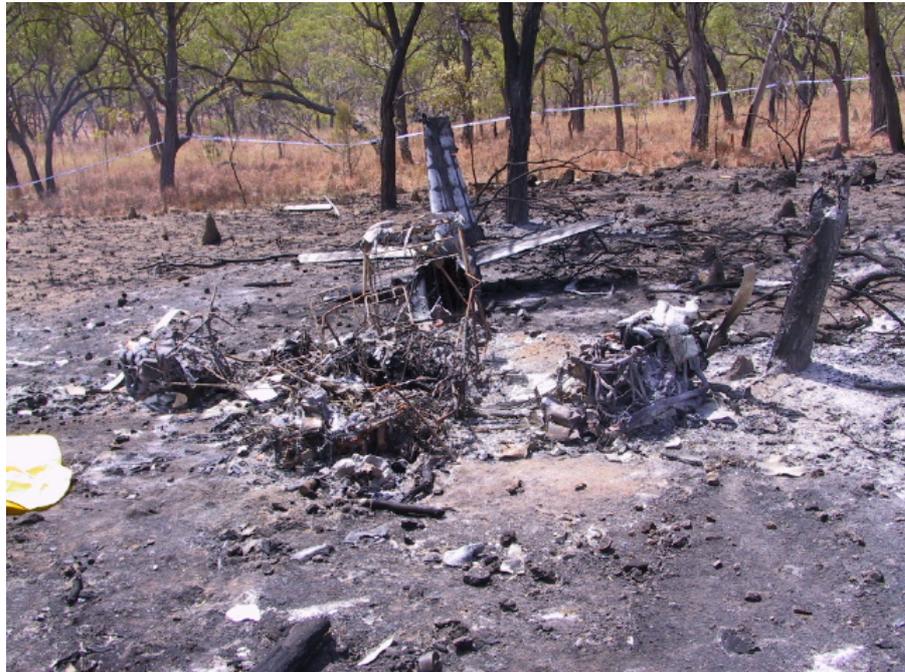
An intense post-impact fire resulted in significant melting and destruction of much of the aircraft structure and components (refer figure 2). The fire damage prevented a conclusive determination of the functionality of the aircraft's systems prior to impact. All aircraft extremities were located at the accident site and the distribution of the wreckage indicated that the aircraft did not sustain a major structural failure prior to impact. The landing gear and flaps were retracted at impact, and the rudder and horizontal stabilator trim tabs were within the range of normal take-off positions. Propeller and impact evidence indicated that both engines were delivering substantial power at the time of impact. The wreckage examination did not identify any pre-existing defect that could have contributed to the development of the accident. A small piece of recovered windscreen did not exhibit any evidence of a birdstrike.

**Figure 2.** Aircraft destroyed by impact forces and post-impact fire

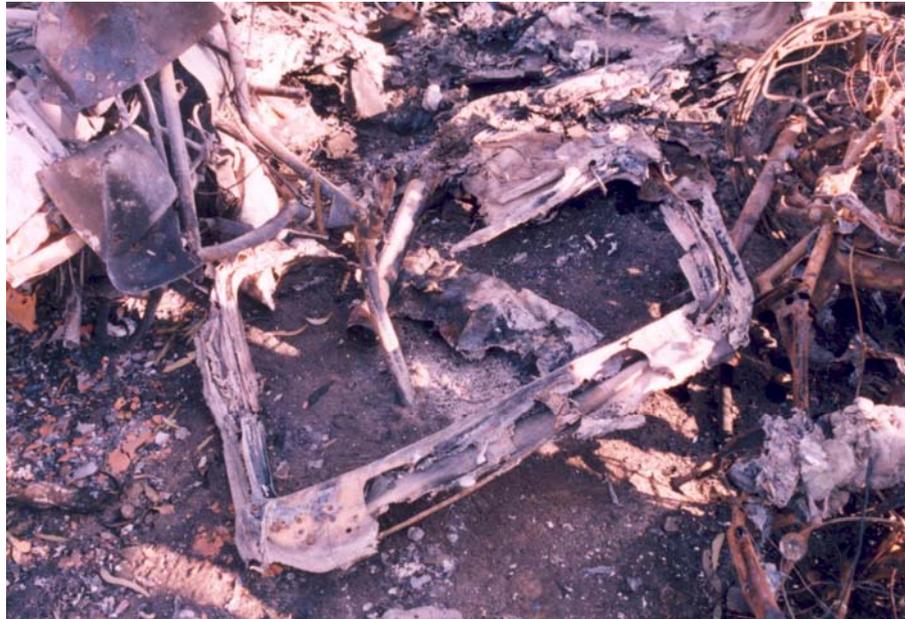
The remains of the cabin door were located immediately adjacent to the right of the fuselage, on top of the remains of the right wing. Because of the extent of airframe destruction, the investigation could not establish from the door itself whether it had been closed or open at impact (refer figure 3).

**Figure 3. Burnt cabin door**
