1. FACTUAL INFORMATION

1.1. History of the event

1.2. Damage to the aircraft

1.5. Wheel failure

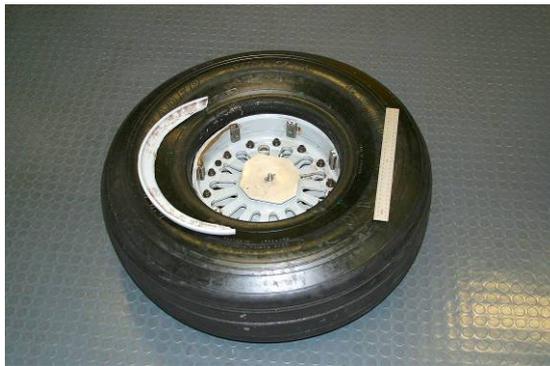
The failed wheel and tyre assembly was forwarded to the ATSB's Canberra technical analysis laboratory for detailed examination. Initial inspection showed that approximately one half of the bead seat circumference had fractured away from the inner rim hub (figure 1), allowing the tyre to ride completely off the rim. The rim fracture (figures 2, 3) had followed a radial path through the bead seat radius, with a central fracture area exhibiting fatigue crack progression markings originating from a point location on the bead seat radius surface (figure 4). The progression markings extended circumferentially for 110 mm before transitioning to a uniform, featureless, fracture typical of ductile overload failure in high-strength aluminium alloys.

Fig. 1 Left outboard main wheel assembly – as received.

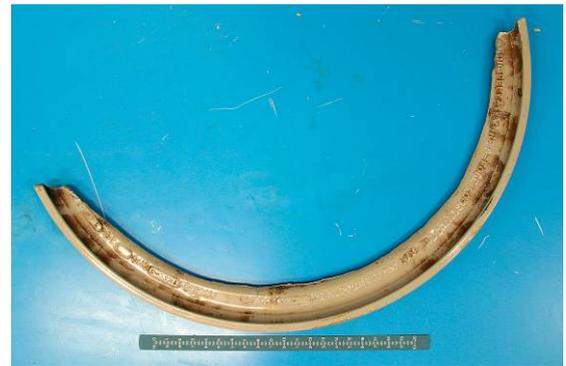
Fig. 2 Section of the inward-facing rim bead seat that had broken away from the wheel rim.

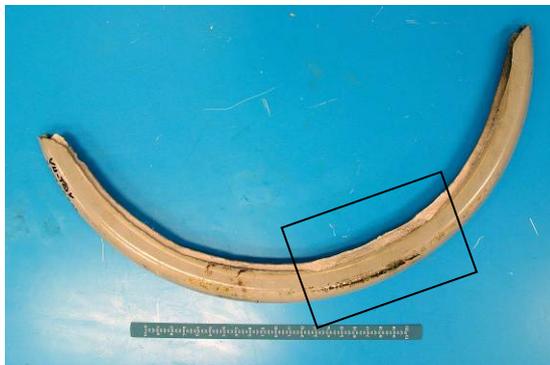
Fig. 3 Inside surfaces of the fractured rim section. The boxed area is shown in greater detail in figure 4

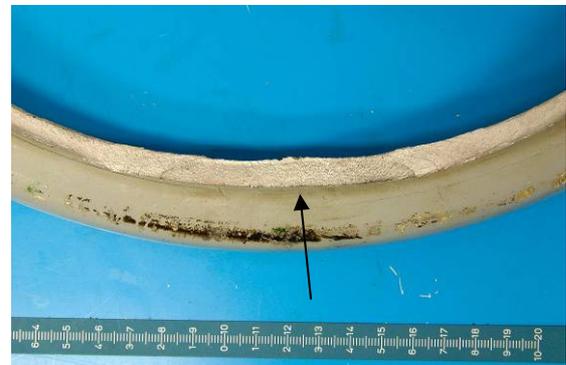
Fig. 4 Fracture surface detail showing crack progression (beach) marks extending from the arrowed location on the bead seat transition radius.

ATSB laboratory analysis characterised the rim failure as the result of a progressive fatigue cracking mechanism, initiated from a location on the internal bead seat transition radius. Around the rim circumference, the internal bead seat radius was the region of maximum tensile bending stresses induced by pneumatic pressures and tyre flexure. The dynamic nature of wheel operation results in the generation of cyclic stresses within the rim as the wheel rotates. The orientation of the rim fracture sustained by VH-TQX was consistent with the rim bending forces dominating the initiation and growth of fatigue cracking within the rim section. The investigation did not identify any material or manufacturing defects at the fatigue crack origin that might have contributed to the development of cracking from that area.

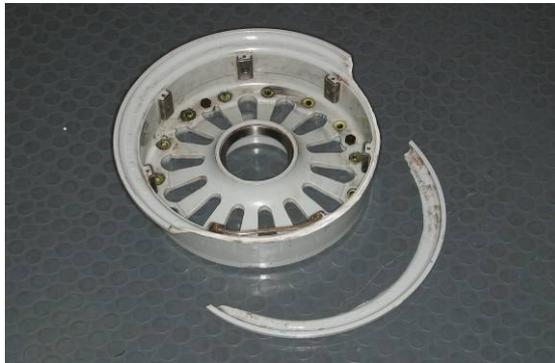
Separation of the rim halves and removal of the tyre allowed inspection of the hub side of the fracture (figure 5 & 6). The fracture features (figure 7) were essentially a mirror of the separated rim section, with fatigue crack progression clearly evident. The crack origin was located approximately 42 degrees around the transition radius between the bead seat and the rim cylinder (figure 8). Optical and scanning electron microscopy of the origin area showed no evidence of pre-existing material or manufacturing defects. A few areas of surface oxide material were shown by metallographic examination to be accumulations of surface contaminants or corrosion products.

Fig. 5 Inner rim half after removal of the tyre.

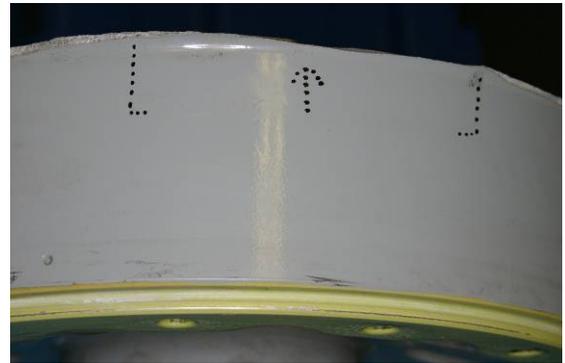
Fig. 6 Cylindrical surface of the inner rim half, with the fatigue crack origin and extent of propagation marked.

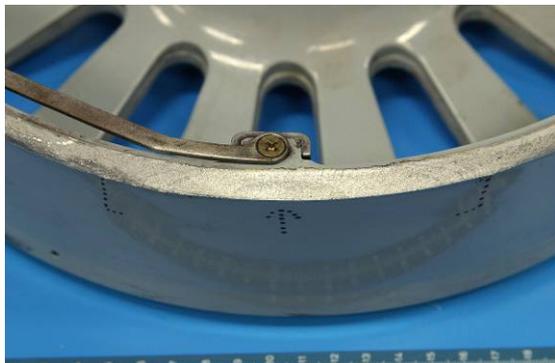
Fig. 7 Fracture features on the rim hub section. Markings as shown in figure 6.

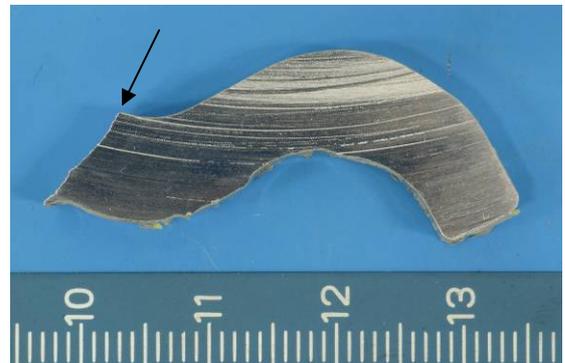
Fig. 8 Cross-section through the bead-seat section showing the crack origin position on the transition radius (arrowed).

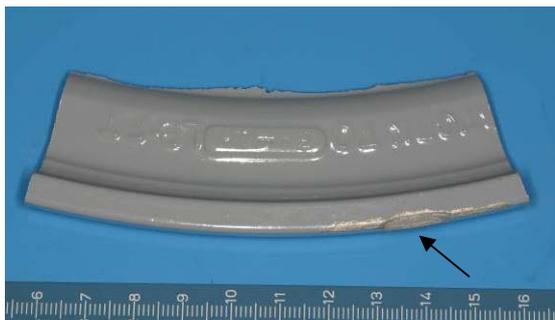
Evidence of a localised physical impact on the inboard rim edge (figure 9) was found approximately 35 mm (circumferentially) from the crack origin, although the investigation was not able to establish whether the impact had occurred prior to, or as a result of, the bead seat separation.

Fig. 9 A section of the fractured rim bead seat showing evidence of impact damage on the outer corner (arrowed).
