Aviation Safety Occurrence Report – 200605843

Preliminary

**In-flight break-up
20 km NE Bathurst, NSW
BAC 167 Strikemaster, VH-AKY
5 October 2006**

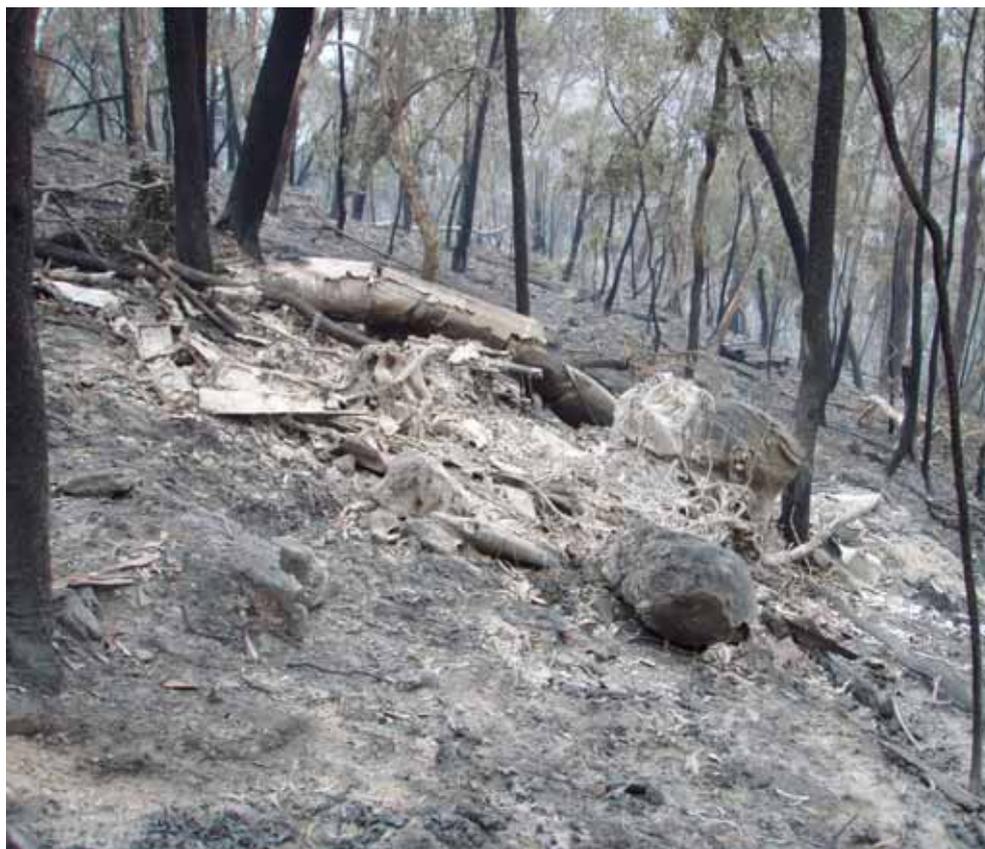
Figure 2. Main aircraft wreckage

- the engine was producing significant power at the time of impact
- the wing flaps and landing gear were retracted
- the right wing had separated in-flight
- tail components had separated from the aircraft in overload as a consequence of separation of the right wing.

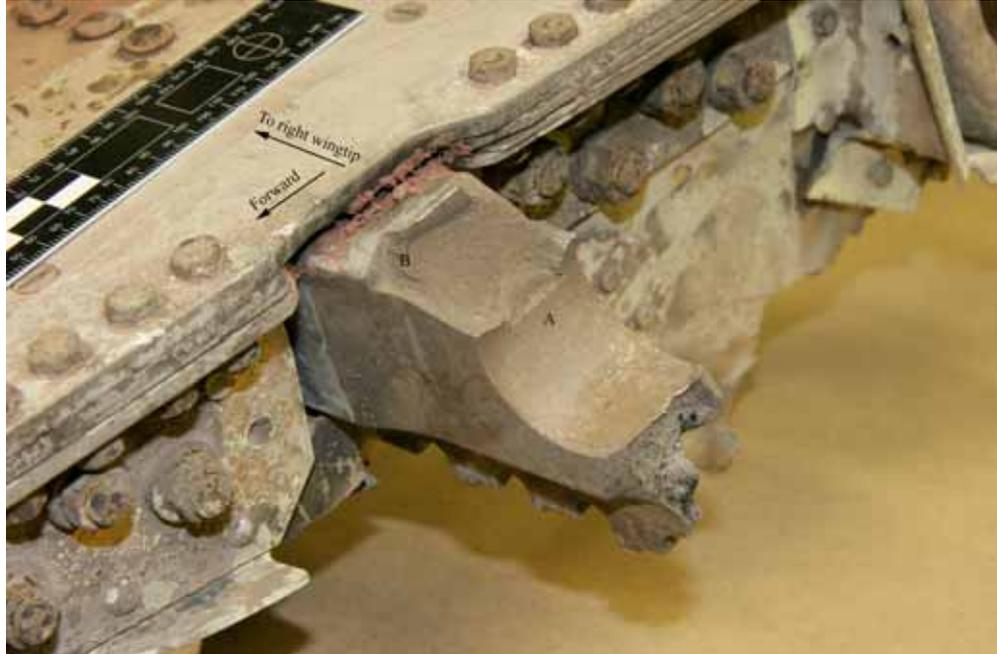
Figure 3. Fracture surface location

The separation of the right wing had initiated from the upper wing main spar attachment lug (figure 3) under downward bending conditions. The investigation found two areas of pre-existing fatigue cracking in the wing attachment lug, identified as positions A and B (figure 4). Area A was the larger of the two, with an

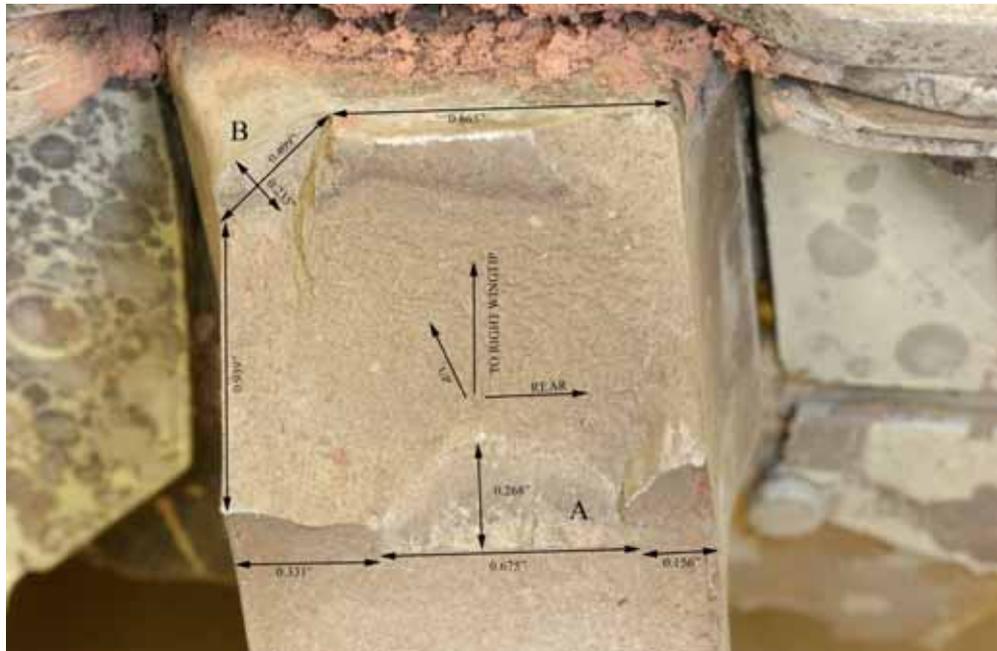
Figure 4. Fracture surface and dimensions

origin at the lug bore surface. Area B appears to have initiated from an area of prior surface/corner blending, which had possibly been carried out for previous defect removal purposes.

As a result of this occurrence, the ATSB briefed the Civil Aviation Safety Authority (CASA) on preliminary findings relating to the wing failure. CASA released *Airworthiness Bulletin AWB 02-018 Issue 1* on 10 October 2006 and subsequently, *Airworthiness Bulletin AWB 02-018 Issue 2* on 20 October 2006. The bulletins were applicable to all BAC 167 Strikemaster and Jet Provost aircraft.
