# Derailment of freight train 4DA2 near Cadney Park, South Australia

## 25 November 2010

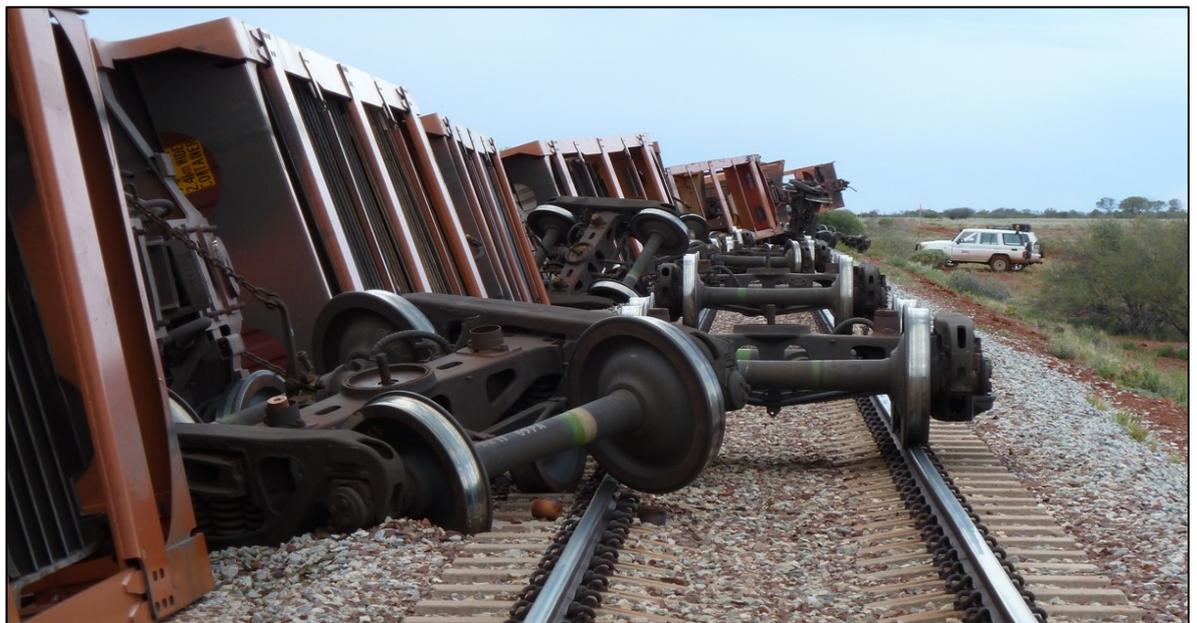
Figure 1: Derailment site, (rear part of train 4DA2) looking towards Adelaide

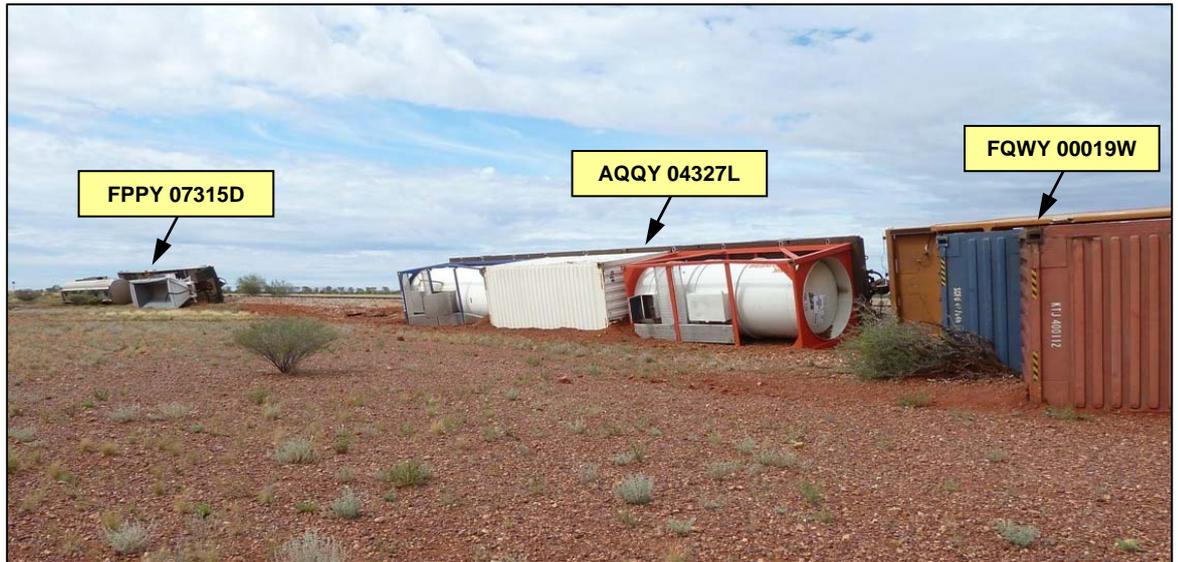
Figure 2: Derailed wagons FQWY 00019W, AQQY 04327L and FPPY 07315D

Examination of the derailment site focused on FQWY 00019W, the 21st wagon (Figure 2) in the consist, a double-stacked container (this unit was considered the initiator of the derailment), and the track in the immediate vicinity of this wagon to establish the likely point of derailment (POD).

FQWY 00019W was the first in the series of 13 double-stacked container wagons, all of which had capsized to the east of the track. The two wagons ahead of FQWY 00019W (AQQY 04327L and FPPY 07315D see Figure 2) probably derailed as a consequence of being pulled over by FQWY 00019W as it capsized.

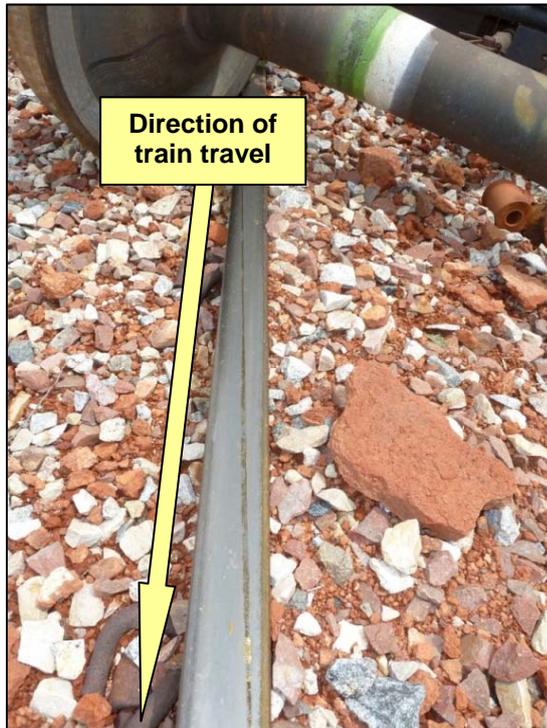
- A single diagonal wheel contact mark<sup>5</sup>, about 2 m in length, (Figure 3) was found on the head of the eastern rail about 70 m before the resting place of derailed wagon FQWY 00019W. The mark extended from the inside to the outside of the rail head. This indicated that a wheel had ridden up and over

the rail at this point. It then dropped off on the field side of the eastern rail. From this point on the ballast was gouged into the sub-grade as the wheels and bogie side frames of derailed wagons dragged along the track, breaking the sleeper ends in the process. About 10 m after the POD the derailed wagons also began to push the eastern rail in towards the western rail causing the gauge to narrow, escalating the derailment process.

**Figure 3: Wheel contact mark**
