INVESTIGATION REPORT
199901959

Traffic conflict near Port Macquarie

VH-IMA, VH-IMH, VH-SVV, VH-TQO
28 April 1999

AIR SAFETY OCCURRENCE REPORT

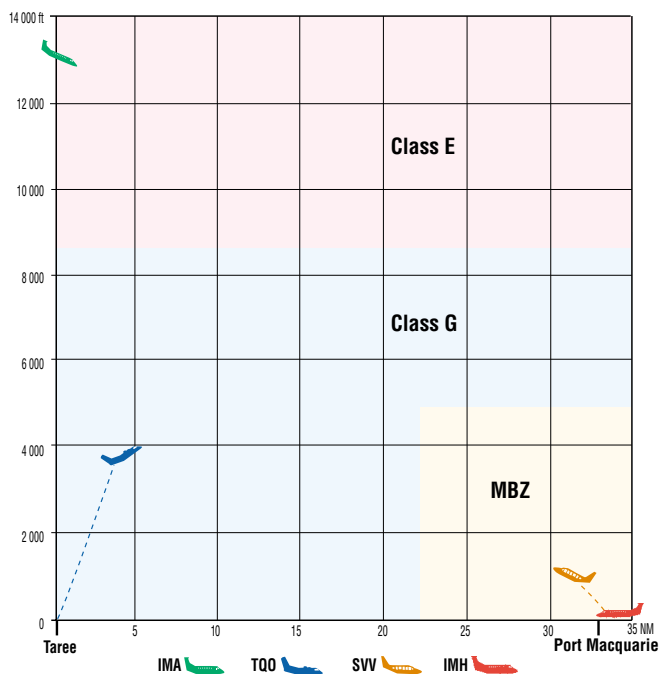
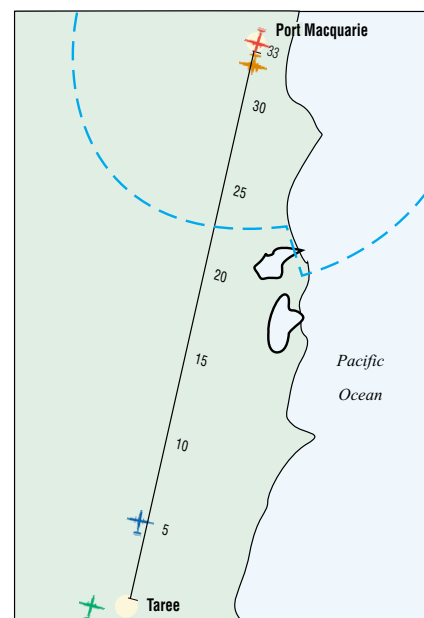
Situation at 2000 EST

All four aircraft were operating under instrument flight rules (IFR) and the flight paths had been planned along the same nominal track—between Port Macquarie and Taree.

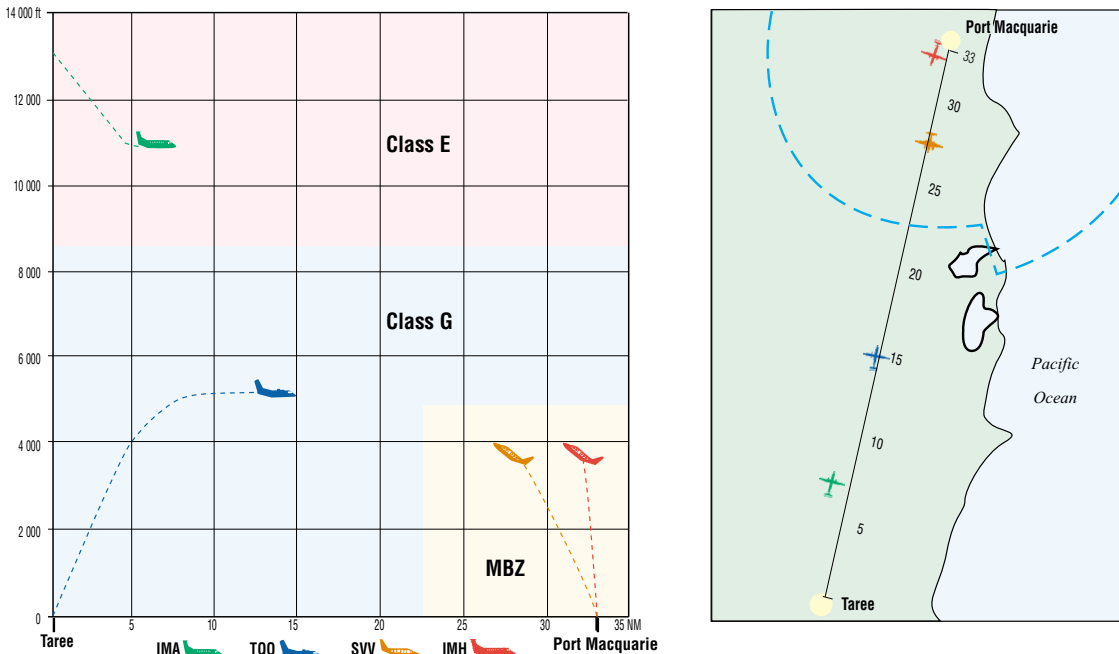
Situation at 2002 EST

At 2002, the crew of IMA broadcast on the Port Macquarie mandatory broadcast zone (MBZ) frequency (118.1 MHz) that they were descending to flight level 110. The crew of TQO responded to that call and then asked the crew of IMH if they were airborne. The reply (at approximately 2002:20) was affirmative and that they were climbing through 4,600 ft.

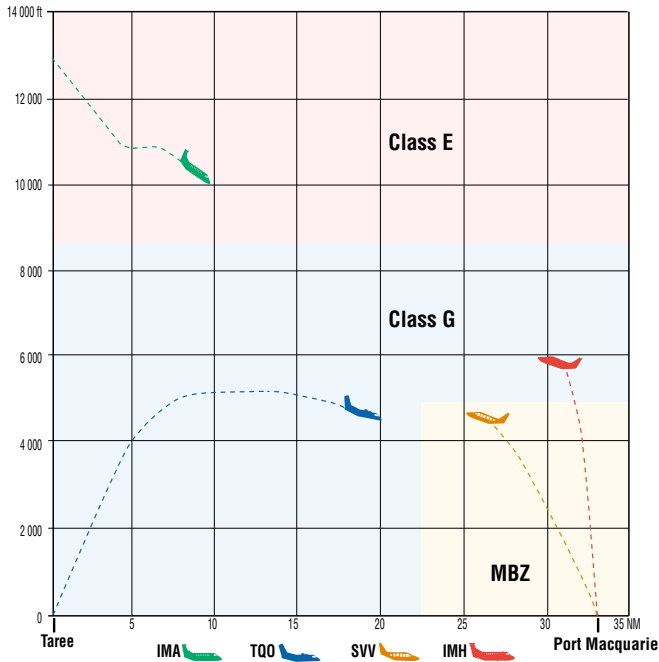
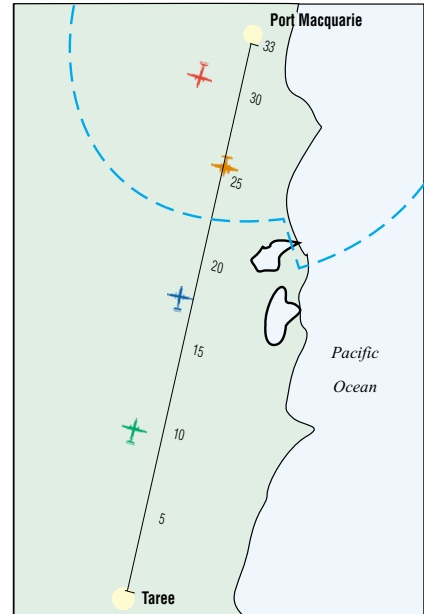
Situation at 2003 EST

At 2003, the crew of IMA broadcast on the MBZ frequency that they were 23 NM south of Port Macquarie and descending to 9,000 ft. They then asked the pilot of SVV for his position, which he reported as 8 NM south and climbing through 4,800 ft. The crew of IMH reported that they heard this exchange but did not acknowledge the broadcast. However, they did elect to maintain 8,000 ft.

Also at 2003, the crews of IMH and SVV were instructed by the flight service officer to contact air traffic control approaching 8,500 ft; the base of controlled airspace in that area. At about the same time, the crew of TQO reported on the flight service frequency that they were transferring to the Port Macquarie MBZ frequency.

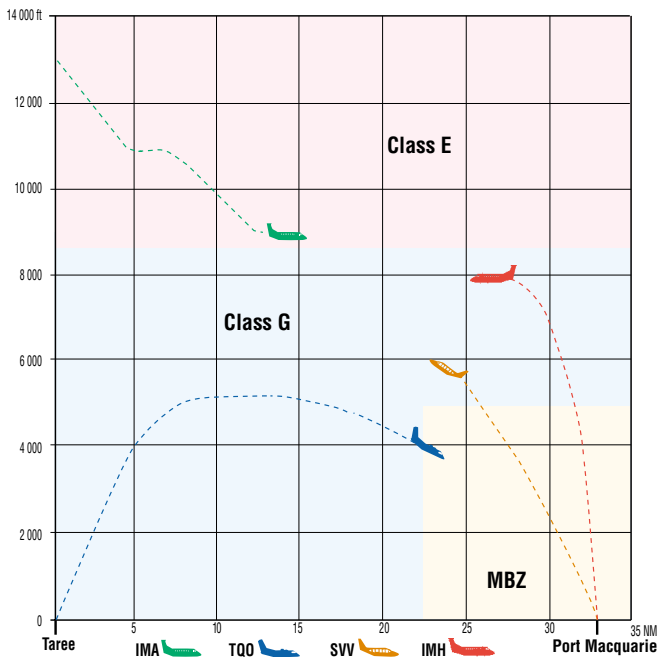
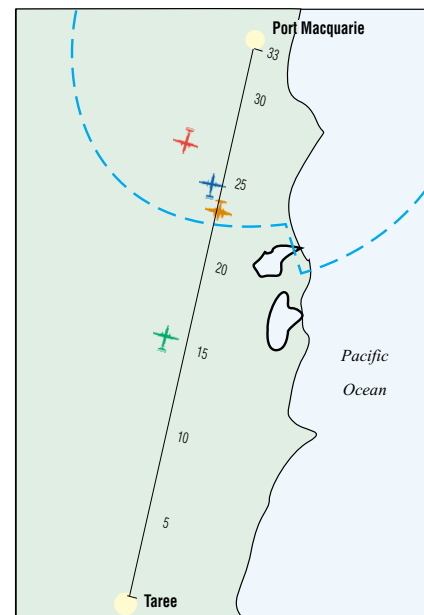
Situation at 2004 EST

At 2003:34, the crew of IMH contacted the sector controller and requested an airways clearance. He reported that the aircraft was 5 NM south of Port Macquarie and passing 7,500 ft. The controller had not received any coordination on the aircraft from flight service and there was an exchange of information with the crew, which included the issue of a secondary surveillance radar transponder code, that lasted until 2005:05. At that time, the controller identified IMH on radar and issued a traffic conflict advice to the crew, which gave the radar-observed position of IMA as 3 NM at 12 o'clock and indicating an altitude of 8,000 ft on descent.

At 2003:57, the crew of IMH questioned the flight service officer regarding the non-availability of a transponder code from air traffic control. The code had not yet been issued to the flight service officer by the sector controller because the flight service officer had been unable to perform the coordination with the sector controller.

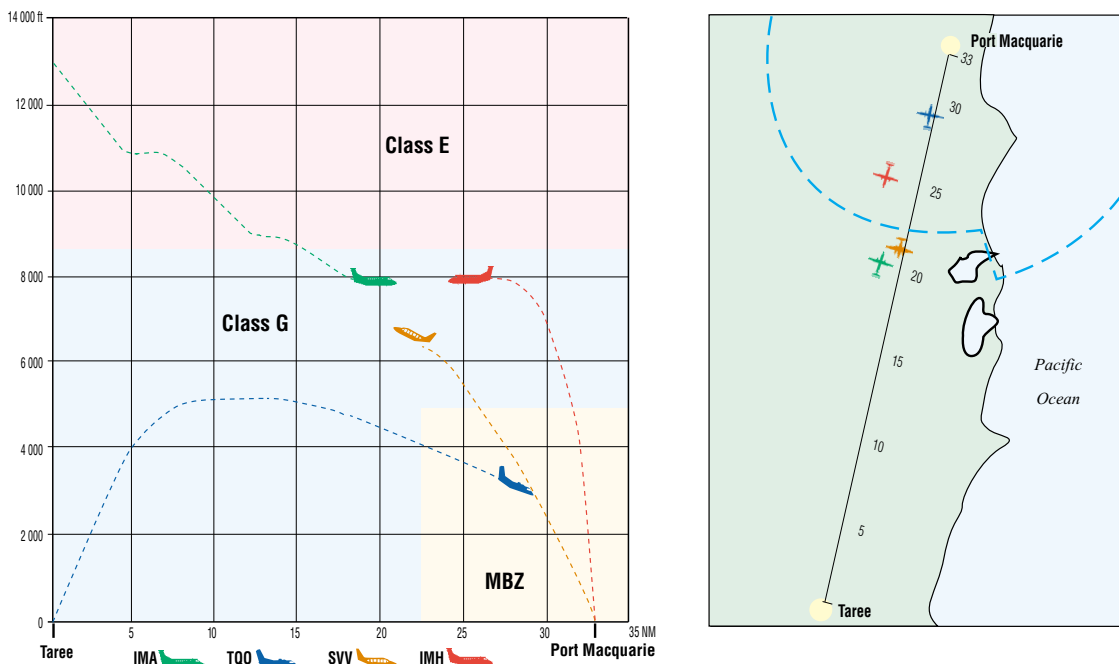
Situation at 2005 EST

At 2005:10, the flight service officer contacted the sector controller and coordinated the departure of IMH. At about the same time, the crew of IMA broadcast on the MBZ frequency that they were 14 NM south and maintaining 8,000 ft.

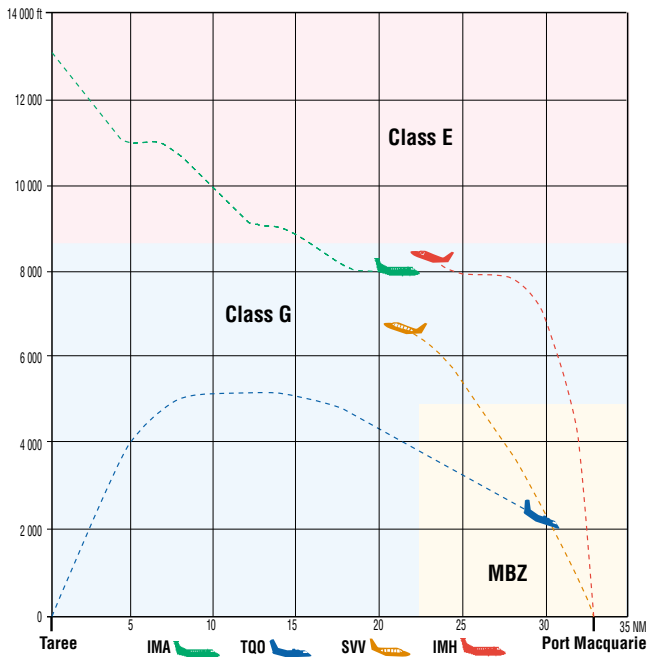
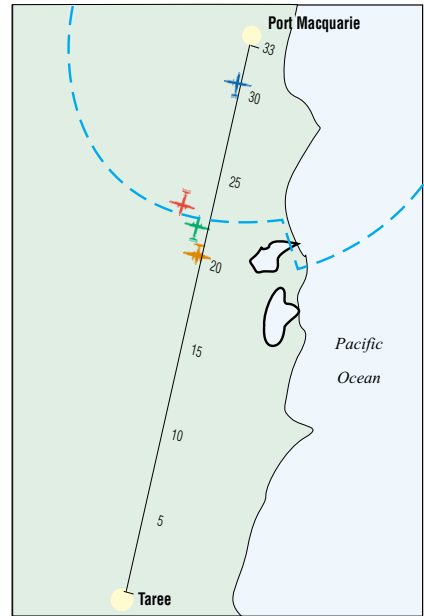
Situation at 2005:30 EST

Analysis of radar information revealed that IMA and IMH passed at 2005:30 while approximately 1,000 m horizontally apart. IMH had left 8,200 ft on climb and IMA was maintaining 8,000 ft.

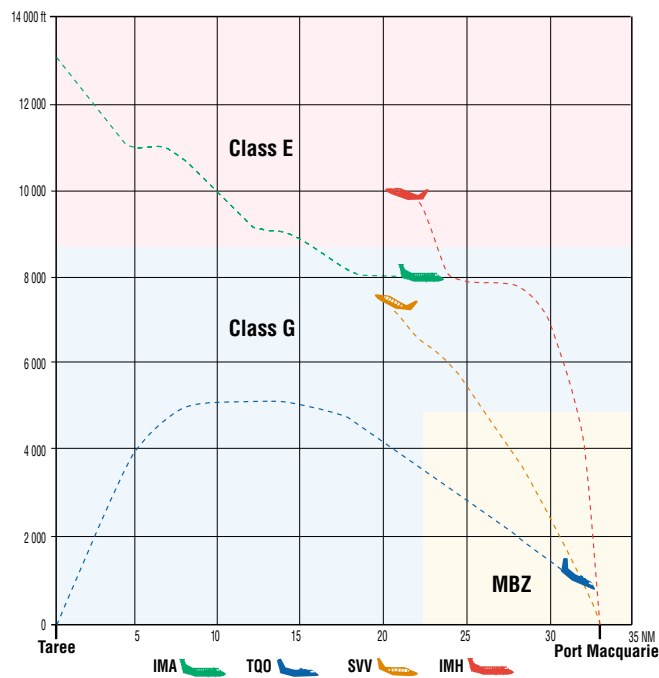
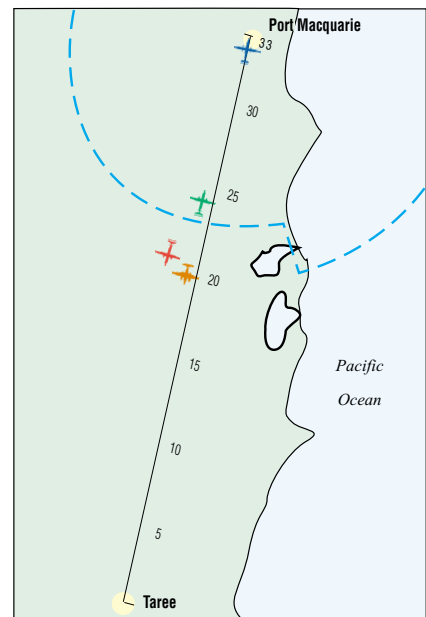
Situation at 2006 EST

At 2005:48, the crew of IMA made contact with the crew of IMH. This was the first radio communication between the two crews and they established that IMH had left 9,300 ft on climb and IMA had left 8,000 ft on descent.

At 2005:54, the sector controller informed the crew of IMH that radar indicated that they had passed IMA.

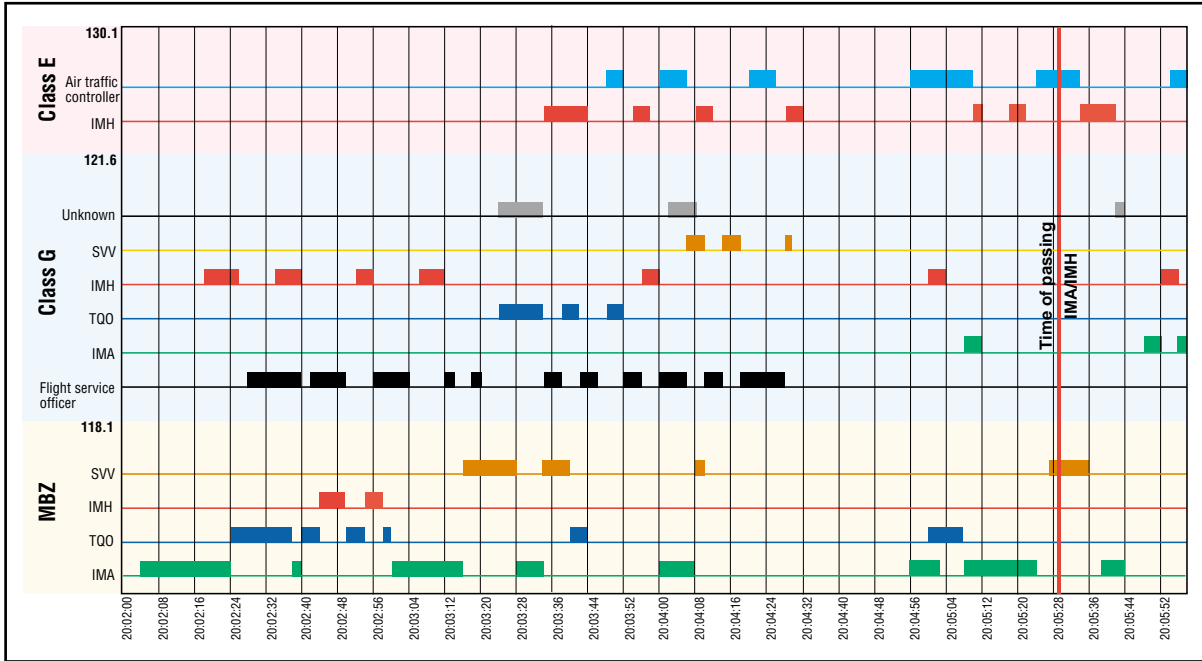
Frequency transmissions between 2002 and 2006

The flight service frequency recorded 37 transmissions between 2000 and 2005 (a 6 minute period), with six being over-transmitted by other sources.
