Aviation Occurrence Investigation – AO-2007-026

Preliminary

Rotor Strike – Maryfield Station, NT

VH-VHQ

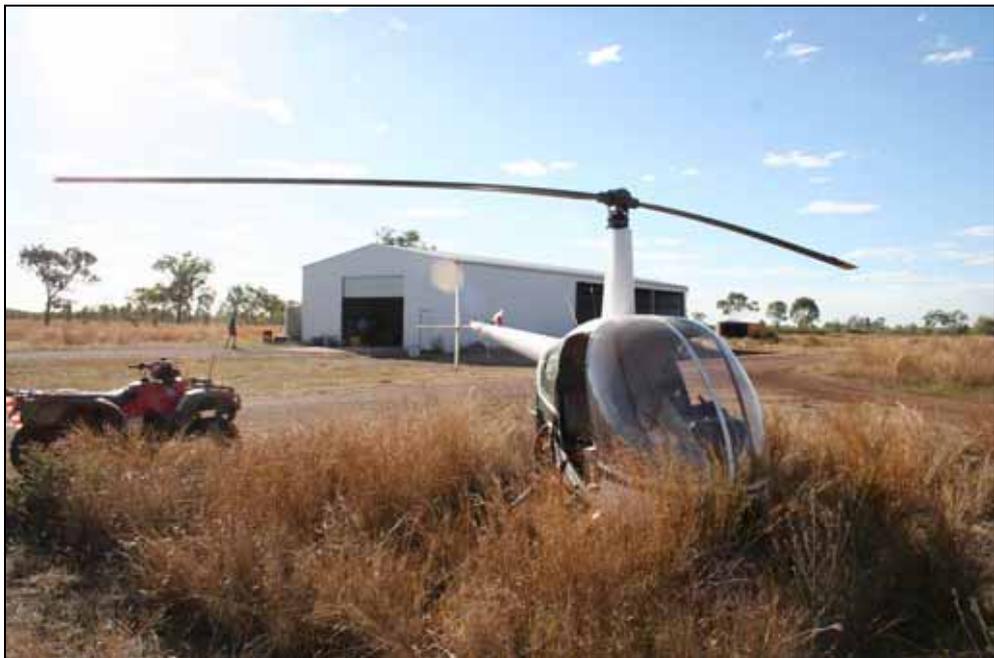
During the initial climb after takeoff, and at a height near the tops of the surrounding trees, the helicopter's 'low RPM'² warning horn activated. During the recovery manoeuvre by the pilot, one of the visitors was struck in the head by the helicopter's main rotor and was fatally injured. The pilot immediately landed the helicopter (Figure 1).

Figure 1: Position of the helicopter after landing. The helipad and hangar are in the background.³

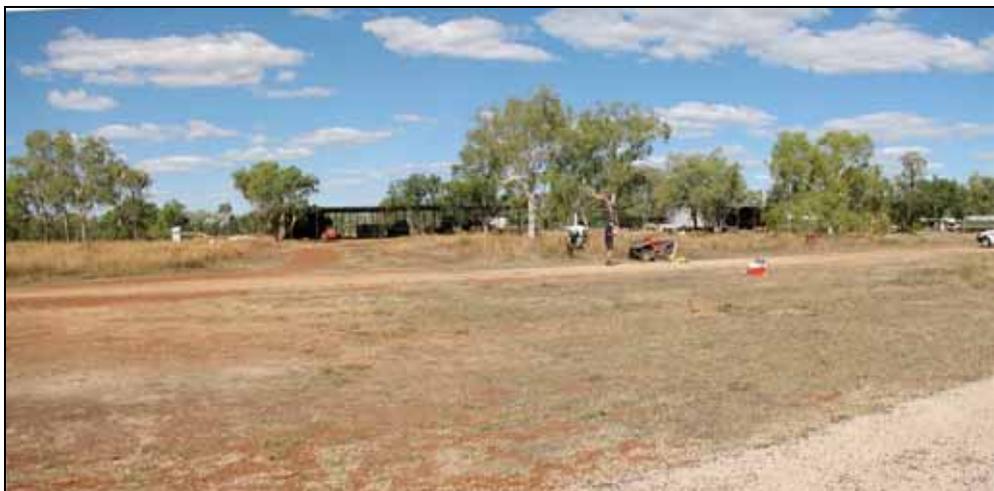
Figure 2: View of takeoff area from the helipad (note the two largest trees immediately to the left of the parked quad-bike).

woman, he banked the helicopter left to re-intercept that profile. The pilot reported that, as he approached the tops of the two largest of the trees in the early climb-out (Figure 2), the helicopter was struck by a gust of wind and that the helicopter's low RPM warning horn sounded.

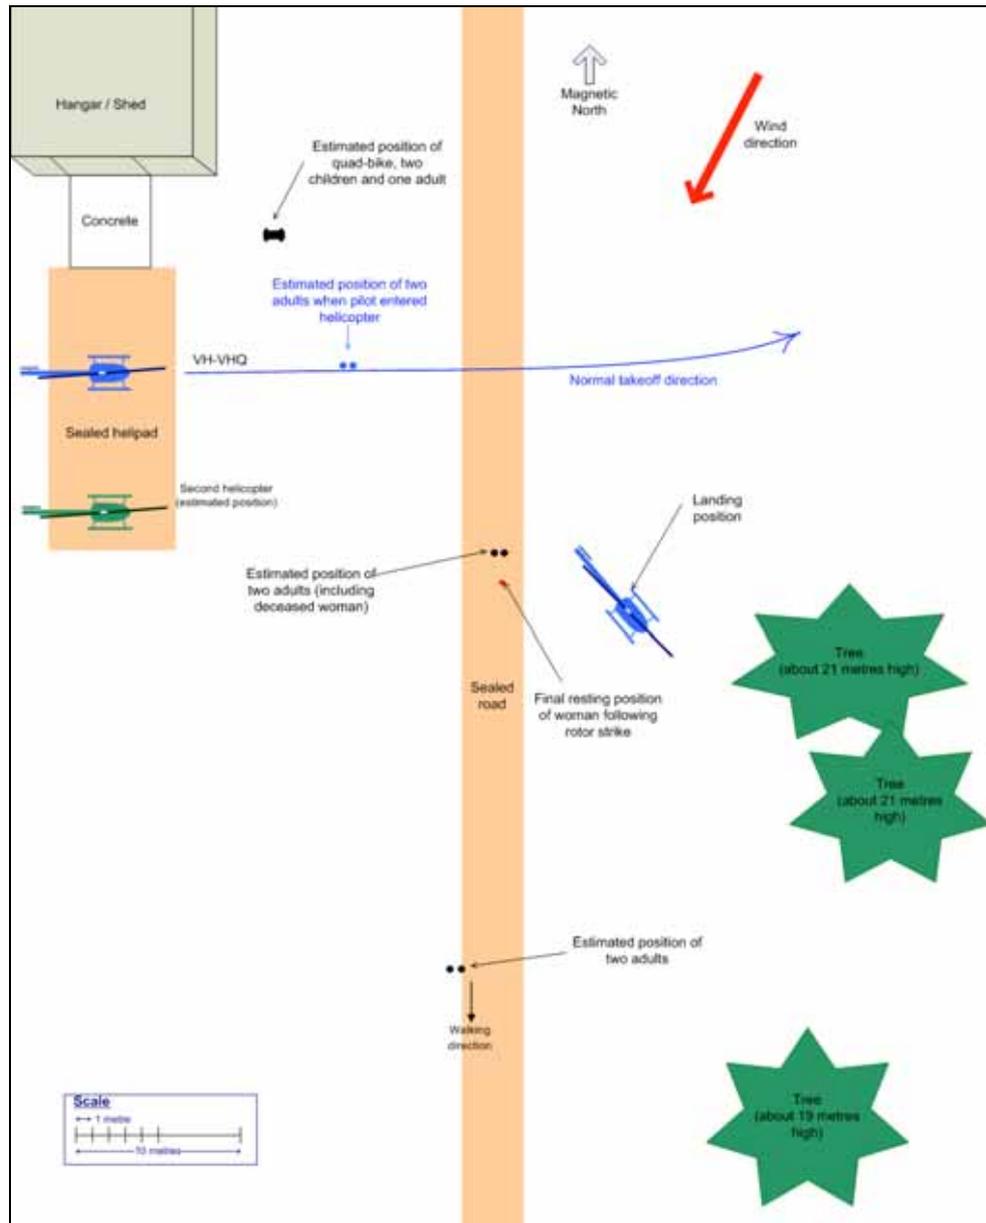
Figure 3: Scale diagram of the helipad, take-off area and accident site at the time of the rotor strike.

The helicopter was parked in its usual position on the helipad prior to the accident flight. The pilot stated that he normally took off tracking and climbing virtually due east and/or turning slightly left towards east-north-east (see Figure 3). An alternative but less commonly used take-off profile involved turning left after becoming airborne and tracking north, along the road that was adjacent to the hangar.

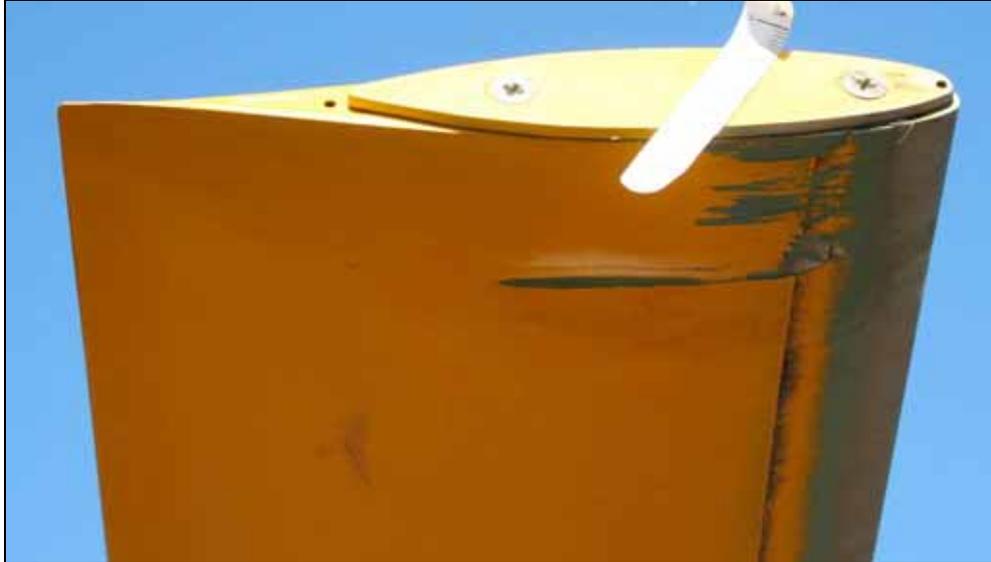
Damage to one of the main rotor blades, including tip distortion and skin indentation (Figure 4), was consistent with that blade having contacted the woman during operation.

Figure 4: Damage to main rotor blade

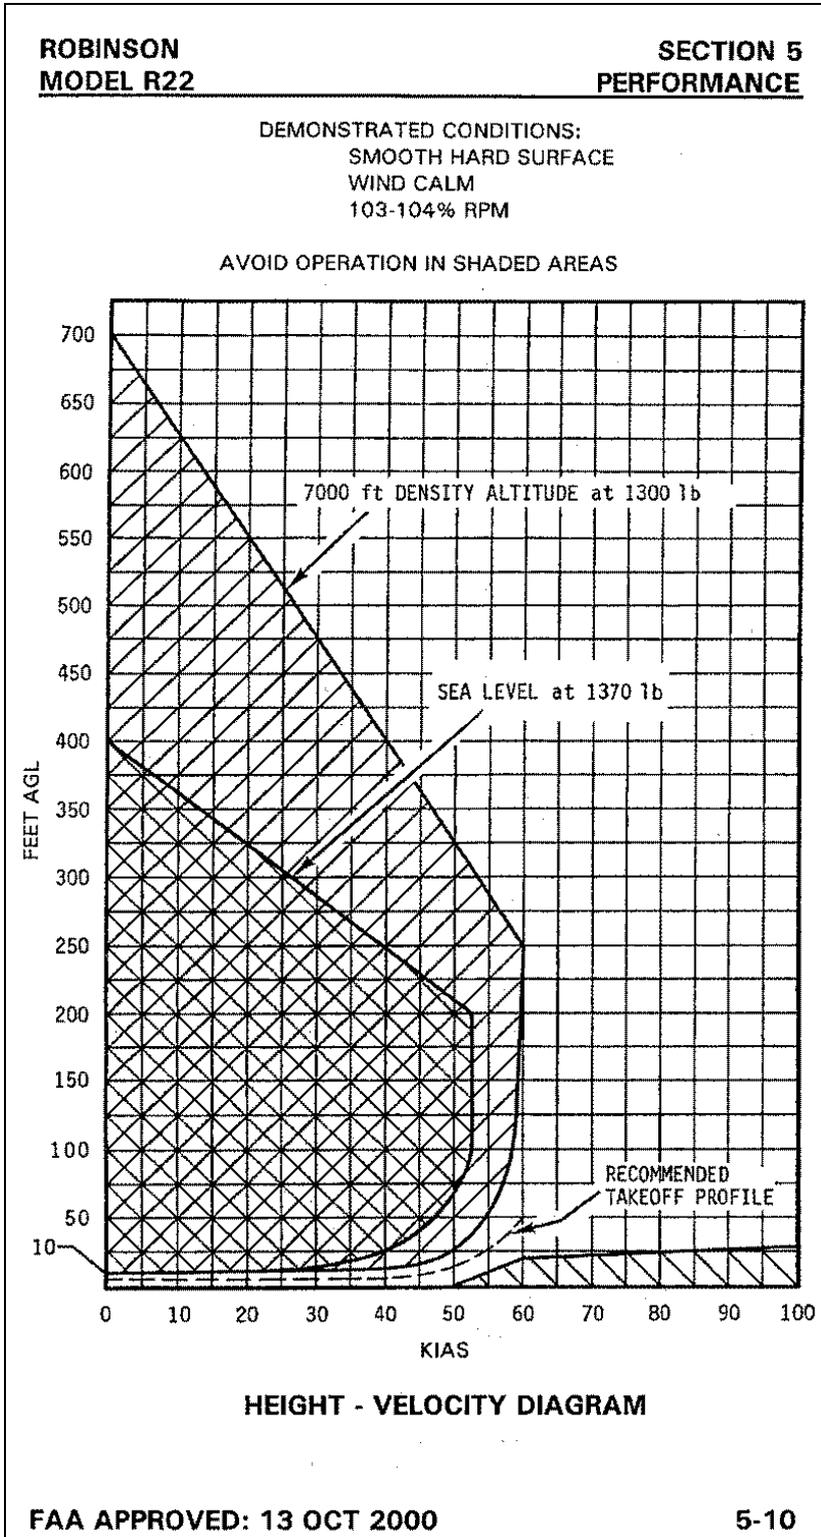
APPENDIX A: HEIGHT-VELOCITY DIAGRAM FROM SECTION 5 OF THE R22 PILOT OPERATING HANDBOOK

The POH stated that the climb airspeed for safe operation was 60 kts indicated airspeed. The height-velocity diagram indicated that the helicopter should not be climbed above 10 ft above ground level (AGL) until it had reached about 30 kts (see Appendix A).
