ATSB TRANSPORT SAFETY REPORT

Aviation Occurrence Investigation AO-2007-026

Rotor Strike – Maryfield Station, NT

Robinson Helicopter Company R22 Beta

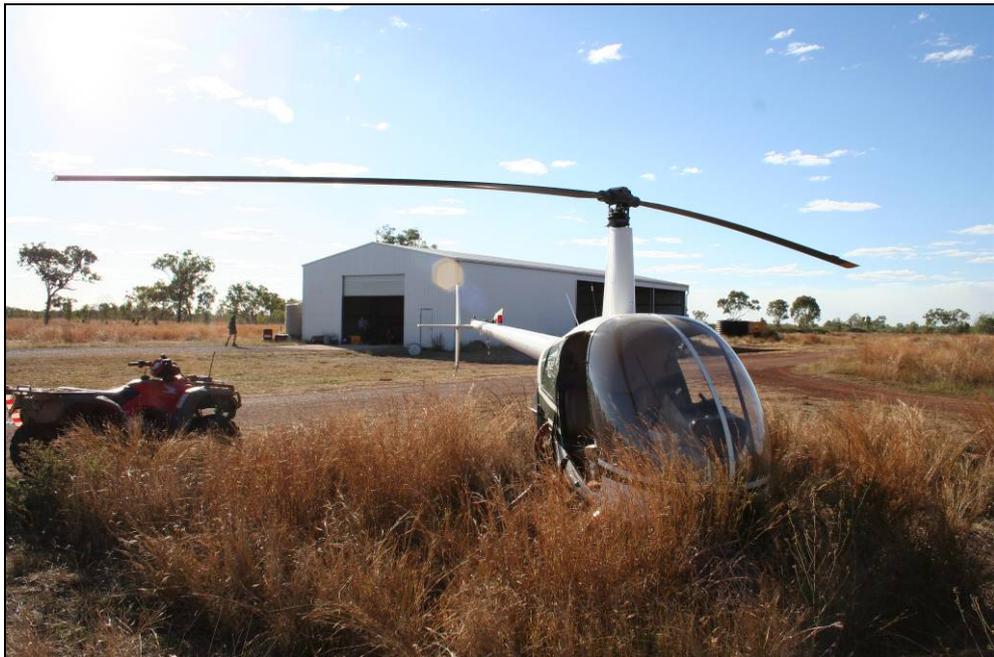
Following the rotor strike, the pilot turned the helicopter to the right into wind and landed (Figure 1). The visitor subsequently died from her injuries.

Figure 1: Position of the helicopter after landing. The helipad and hangar/shed are in the background.³

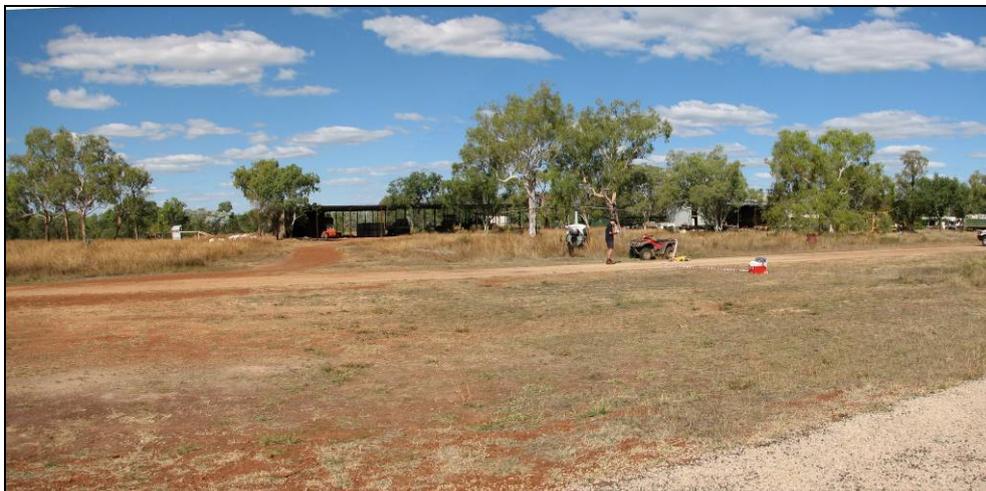
The pilot reported that shortly prior to entering the helicopter for takeoff, he saw the latter two adults (one man and one woman) walking slowly from left to right in front of the helicopter, and between the helicopter and the road (Figure 2). The

Figure 2: View of take-off area from the helipad (note the two largest trees immediately to the left of the parked quad-bike).

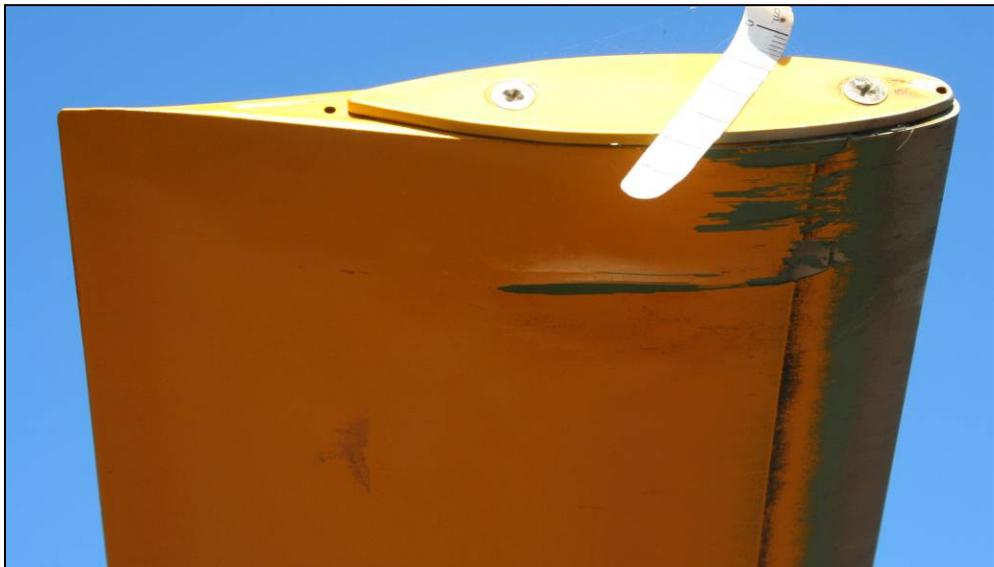
Figure 3: Damage to main rotor blade

Damage to one of the main rotor blades, including tip distortion and indentation of the metal skin (Figure 3), was consistent with that blade having contacted the woman during its operation.

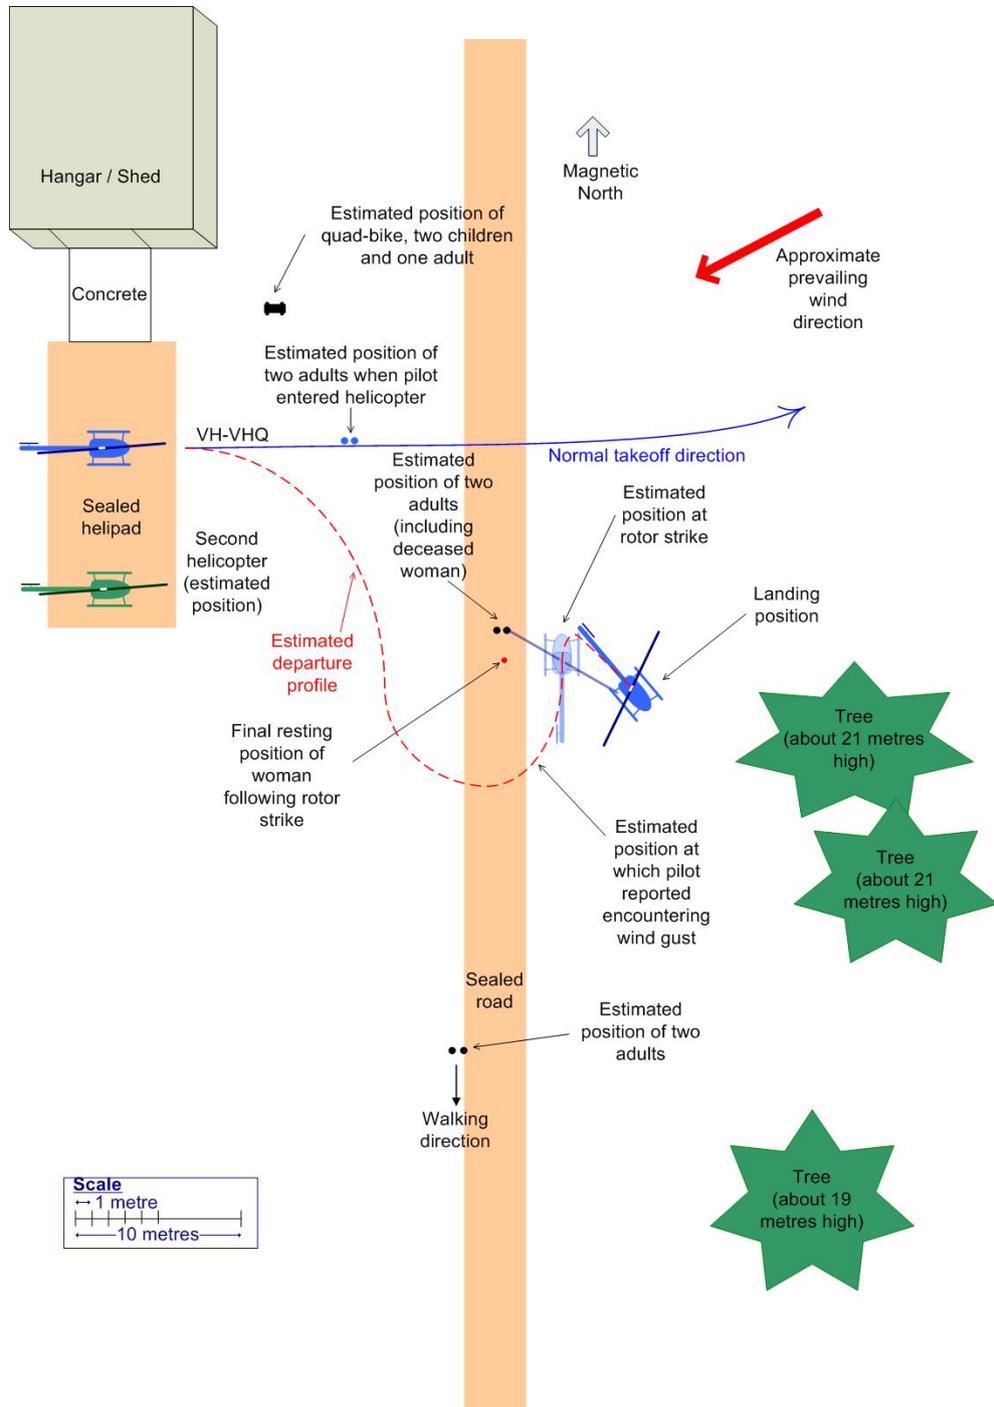
APPENDIX A: SCALE DIAGRAM OF THE HELIPAD, TAKE-OFF AREA AND ACCIDENT SITE

The pilot stated that he normally departed from the helipad tracking and climbing virtually due east and/or turning slightly left towards the east-north-east (see Appendix A). An alternative, but less commonly used take-off profile, involved turning left after becoming airborne and tracking north along the road that was adjacent to the hangar/shed.

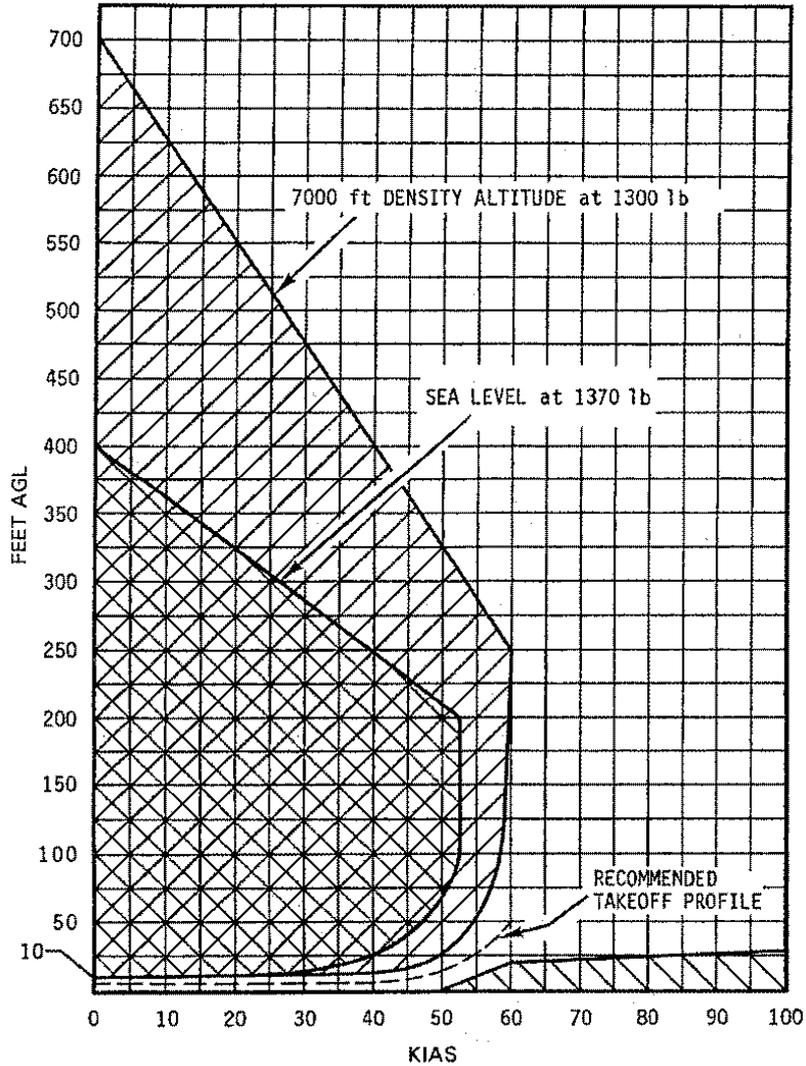
HEIGHT - VELOCITY DIAGRAM

The POH stated that the climb airspeed for safe operation was 60 kts indicated airspeed (KIAS). An examination of the manufacturer's recommended take-off profile (see Appendix C) suggested that, if following that profile, a pilot should not climb above 10 ft AGL until reaching about 30 KIAS.
