ATSB TRANSPORT SAFETY INVESTIGATION REPORT

Aviation Occurrence Report – 200700357

Interim Factual

**Engine failure – 28 km WSW of Warialda, NSW
2 February 2007
VH-HRT
Bell Helicopter Company 407**

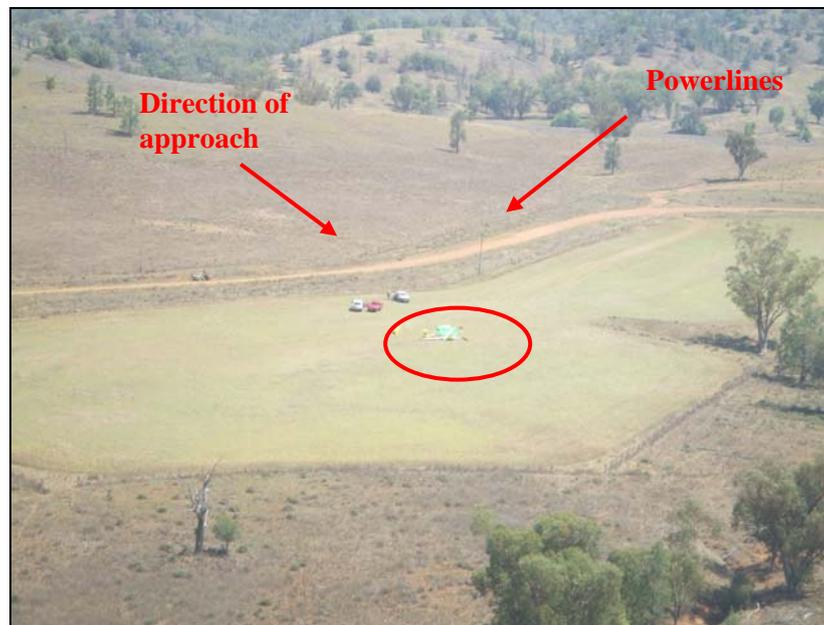
Figure 1: Helicopter emergency landing site

During the emergency landing, the helicopter sustained major damage and was later deemed to be uneconomical to repair. The elevation at the site of the emergency landing was about 1,100 ft AMSL (Figure 1).

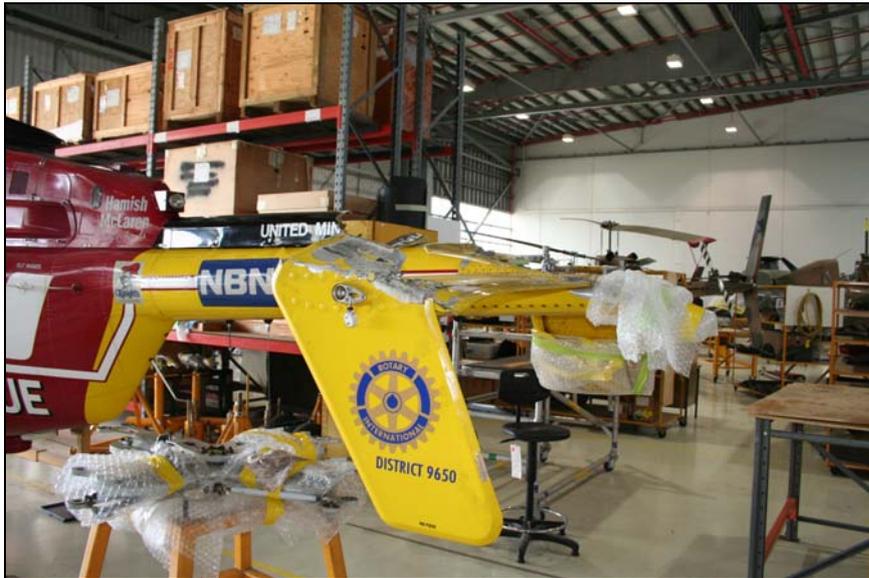
Figure 2: Wreckage examination

The helicopter was recovered to an authorised repair facility for further examination. At the time of the occurrence, the helicopter had completed 3,203.0 hours total time since new (TTSN). The front passenger's windscreen was broken and the landing gear was destroyed. The main rotor and tail rotor blades were heavily damaged by impact. The main rotor head assembly, main rotor transmission, tail rotor gearbox and all main and tail rotor drive components were removed for sudden stoppage inspection⁵. The helicopter tail boom and horizontal stabilisers were impact damaged and the tail section had separated. The helicopter skid-type landing gear was also heavily damaged (Figure 2).

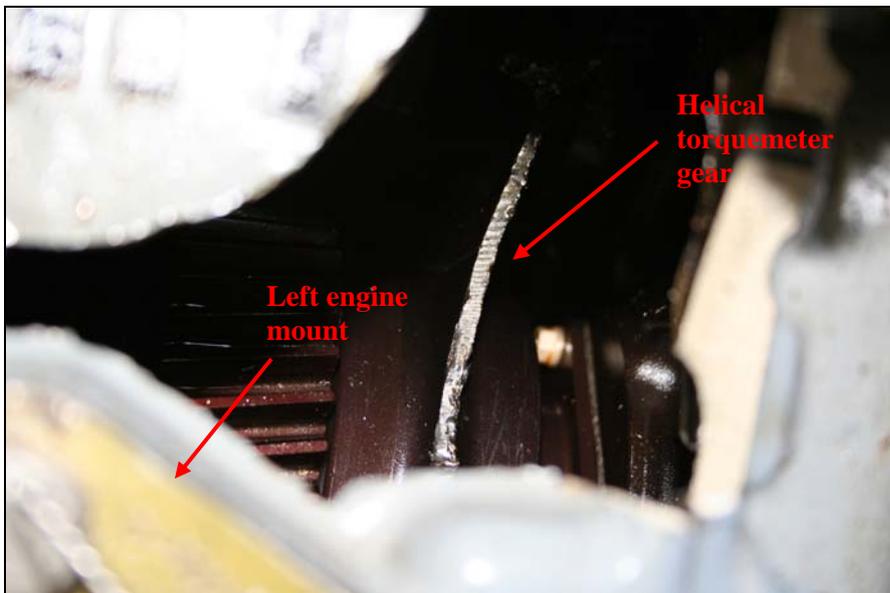
Figure 3: Engine gearbox cover damage

The helicopter was powered by a single Rolls-Royce Corporation model 250-C47B turboshaft engine, part number 23063393, serial number CAG-47048. Initial examination of the engine accessory gearbox case revealed a 5 cm diameter hole in the case above the left side engine mounting pad. A section of the separated portion of the gearbox case was found on the engine deck, along with bearing material. The internal gear train components were visible through the hole, and it appeared that the gearshaft assembly helical torquemeter (helical torquemeter gear) had fractured (Figure 3).

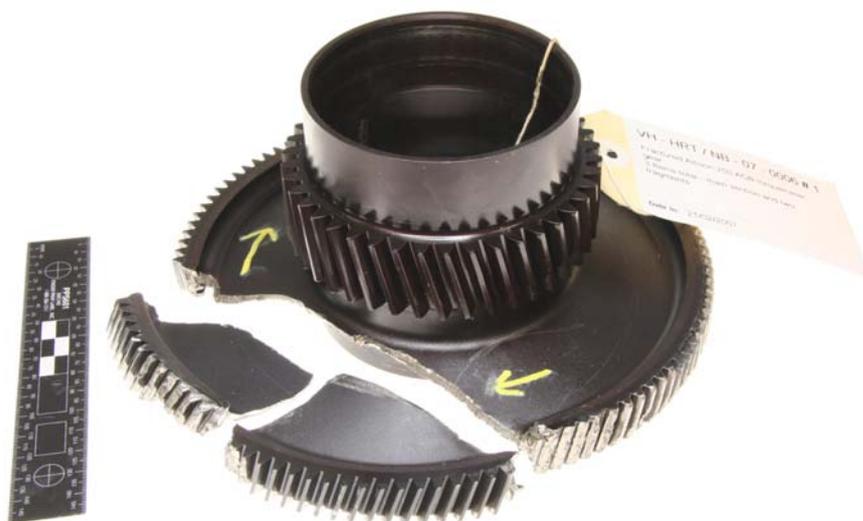
Figure 4: Helical torquemeter gear examination

Preliminary examination of the part number 6893673, serial number NN143262 helical torquemeter gear confirmed that the component fractured through the rim and web sections, releasing two similarly sized segments (Figure 4).

Fracture surface appearances suggested the failure had developed from the radial and chordwise growth of fatigue cracking from an origin at the root region of a rim gear tooth. Magnetic particle inspection showed evidence of cracking at the roots of several other gear teeth adjacent to the location of the fracture (Figure 5).

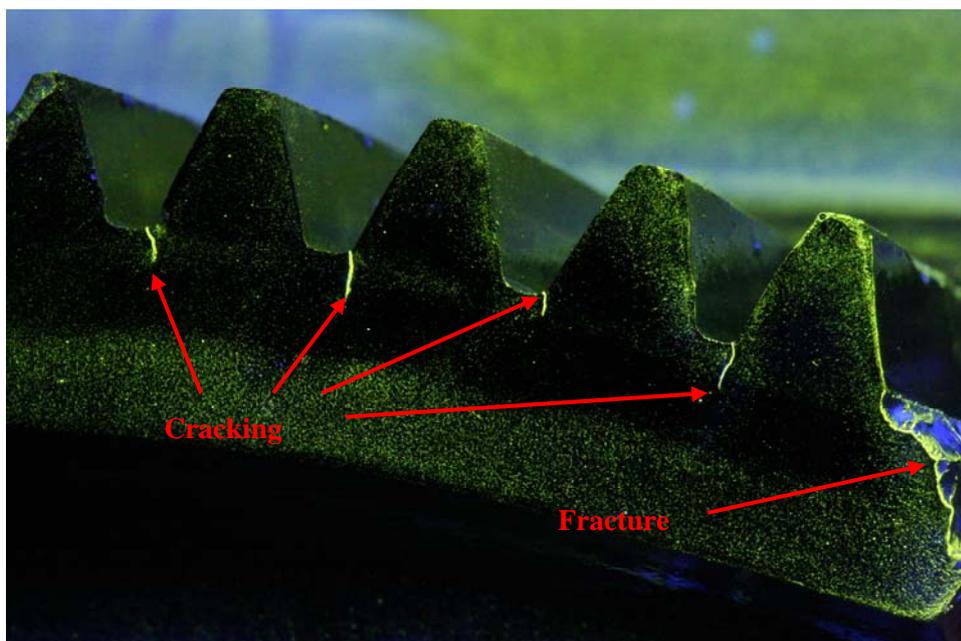
Figure 5: Cracking at the roots of gear teeth

Evidence of localised gear tooth spalling and uneven surface contact patterns was also observed, suggesting a possible misalignment condition between the helical torquemeter gear and the N1 input spur adapter gearshaft.
