ATSB TRANSPORT SAFETY INVESTIGATION REPORT

Aviation Occurrence Report – 200700357

Engine failure
28 km west-southwest of Warialda, NSW
2 February 2007
VH-HRT
Bell Helicopter Company 407

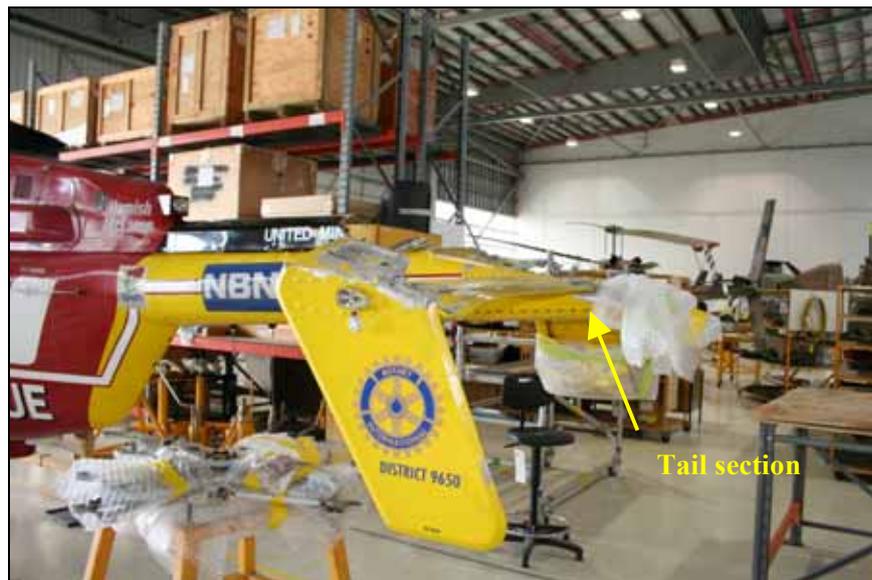
Figure 2: Wreckage examination

The helicopter was recovered to an authorised repair facility for further examination. At the time of the occurrence, the helicopter had completed 3,203.0 hours time since new. The front passenger's windscreen was broken and the landing gear was destroyed. The main rotor blades and the main rotor head assembly were substantially damaged by sudden stoppage. The tail boom and horizontal stabilisers were damaged and the tail section had separated. The tail rotor blades and tail rotor gearbox were also damaged by sudden stoppage (figure 2).

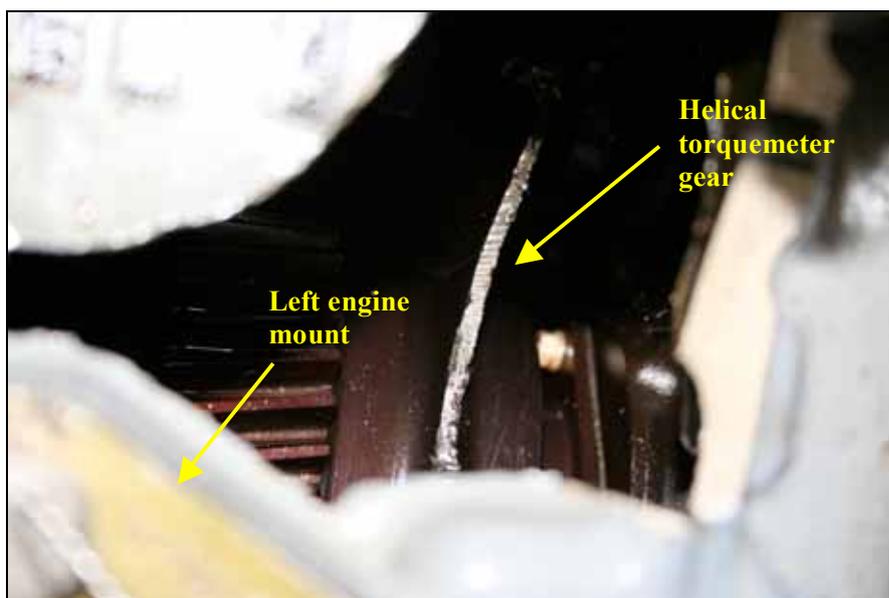
Figure 3: Engine accessory gearbox cover damage

The Rolls-Royce Corporation model 250-C47B engine accessory gearbox assembly was damaged. There was a 50 cm diameter hole in the gearbox above the left side engine mounting pad (figure 3).

A section of the separated portion of the gearbox casting was found on the engine deck, along with bearing material. The internal gears of the gearbox were visible and it appeared that the part number 23078713 gearshaft assembly helical torquemeter (helical torquemeter gear) had fractured. The engine and electronic engine control unit were removed from the helicopter and sent to an authorised repair facility for further examination under the supervision of the Australian Transport Safety Bureau.

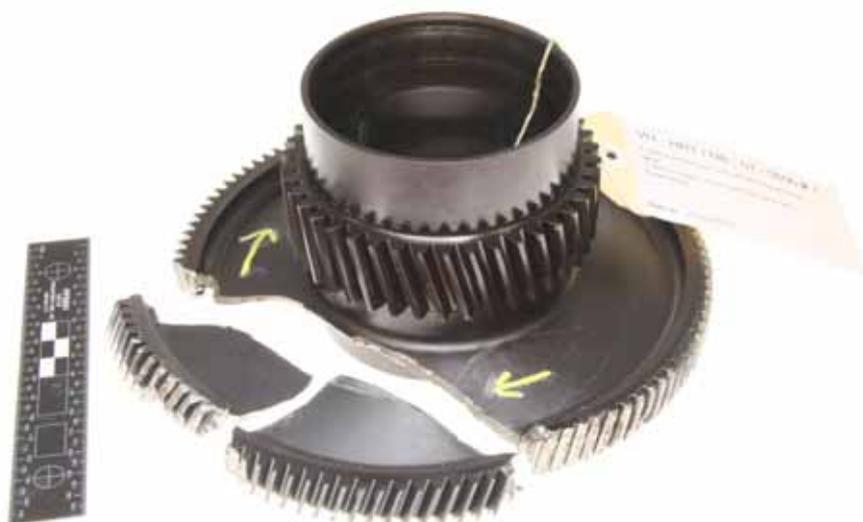
Figure 4: Helical torquemeter gear examination

Preliminary examination of the helical torquemeter gear confirmed the component fractured through the rim and web sections, releasing two similarly sized segments (figure 4). Fracture surface appearances suggested the failure had developed from the radial growth of fatigue cracking from an origin at the root region of a rim gear tooth. Magnetic particle inspection showed evidence of cracking at the roots of several other gear teeth adjacent to the location of the fracture. Evidence of localised gear tooth spalling and uneven surface contact patterns was also observed, suggesting a possible misalignment condition between the helical torquemeter gear and a smaller driving pinion gear.
