Aviation Occurrence Report – 200700358

Preliminary

**Engine power loss
15 km south-east Gold Coast Airport, Qld
4 February 2007
VH-DIC
Piper Aircraft Co. PA-30 Twin Comanche**

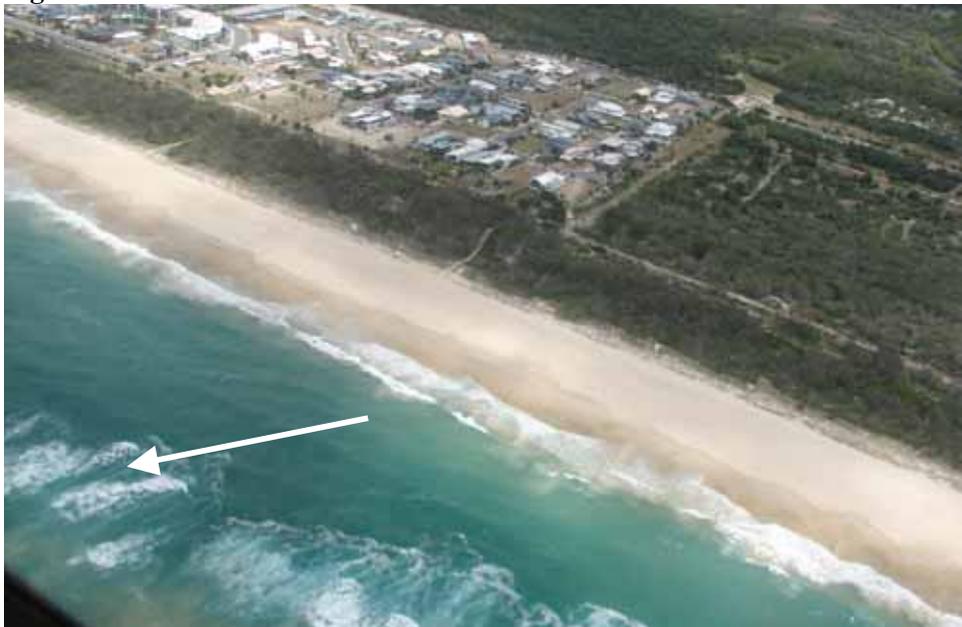
Figure 1: Aerial view of the accident site

Note: The approximate location of the accident site is indicated by the arrow.

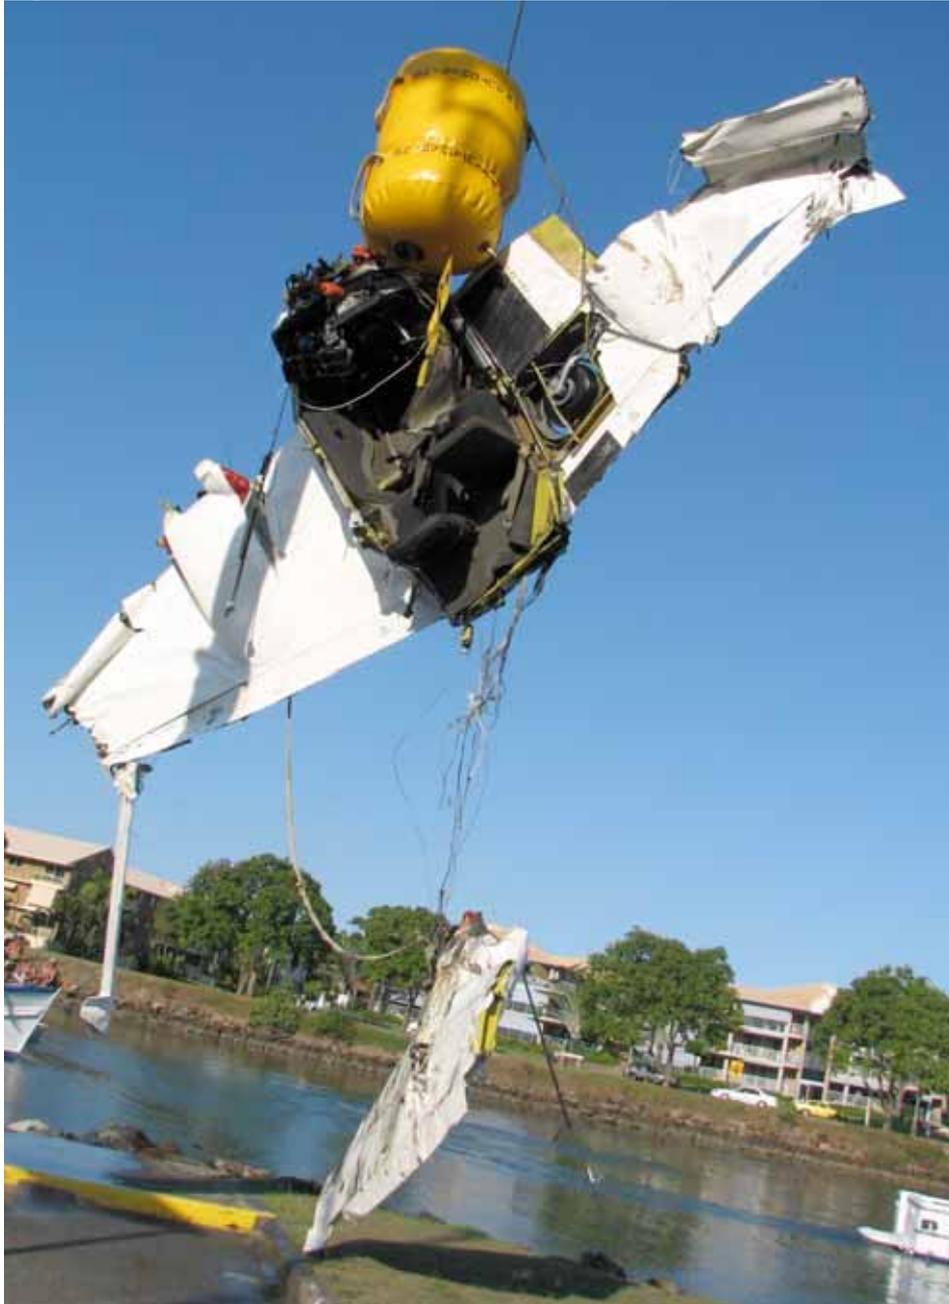
Figure 2: The aircraft as recovered

The aircraft wreckage, consisting of most of the lower centre fuselage (figure 2), wings, and both engines and propellers, were recovered two days after the accident. Both wing tip tanks, a seat and a number of pieces of the fuselage and wing skin were collected from the beach shortly after the accident.

- cabin roof with windows and door
- approximately 1.8 m outboard section of each wing
- right aileron
- right wing outboard fuel tank
- approximately 1.5 m section of empennage
- approximately 0.6 m outboard section of the left horizontal stabiliser and elevator
- vertical stabiliser and rudder

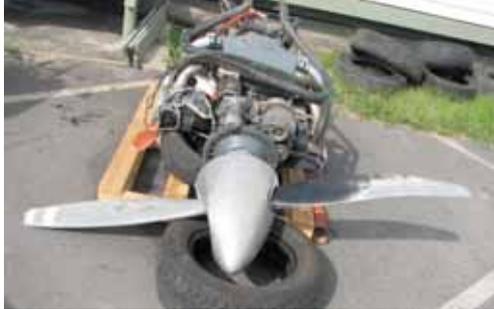
(a)

The right propeller was recovered with the blades in the feathered position and with minimal deformation of the blades (figure 3). An examination of the right engine found significant damage to the number-4 connecting rod big end bearing. The engine was found to have been contaminated by metal particles.

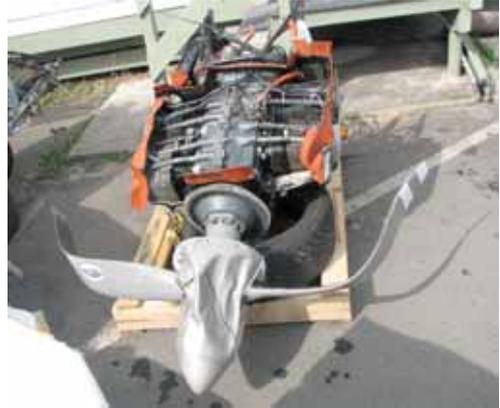
(b)

The left propeller blades were recovered in the normal operating range with deformation consistent with power being applied at the time of the accident.
