Aviation Occurrence Investigation AO-2007-049

Engine power loss (fuel tank exhaustion)

VH-TMP

Cessna Aircraft Company C404

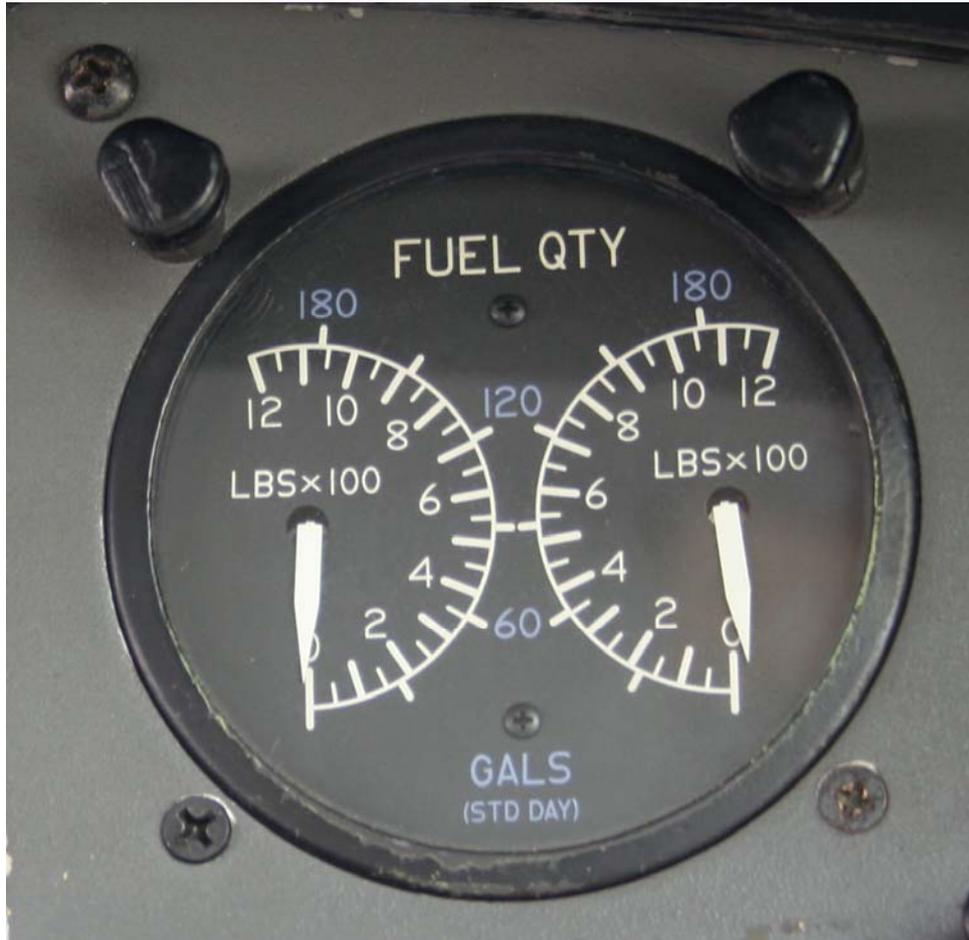
Figure 2: Fuel quantity gauge

Draining of the fuel tanks yielded 3 L (5 lbs) of fuel from the right tank and 90 L (142 lbs) from the left tank. After draining the tanks, the fuel quantity gauge indicated 150 lbs (95 L) fuel in the right tank and zero in the left tank.

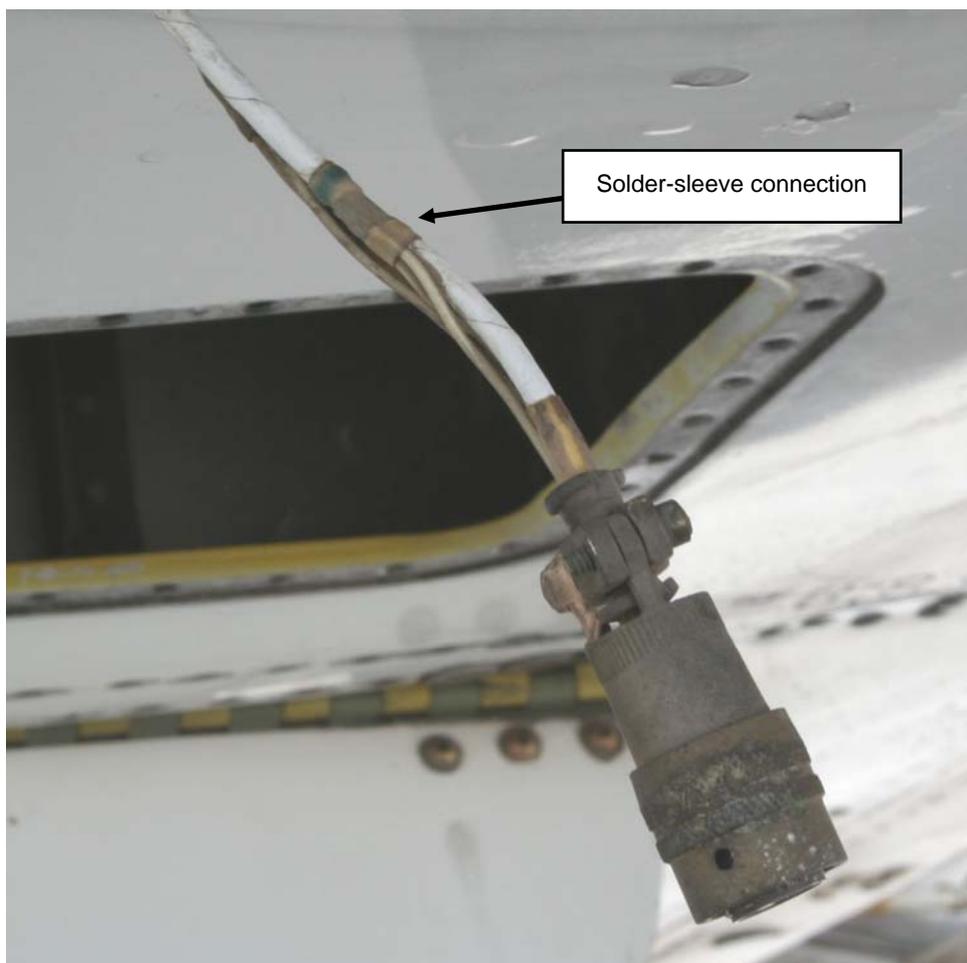
Figure 3: Typical solder-sleeve connection

The right fuel quantity indication system was inspected by a suitably qualified LAME⁵, who found that one of the electrical circuits in the wiring loom between the signal conditioner and the fuel tank bulkhead, had a high resistance. The main conductor in the circuit was the shielding braid of a wire in the loom. At each end of the circuit, the braid was electrically connected to a plug through a short wire that was soldered to the braid (Figure 3). The engineer found that the soldered connection between both solder-sleeves and the corresponding shielding braid had deteriorated and there were signs of arcing. Resoldering both joints resulted in the gauge indicating correctly. The left fuel quantity indication system was also inspected and no defects were found in the wiring.

The right fuel quantity indication remained incorrect and undetected until after the engine power loss, when it was over-reading by 200 lbs (127 L) in the air or 150 lbs (95 L) on the ground. The post-incident maintenance discovered that the over-reading was the product of a high-resistance solder joint in part of the system wiring, possibly in combination with a defective signal conditioner.

- From 16 October 2007 onwards (and possibly before), the right fuel quantity indication system was over-reading by up to 200 lbs (127 L), due to a high-resistance solder joint wiring, possibly in combination with a defective signal conditioner.

The maintenance organisation advised that the fuel quantity indication system was calibrated in accordance with the aircraft's maintenance manual using a Barfield test box. During that process, the left signal conditioner was found to be producing incorrect indications and was replaced. The right signal conditioner did not provide consistent indications and was repaired. Subsequent calibration was successful and the aircraft was returned to service.
