ATSB TRANSPORT SAFETY REPORT  
Aviation Occurrence Investigation AO-2007-035  
Final

## Engine in-flight shutdown – 926 km NW of Sydney, NSW - 15 August 2007

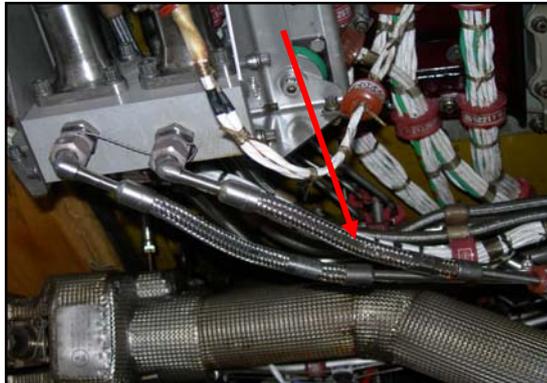
After landing, the operator's contracted maintenance staff inspected the No-2 engine, a Rolls-Royce RB211-Trent 700 series, serial number 41053. That inspection found that the flexible oil pressure tube that supplied oil from the oil pump to the oil pressure transmitter was leaking at the braided section (Figure 1).

**Figure 1: Flexible oil pressure tube**

A new tube was fitted and approximately 27 litres of engine oil was placed in the engine. An engine run and performance check was carried out before the aircraft was returned to service.

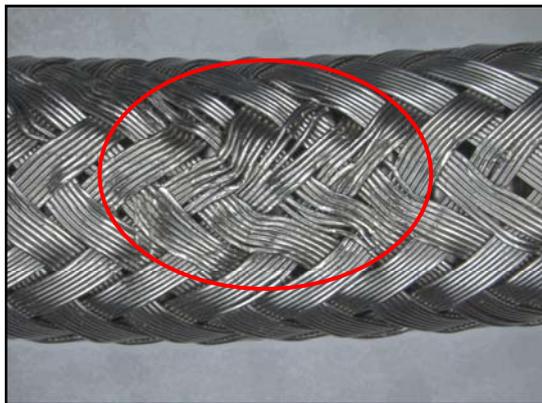
The stainless steel outer braiding was found bowed outwards in the area of the fracture. Further examination of the outer braiding found multiple vertical and horizontal score marks in an area that was locally crushed and distorted (Figure 2), with individual strands having been separated. However, the fracture of the convoluted stainless steel tube did not appear to be associated with the damage to the outer braiding.

**Figure 2: Damaged outer stainless steel braided sheaf**

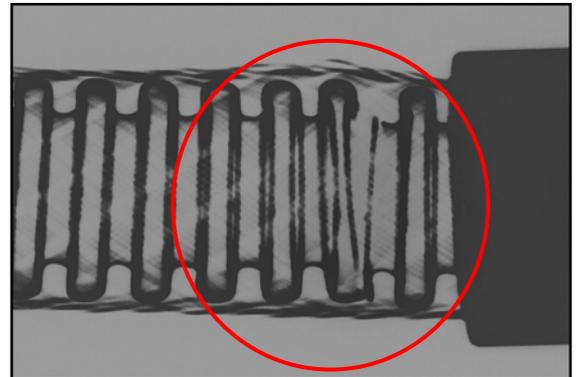
The engine manufacturer x-rayed the convoluted stainless steel tube (Figure 3) under the supervision of the UK Air Accidents Investigation Branch (AAIB). That examination showed a fracture located between the first and second visible (third and fourth actual) convolutes adjacent to the 90 degree end fitting, and a corresponding area of bulging on the outer stainless steel braiding.

**Figure 3: X-rayed tube showing fractured convoluted tube**

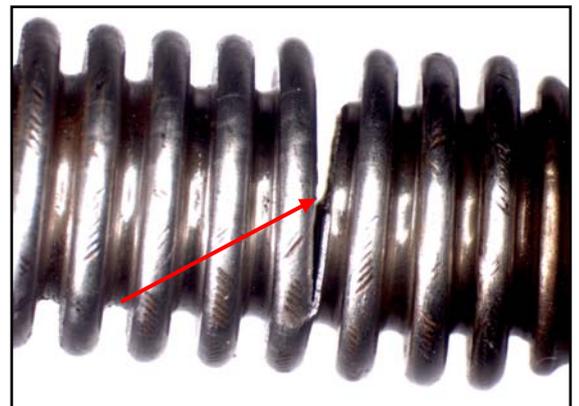
The stainless steel braiding was then removed to reveal the convoluted tube and fracture, which extended approximately 180 degrees around the tube's circumference (Figure 4). The fracture was located in the corner radius of the trough between the convolutes.

**Figure 4: Convoluted tube showing the fracture**

It was probable that the fracture to the flexible oil pressure transmitter tube was a result of the tube not being adequately supported while being subjected to high levels of vibration, causing a fatigue crack to propagate. As a result of the crack, engine oil leaked to atmosphere, activating the right (No-2) engine low oil pressure warning. The fracture was not associated with the damage to the stainless steel outer braiding sheath.

- The flexible oil pressure transmitter tube fitted to the No-2 engine fractured in flight, probably due to high levels of vibration that induced metal fatigue.

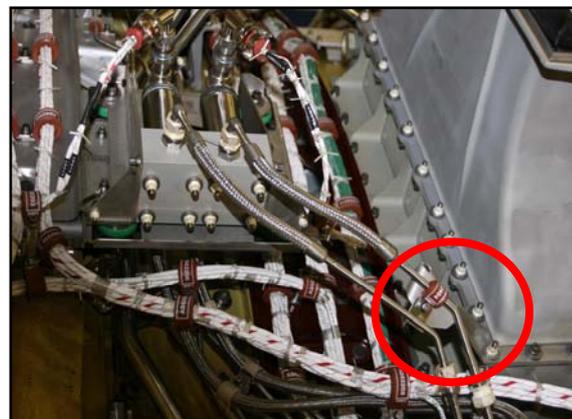
In September 2005, the engine manufacturer issued Service Bulletin RB211-24-E914 as a result of reported oil pressure transmitter tubes leaking and fracturing. That service bulletin was also a 'recommended 2B category', and was designed to support and secure the flexible oil pressure transmitter tube P/N AE711312-2 and scavenge tube P/N AE711312-1 to prevent failure from fractures that can occur from high levels of vibration (Figure 5). Further investigation in conjunction with the National Transportation Safety Committee of Indonesia (NTSC) found that, at the time of the incident, Service Bulletin RB211-24-E914 had not been incorporated by the aircraft operator.

**Figure 5: Example of the flexible oil pressure transmitter tube with modification RB211-24-E914 fitted**

It was probable that, had the operator incorporated the requirements of Service Bulletin RB211-24-E914, the risk of the oil tube fracturing due to metal fatigue from high levels of vibration would have been reduced.

As a result of this incident the aircraft operator implemented a programme to modify all of its Airbus A330 Rolls-Royce RB211-700 series aircraft engines (14 in total) to incorporate the requirements of Service Bulletin RB211-24-E914.
