ATSB TRANSPORT SAFETY INVESTIGATION REPORT

Aviation Occurrence Investigation – AO-2007-037

Collision with terrain

24 km S Tully, Qld – 16 August 2007

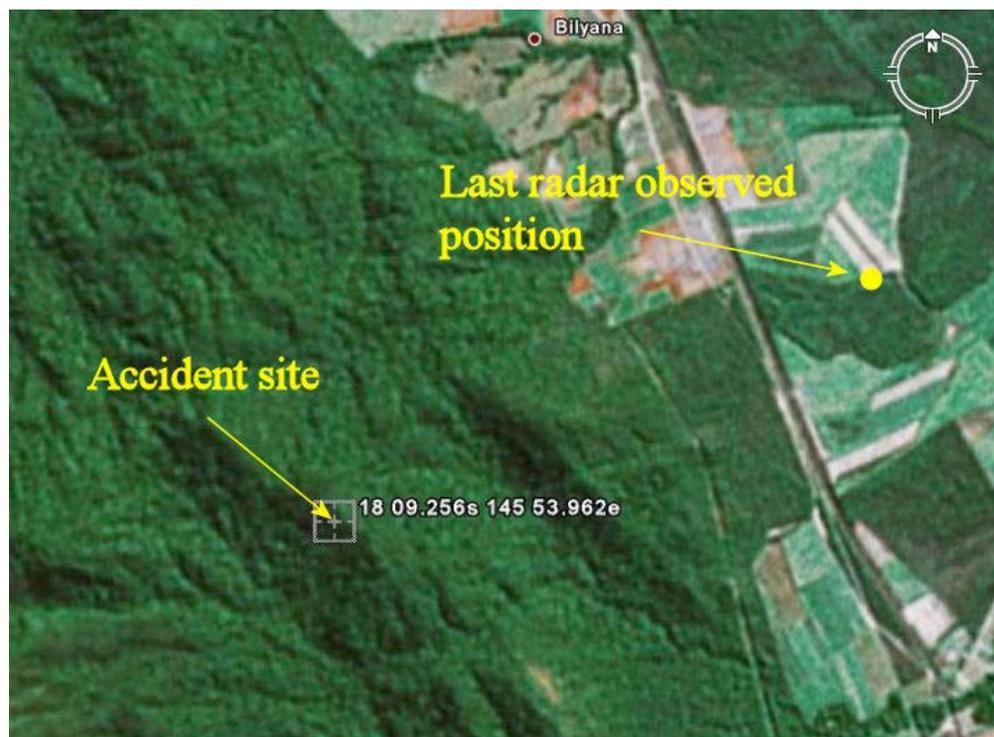
Figure 1: Satellite image of accident location

The purpose of the flight was to return the aircraft to the operator's base at Tully after completion of some non-scheduled aircraft maintenance. The aircraft was being operated under the visual flight rules (VFR) in non-controlled airspace and the pilot was the sole occupant. The aircraft did not arrive at Tully and the pilot and aircraft were not reported missing until 17 August. Subsequent searches located the aircraft wreckage on the morning of 18 August. The aircraft had impacted mountainous terrain in a state forest 24 km south of Tully (Figure 1). The pilot was fatally injured and the aircraft was destroyed.

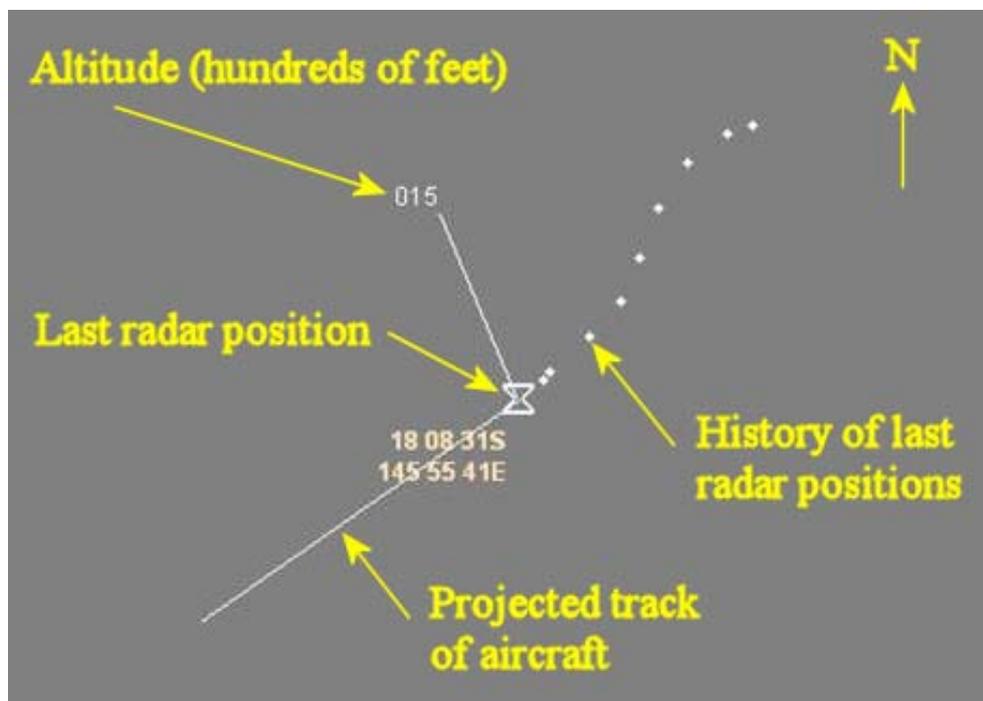
Figure 3: Last radar position of unidentified aircraft at time 1512:16

That return first appeared on radar at 1511:22, 11.7 NM (21.7 km) south of Tully on a westerly heading. The aircraft then appeared to commence a turn, initially towards the south and then onto a south-westerly heading. The aircraft disappeared from radar and the last observed radar return at 1512:26 (Figure 3) was later calculated to be 1.8 NM (3.3 km) from the accident site (Figure 1) with an approximate groundspeed of 113 kts.

While the aircraft's Mode C altitude had not been verified³, the aircraft's radar returns indicated an initial climb from 1,800 ft above mean sea level (AMSL) to 2,400 ft before a descent to 1,500 ft. The descent rate was calculated to be about 1,800 ft/min before the aircraft disappeared from radar.

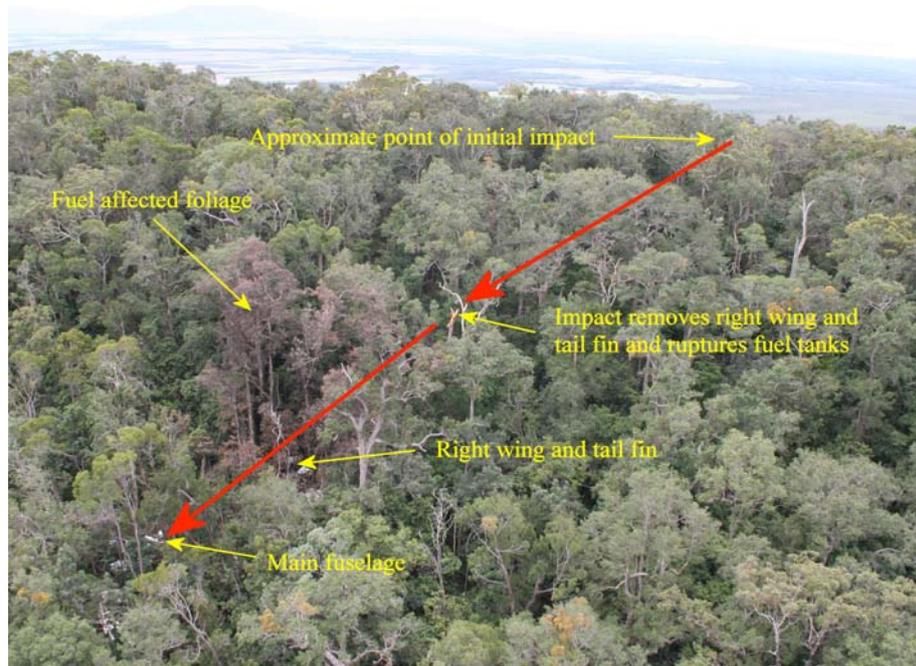
Figure 4: Wreckage trail

The aircraft initially impacted large trees near the top of a ridge line at an elevation of 1,279 ft AMSL. The outer section of the left wing was separated and the aircraft continued forward on a bearing of approximately 260 degrees magnetic. It collided with a number of smaller trees, causing additional damage, before impacting with another large tree. At this point, the outer and middle sections of the right wing, together with the tail fin separated from the fuselage. The impact forces also ruptured the fuel tanks and distributed fuel forward over a large section of the forest (Figure 4).

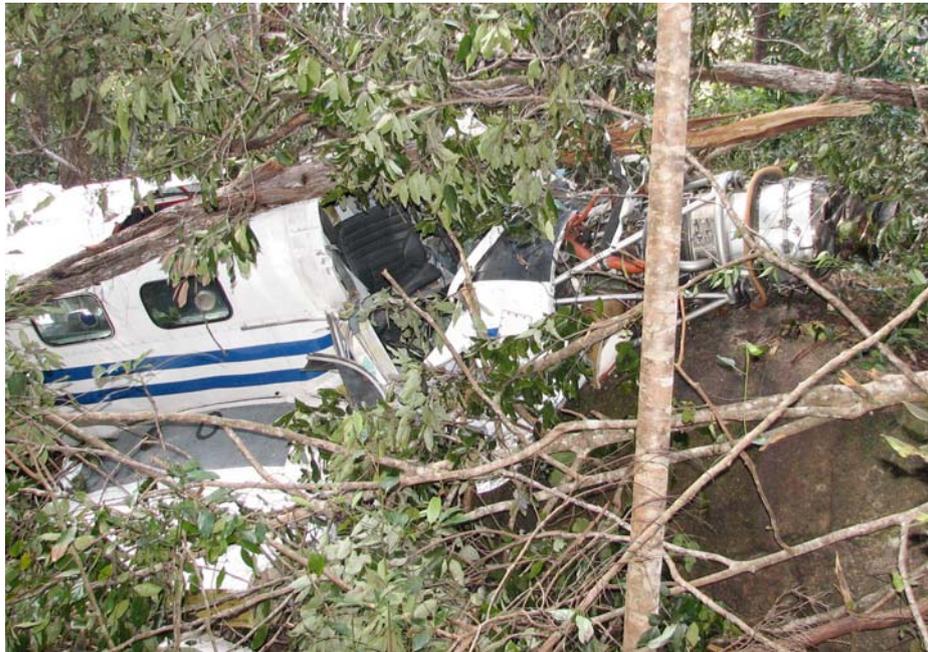
Figure 5: Forward fuselage and engine resting on a large rock

The final impact angle was calculated to be approximately 45 degrees. The forward section of fuselage together with the engine, inner section of both wings, horizontal stabiliser and rudder came to rest on a large rock (Figure 5).

Examination of the aircraft wreckage accounted for all major parts of the aircraft, including all flight control surfaces on-site. Continuity of the flight control systems was established. All fracture surfaces showed evidence of impact overloads and there was no evidence of fatigue cracking, corrosion or any pre-existing defect. There was no evidence of any pre-existing defect with the aircraft that would have contributed to the accident.

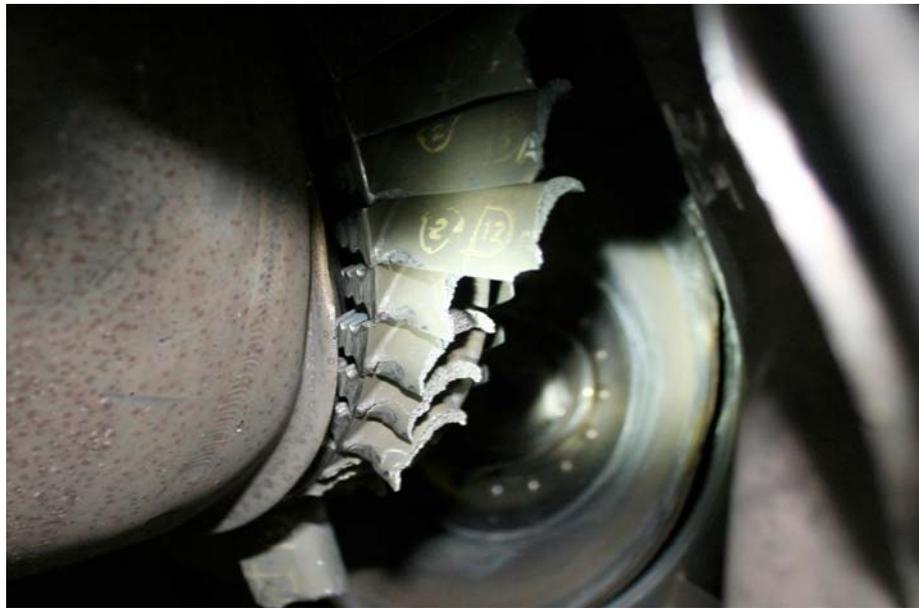
Figure 6: Damage to power turbine blades

The engine was inspected on site and there was no evidence of any pre-impact defect. Continuity of the engine controls was established. Examination of the power turbine blades indicated that they had fractured in overload due to the blade tips coming in contact with the power turbine shroud (Figure 6). Approximately two-thirds of the blades were missing and the remainder were broken at the tips. There was also evidence of rotational damage to the power turbine shroud. The power turbine and shroud damage were indicative of the engine producing significant power at impact.

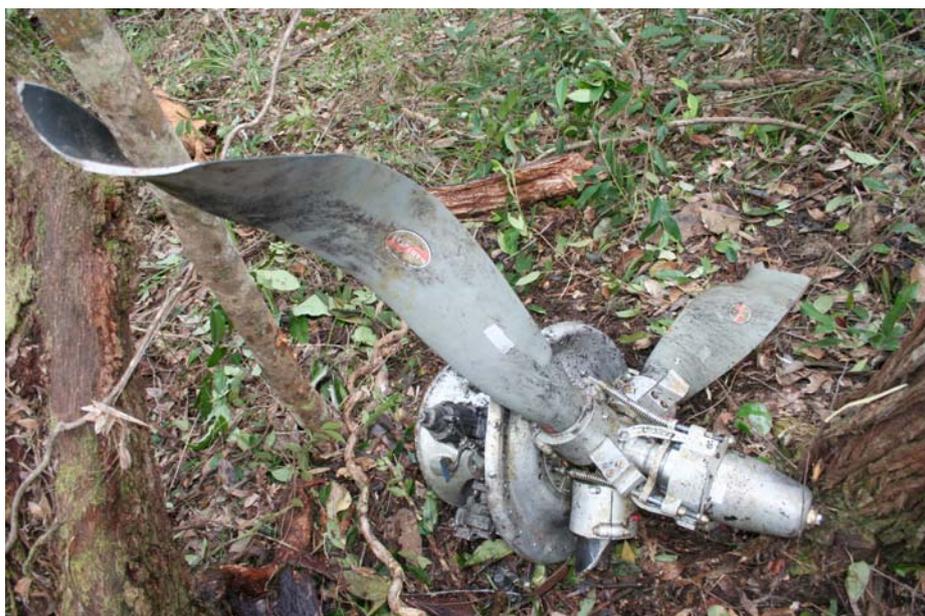
Figure 7: Propeller showing blade bending and missing tip section

The propeller and forward section of the engine reduction gearbox were located approximately 15 m from the main fuselage (Figure 7). One blade had fractured in overload at the propeller hub and it was located approximately 30 m back along the wreckage trail. All of the blades had approximately 25 cm sections missing from their tips and the fracture surfaces of the missing tips showed evidence of overload due to rotational impact forces. All blades exhibited significant bending due to rotation impact damage. There was no evidence of any pre-existed propeller defect. The large amount of rotational damage to the propeller indicated that the engine was producing significant power at the time of impact with terrain.
