ATSB TRANSPORT SAFETY REPORT
Aviation Occurrence Investigation AO-2007-045

Final

Ground Strike - Sydney Kingsford Smith Airport, NSW
13 October 2007
VH-EEB
Embraer-Empresa Brasilia EMB-120 ER

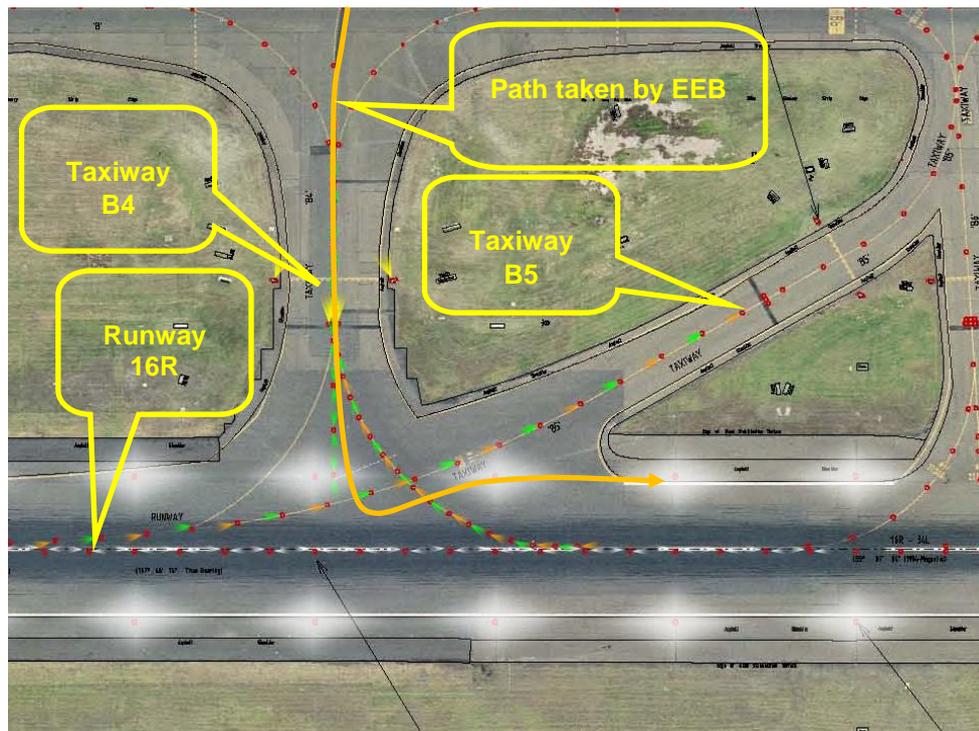
Taxiway B4 was used to enter the runway. It was located beside taxiway B5 as it entered runway 16R (Figure 1). Taxiway B5 was a rapid exit taxiway to the left of Runway 16R aligned at an angle of 30 degrees from the runway. An area of tarmac of approximately half the runway's width extended to the left of runway 16R between taxiways B4 and B5, providing a greater area of tarmac to the left of runway 16R centreline in that location compared with most of the remainder of the runway.

Figure 1. An overhead photograph depicting runway and taxiway lighting in the area near runway 16R, taxiway B4, taxiway B5 and the path taken by EEB.

The additional area of tarmac to the left of runway 16R at the intersections of taxiways B4 and B5, the runway markings leading to taxiway B5 and the absence of a solid runway edge line that led directly from the taxiway in use to the runway, may have given the impression to the crew that the aircraft had proceeded further towards the centre of the runway than it actually had. This may explain why the aircraft was turned onto the left side of the runway and aligned with the left edge.

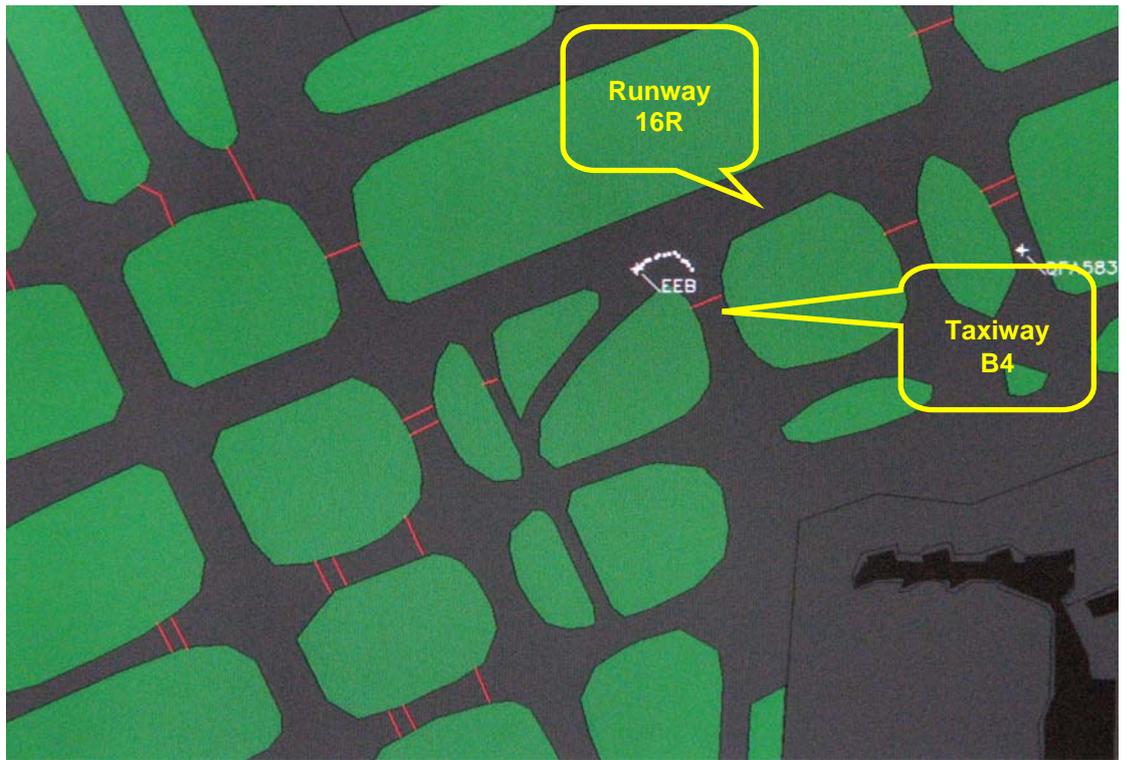
Sydney Airport had a surface movement radar system with a rapid refresh rate that enabled air traffic controllers to use the return signal from an aircraft's transponder to provide an accurate depiction of an aircraft's location on the ground. Recorded images from the surface movement radar indicated that the PIC of the Brasilia initially steered the aircraft towards the centre of the runway. However, the path of the aircraft was then altered, taking the aircraft to the left side of the runway, aligning it with left side of runway 16R for the takeoff (Figures 2 and 3).

Figure 2. Radar image of VH-EEB as it entered runway 16R

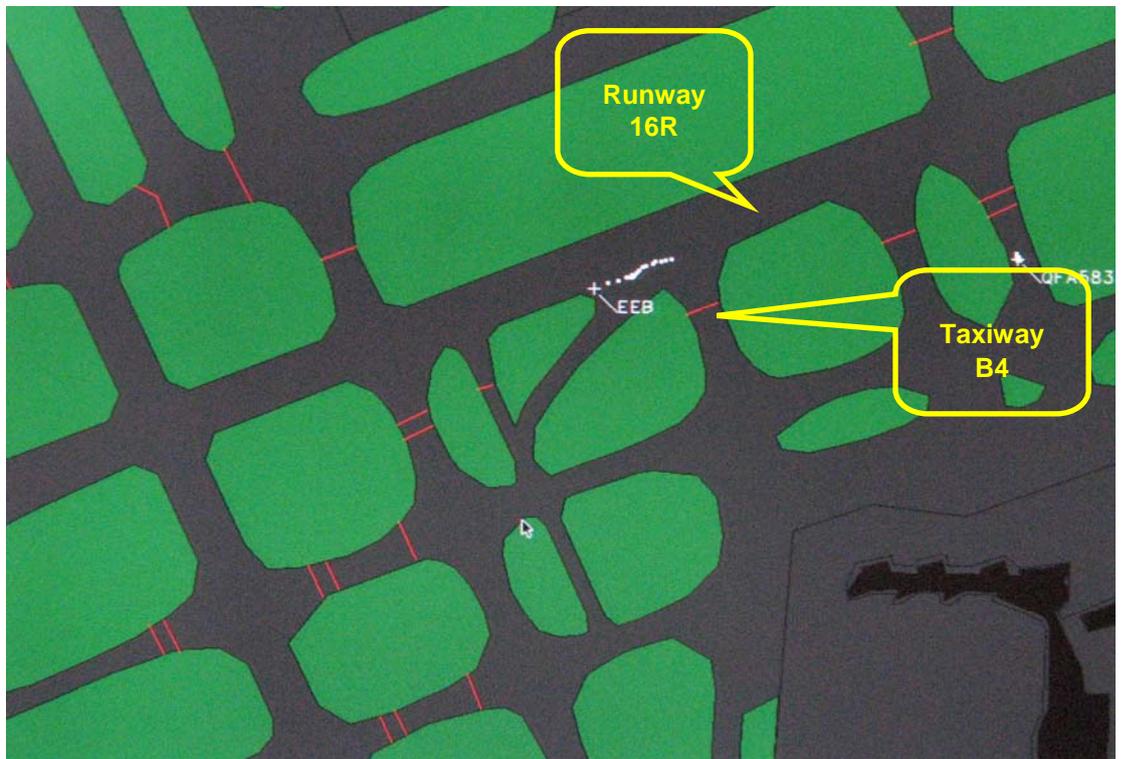
Figure 3. Radar image of VH-EEB during the initial stages of takeoff
