Aviation Occurrence Investigation – AO-2008-001

Preliminary

**Elevator tab failure
Pt. Moresby, PNG - 31 Dec 2007
VH-OZX
Boeing 737-229**

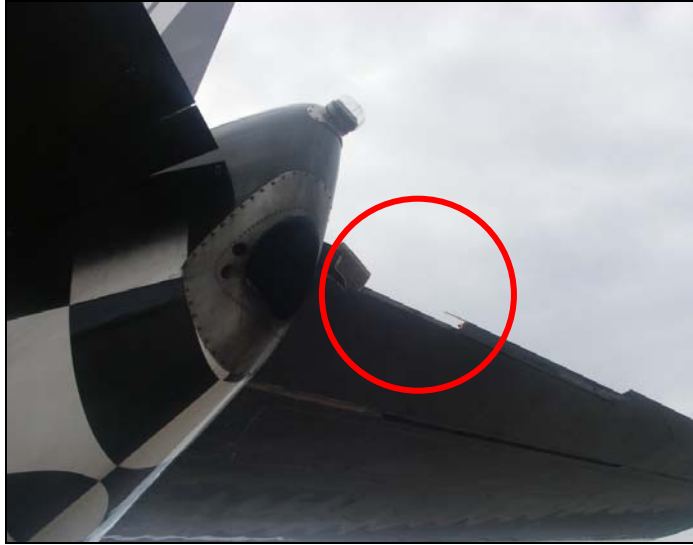
A subsequent examination of the aircraft on the ground found that a section of the right elevator balance tab had detached and was missing (Figure 1).

Each elevator contained a balance tab to reduce control forces when operated manually. A subsequent inspection indicated that the right elevator tab had failed with a section separating from the aircraft. The remaining sections of the elevator tab were removed and sent to the Australian Transport Safety Bureau (ATSB) for further examination.

Figure 1: Right elevator tab section detached

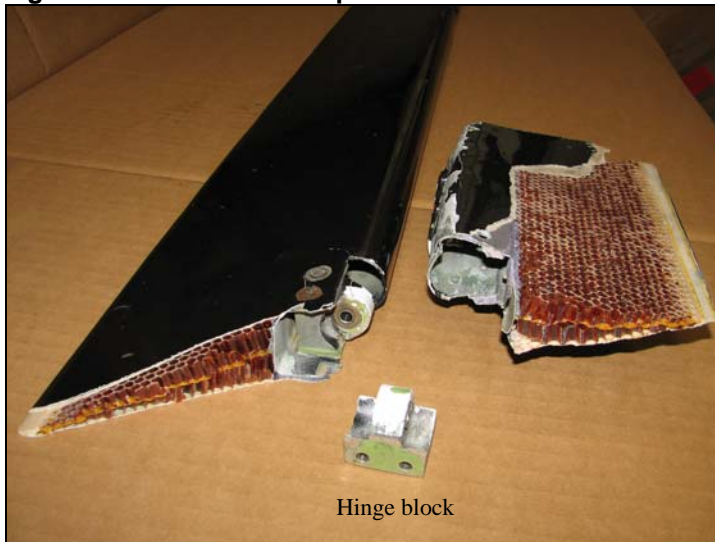
A preliminary examination indicated that the failure of one of the elevator tab hinge blocks had occurred (Figure 2).

Figure 2: Sections of separated elevator tab

The Boeing 737-200 aircraft was subject to service bulletin (SB) SB737-55A1078 issued by the aircraft manufacturer and mandated through airworthiness directives (AD) issued by the US Federal Aviation Administration (AD/2006-14-07) and the Australian Civil Aviation Safety Authority (AD/B737/292). That SB related to wear in the elevator web and tab hinge components that could lead to vibration and subsequent elevator tab failures. The aircraft operator had complied with the SB requirements, with relevant inspections having been carried out and current. Further examination of the elevator tab and hinge block is ongoing.
