ATSB TRANSPORT SAFETY INVESTIGATION REPORT

Aviation Occurrence Report – 200505170

**Runway Incursion – Sydney (Kingsford Smith) Airport,
NSW – 20 October 2005**

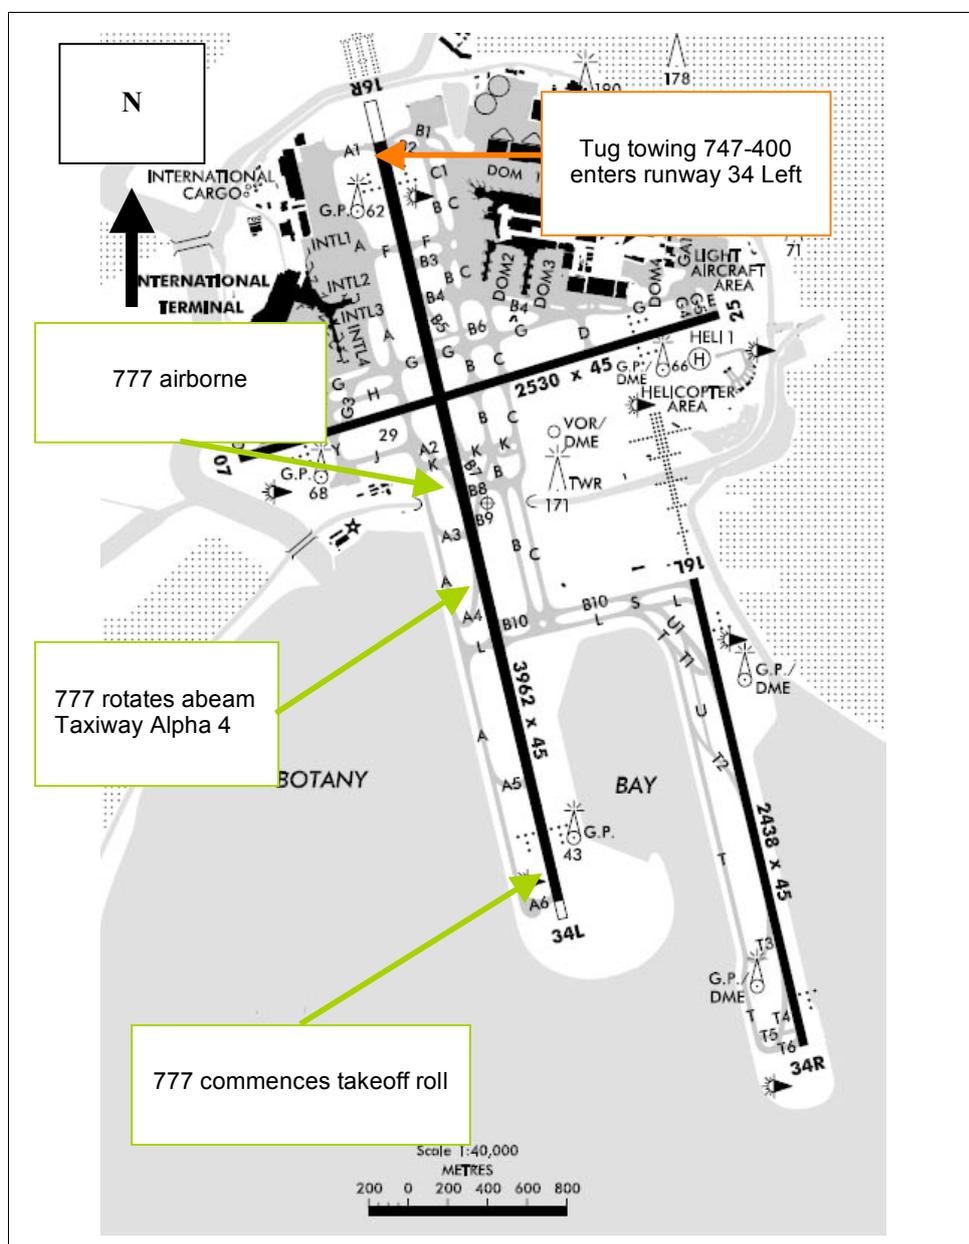
Figure 1: Location of runway incursion on Sydney Airport

The driver of tug red golf was tasked to tow the 747 from the international cargo area, located in the northwest sector of the airport, to the maintenance area adjacent to the domestic terminals in the north-eastern sector of the airport. This operation involved crossing runway 34L and was normally accomplished by using one of the three northern taxiways, Alpha 1, Foxtrot or Golf. (Figure 1)

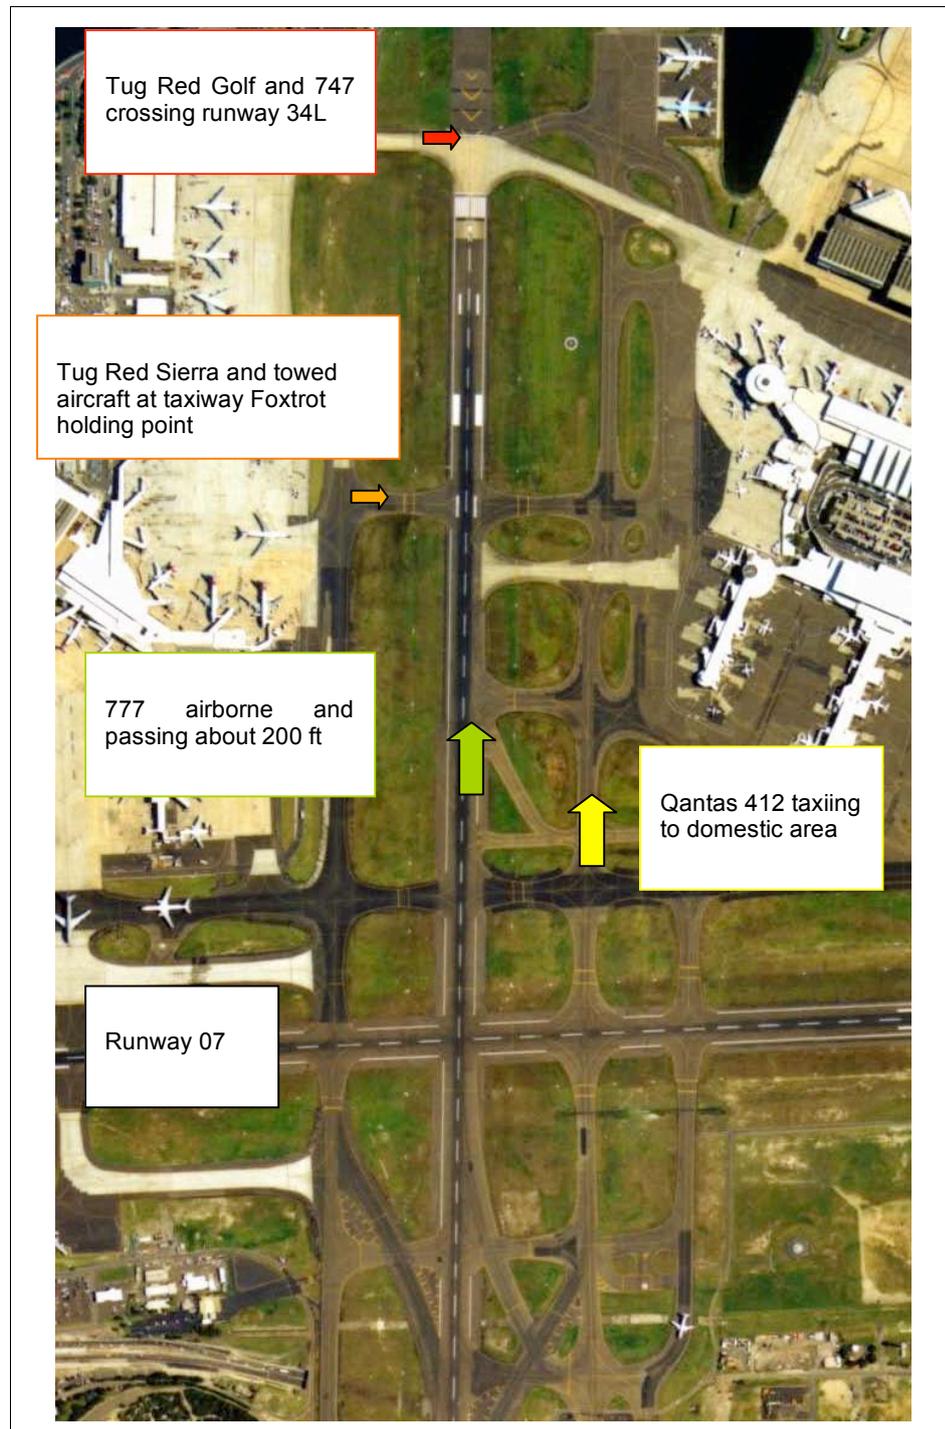
Figure 2: Approximate location of tug, Boeing 777 and taxiing 767 at 0847:12³

The first valid radar plot from the Australian Advanced Air Traffic System (TAAATS) for the 777 was at 0847:12 (Figure 2) when it had passed the intersection of taxiway Golf with runway 34L. The displayed altitude of the aircraft was about 200 ft above mean sea level (AMSL). At 0847:24, the plot of the 777 passed just behind the plot of tug red golf as it exited the runway at taxiway Bravo 2. At that time, the displayed altitude of the 777 was 800 ft AMSL. The elevation of the northern end of runway 34L is 8 ft AMSL. The top of the tail section of the towed 747 was 63 ft 8 in above ground level.

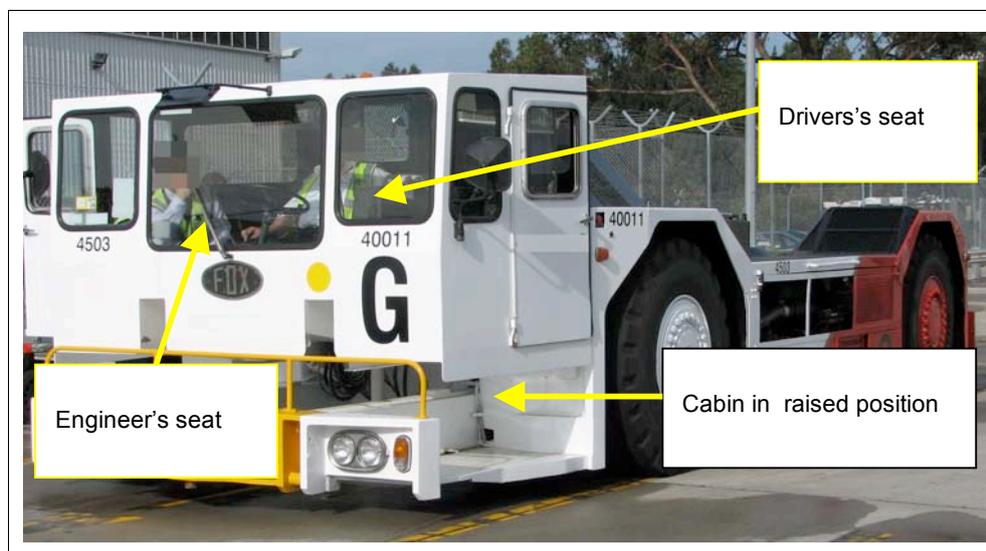
Figure 3: Tug Red Golf

The driver's cabin of the tug could be raised about 0.5 m in height (Figure 3) to assist the driver's view when towing. It was normal practice for the tug driver to raise the cabin when towing aircraft and the driver reported that the cabin was raised during the tow. The cabin was fitted with a VHF radio. The driver used a headset and handheld microphone to communicate with air traffic control when operating on the airport movement area. There was a second radio available to the driver to communicate with a company operations manager. The driver monitored that radio via a speaker in the cabin and used a separate handheld microphone.
