ATSB TRANSPORT SAFETY INVESTIGATION REPORT
Rail Occurrence Investigation 2007/008
Final

Collision between Tandem Tip Truck and the *Indian Pacific* Passenger Train, 4SA8

Virginia, SA

13 December 2007

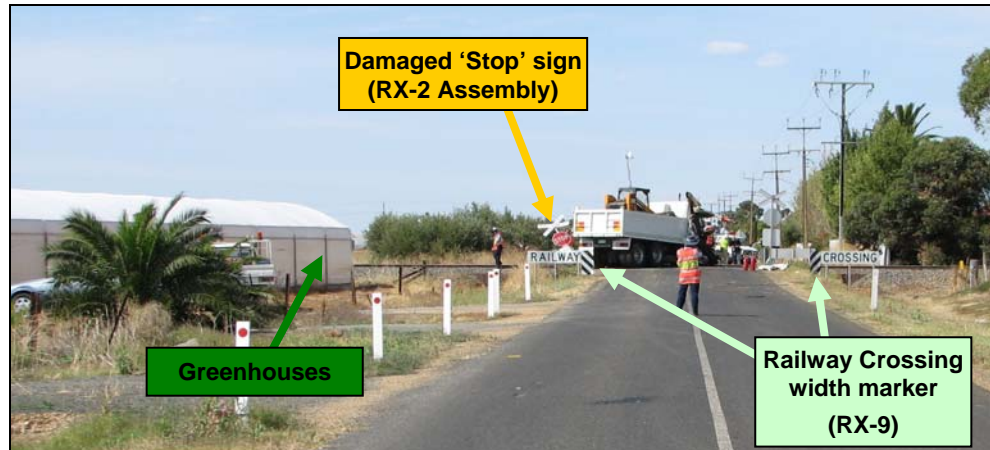
Figure 3: Site of collision, truck driver's view, travelling in a north-easterly direction

Travelling along Moloney Road in a north-easterly direction (the direction of the truck's travel) the visibility of the rail line to the north-west (the direction from which the train approached) is obstructed by a row of sheds used for horticultural purposes (greenhouses).

Sighting along the rail line remains obstructed until a motor vehicle is about 13 m from the crossing and near the 'railway crossing width marker assembly' (RX-9)

(Figure 3). The line of sight then opens up and sighting along the rail line is in excess of 650 m at the level crossing's stop line.

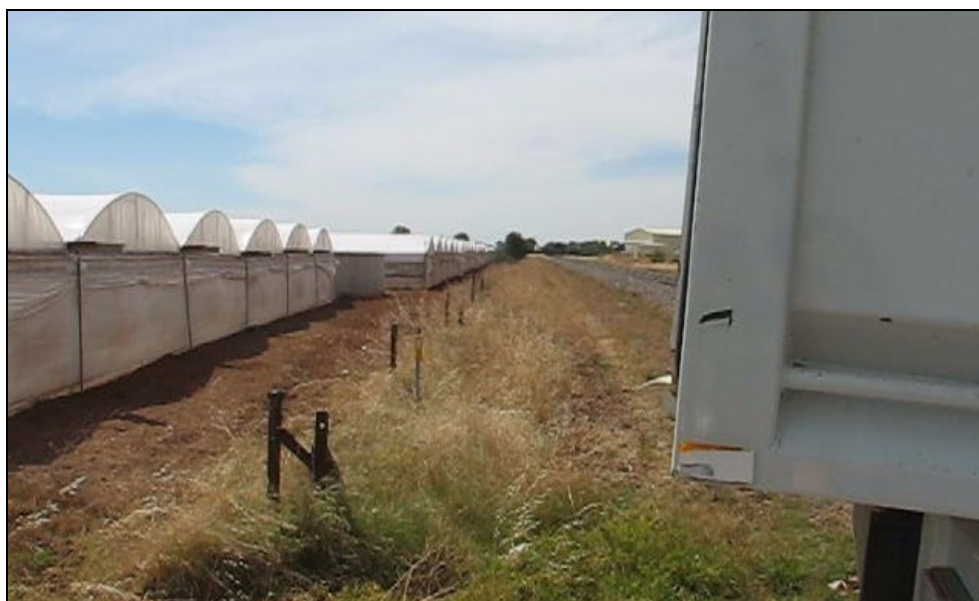
Figure 4: View from stop line looking towards direction of train travel

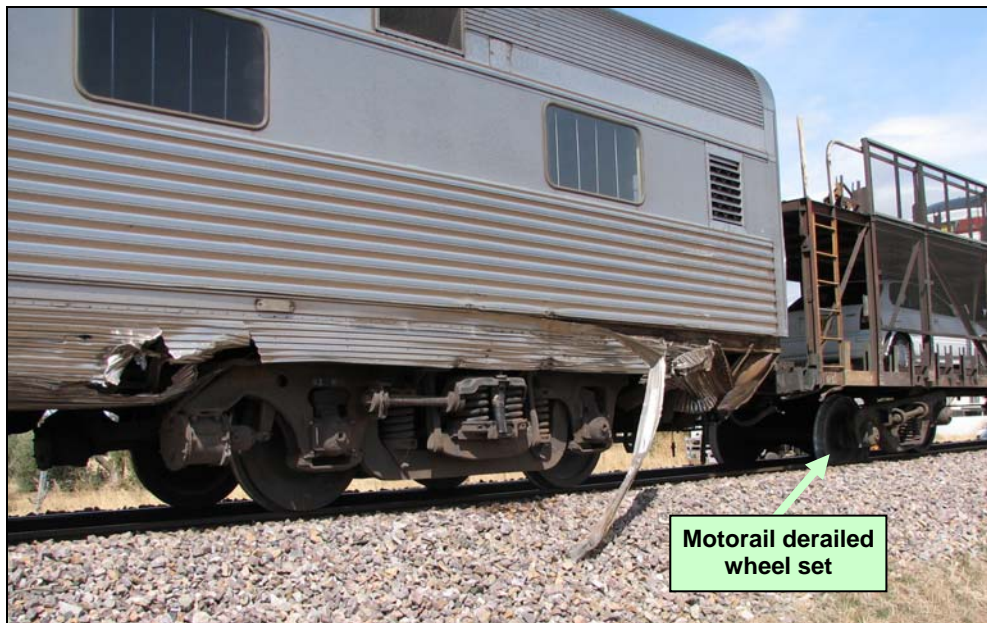
As a result of the collision the truck was extensively damaged. The train sustained damage to the Motorail wagon, power van and crew van. Most of the damage was superficial but the trailing bogie of the Motorail wagon derailed (Figure 5).

Figure 5: Damage to power van (foreground) derailed bogie of Motorail wagon (background)

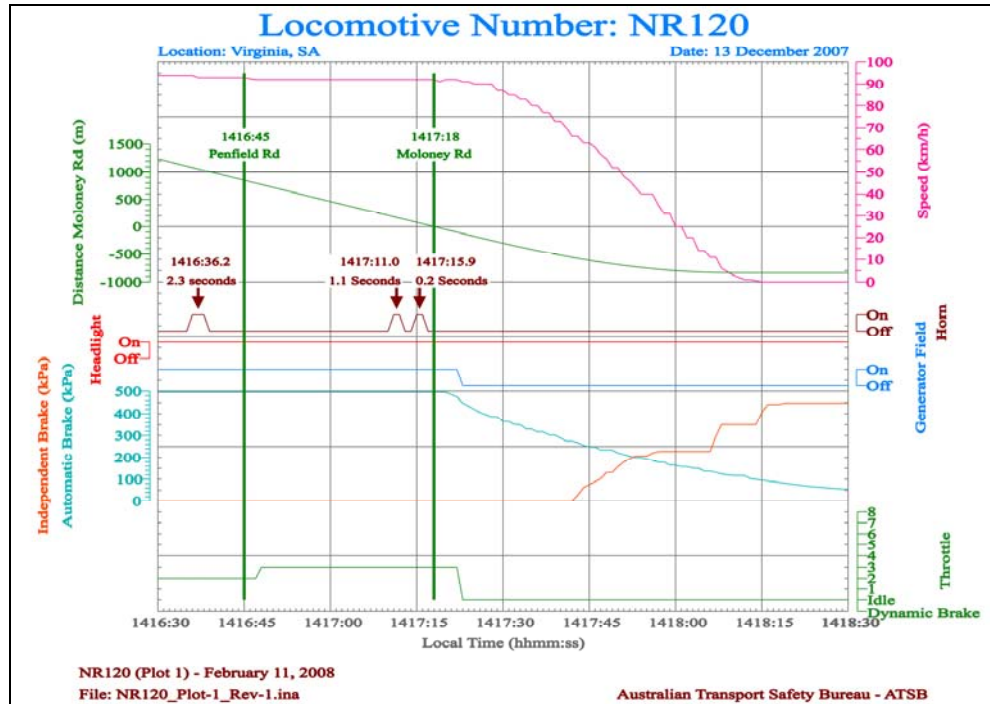
- The collision occurred at approximately 1417:18, just as the train entered Moloney Road level crossing.
- The train brakes were applied approximately four seconds after the train had passed over the Moloney Road level crossing, i.e. about 100 m after the point of impact, when the driver became aware of the collision. This was corroborated by the train driver who stated that he applied the brakes as soon as he became aware of the collision.

- The headlights and ditch lights were on and in good working condition.
- The locomotive horn was in good working order.

Figure 6: Locomotive NR120 ‘loco log data’ extract

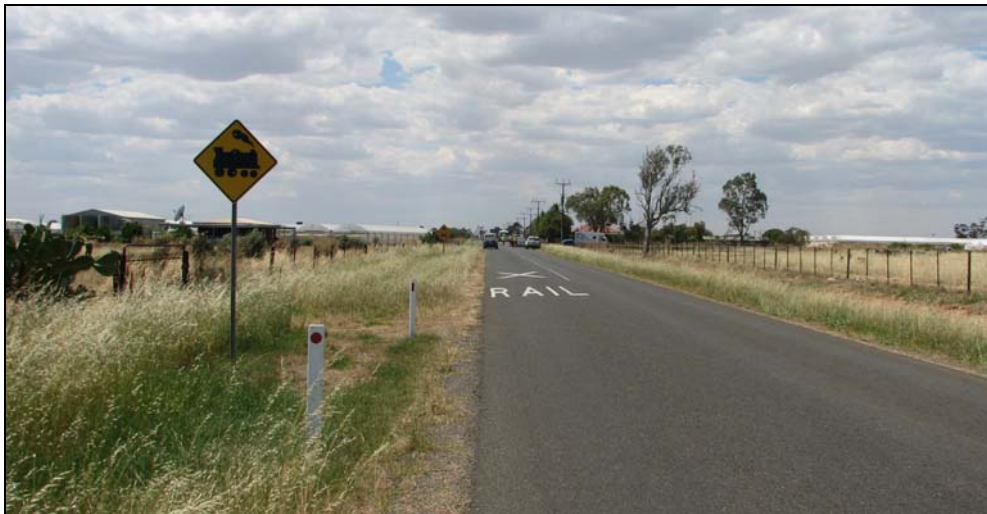
Figure 7: Motorist's view of Moloney Road level crossing, travelling in a north-easterly direction (direction of truck travel)

The greenhouses adjacent to the rail corridor completely obscure any train approaching the level crossing from the north-west for motorists driving along Moloney Road in a north-easterly direction. The truck driver's familiarity with the crossing meant he would have been fully aware of this impediment to sighting a train and the consequent need to stop at the level crossing. His failure to stop on this occasion was high risk behaviour, especially in light of his knowledge that

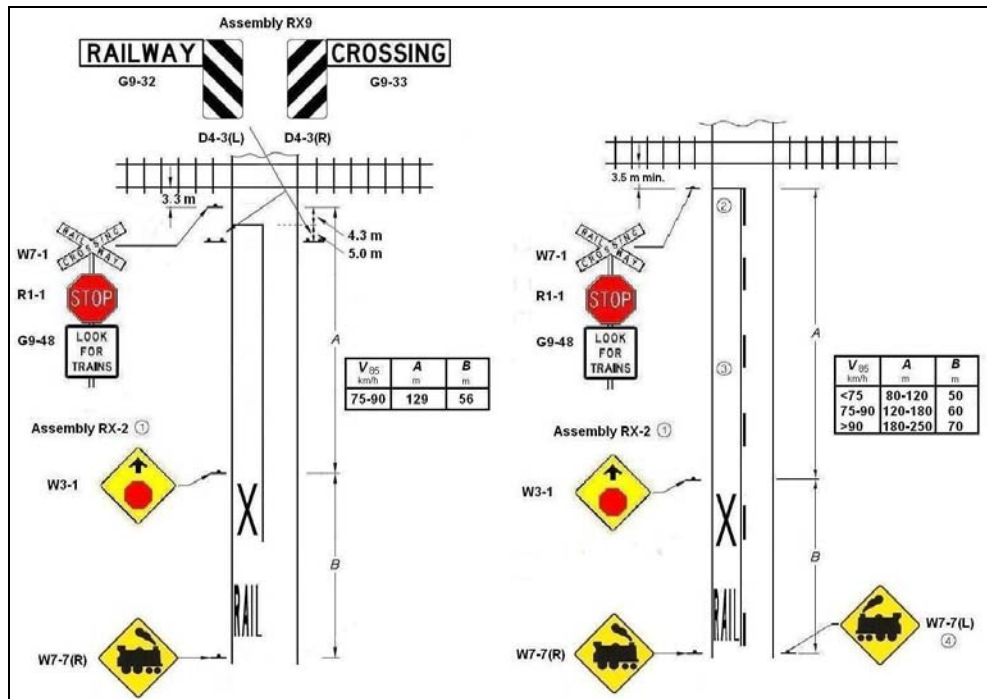
The investigation found that the Moloney Road level crossing approach signage and road markings complied with the Australian Standard AS1742.7 – 2007 other than some very minor issues. It is unlikely that these issues would have contributed to the accident.

Figure 8: Signage at Moloney Rd level crossing on 13 Dec 07. RX-9 assembly is optional

Figure 9: Signage prescribed in AS1742.7-2007. W7-7(L) is optional

An examination of the signage (Figure 8) approaching from the south-west (direction of truck travel) established that it was generally in compliance with the requirements of the Australian Standard. There was only one issue that related to the positioning of the stop line in that it was set back from the RX-2 assembly by 4.3 m. The standard specifies that the stop line and RX-2 assembly should be adjacent to one another¹¹. However, the location of the stop line was unlikely to have been a factor in this collision, but closing the distance between the RX-2 assembly and stop line could under certain circumstances improve sighting along the track.

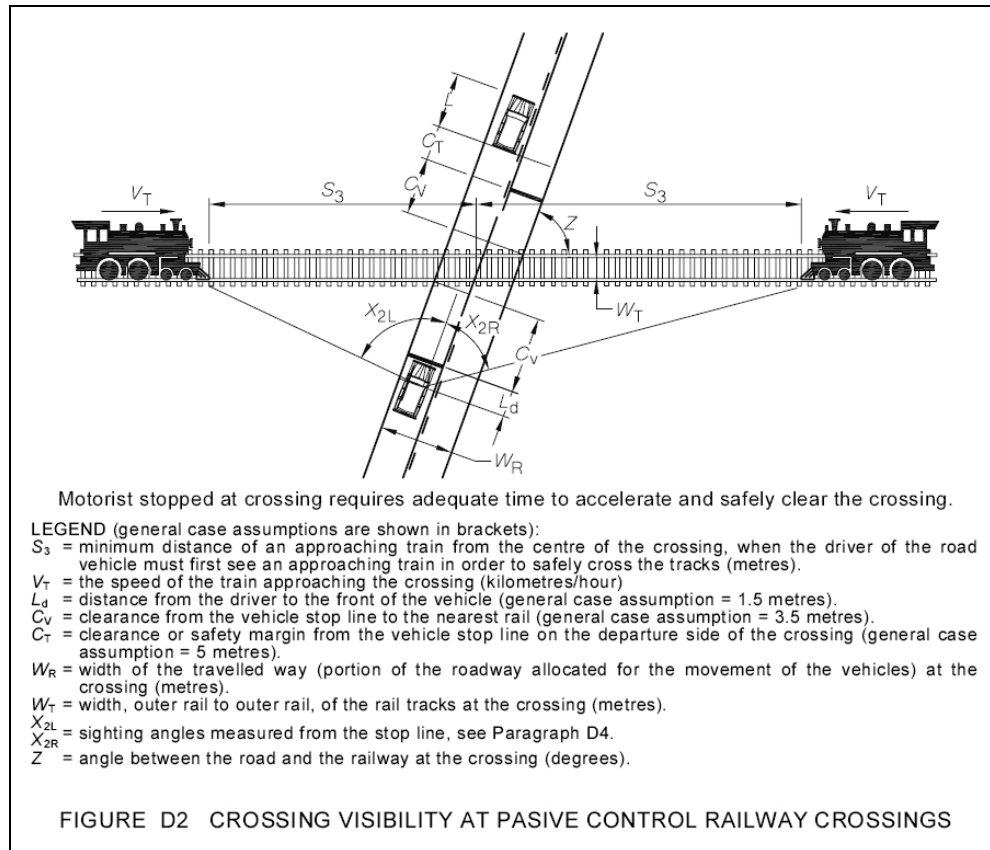
Using the formulae contained within AS1742.7-2007, a truck of the class involved in the collision at Moloney Road when stopped on the stop line, on the south western side of the level crossing, needs about 395 m¹³ sighting (S₃ Figure 10) to safely traverse the crossing with a train approaching at 100 km/h. The sighting distance to the left (S₃) from the stop line was found to be in excess of 650 m¹⁴, and thus well in excess of the requirements of the standard.

In summary, had the truck driver come to a halt at the stop line as required he would have been able to clearly see the train, remain at a standstill at the stop line and then proceed safely over the crossing when the train had passed.

Figure 10: AS 1742.7-2007 approach distances and viewing angles sighting diagram
