A U S T R A L I A N T R A N S P O R T S A F E T Y B U R E A U

AIR SAFETY INVESTIGATION

200100348

**Cessna C310R, VH-HCP
3 km E Newman Aerodrome
26 January 2001**

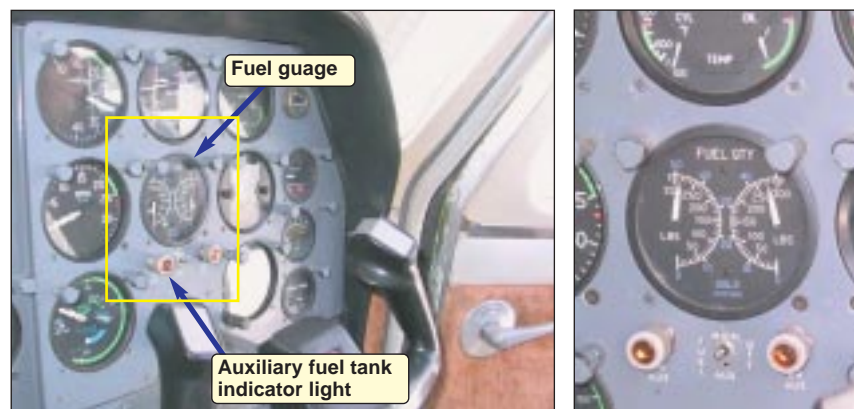
The fuel gauges were calibrated during routine servicing in March 2000, and the left main, left auxiliary and right main tank gauges were found to be accurate within +/- 5 per cent throughout their indicating range. The gauge for the right auxiliary tank was found to slightly under-read and a calibration card¹⁰ was completed. That card indicated for an actual fuel quantity of 50 lbs (32 L), the gauge reading would be 40 lbs (26 L).

FIGURE 3:
Typical C310 fuel gauge and position on right side of instrument panel

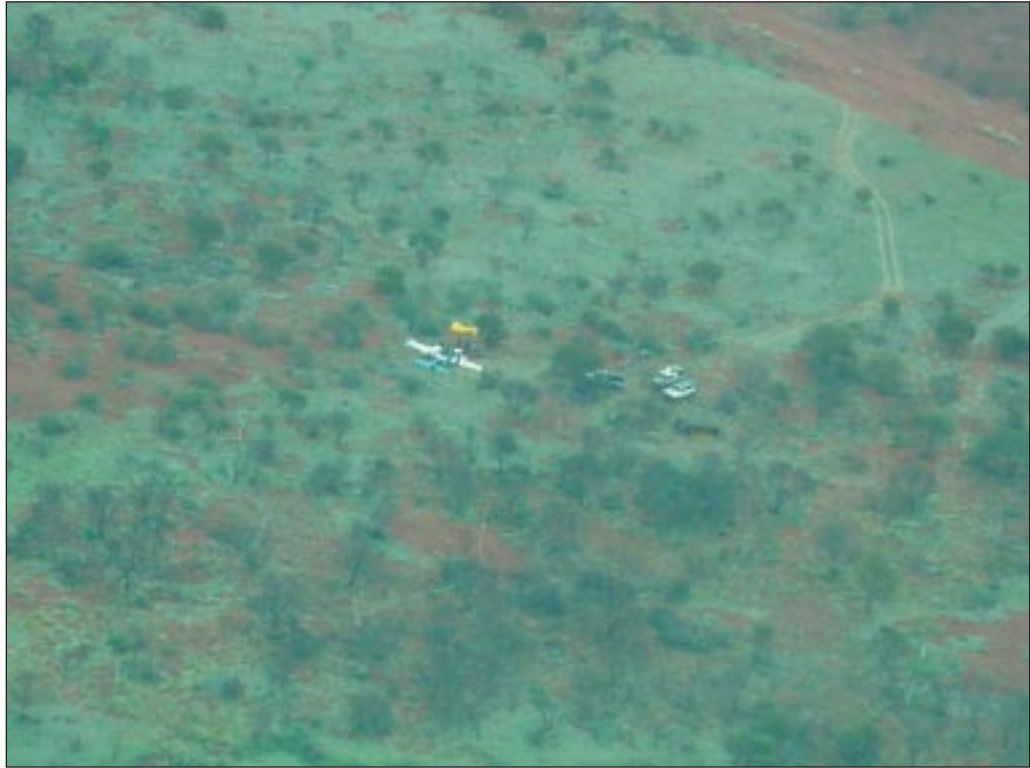
FIGURE 8:
Aerial view of aircraft wreckage (note lack of wreckage trail, indicating steep flight path impact angle and low relative forward speed)

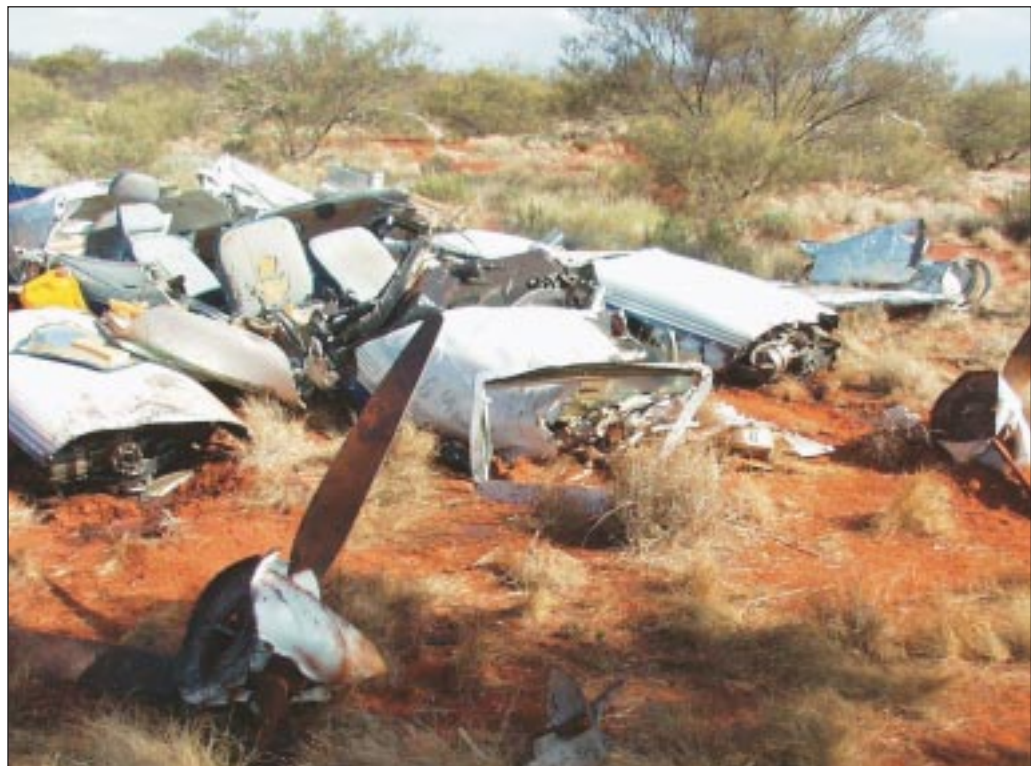
FIGURE 9:
View of wreckage from front of aircraft (roof of aircraft cabin cut away by emergency services personnel, prior to arrival of ATSB investigators)

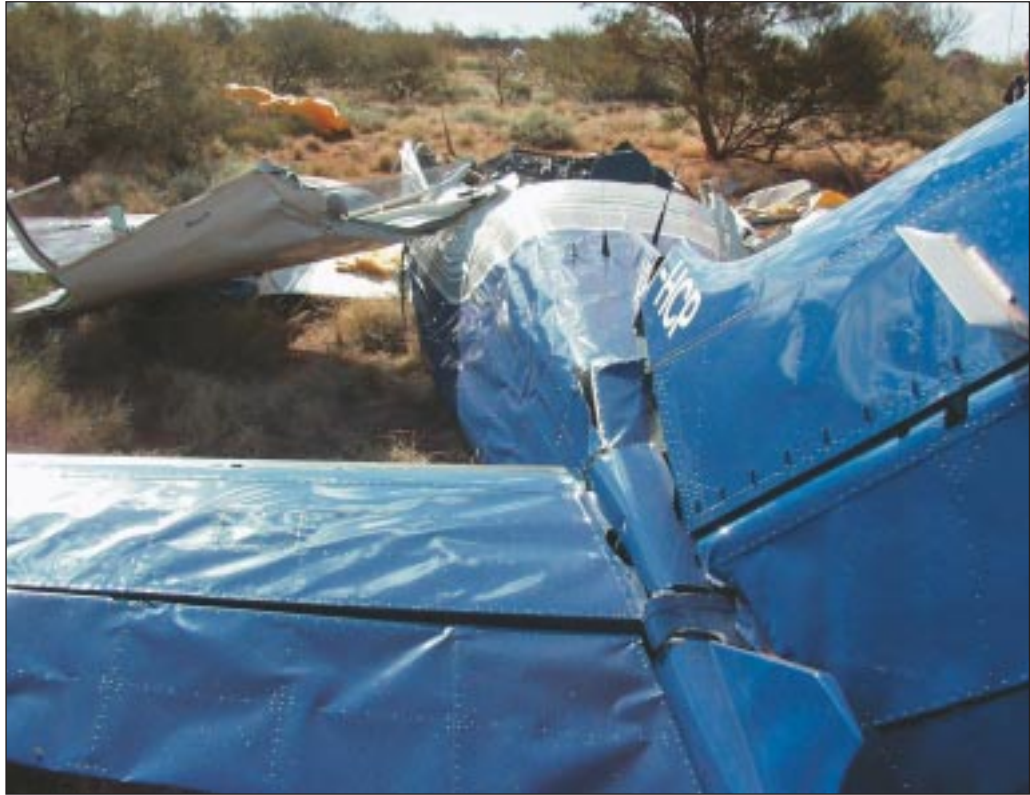
FIGURE 10:
Rear view of aircraft fuselage

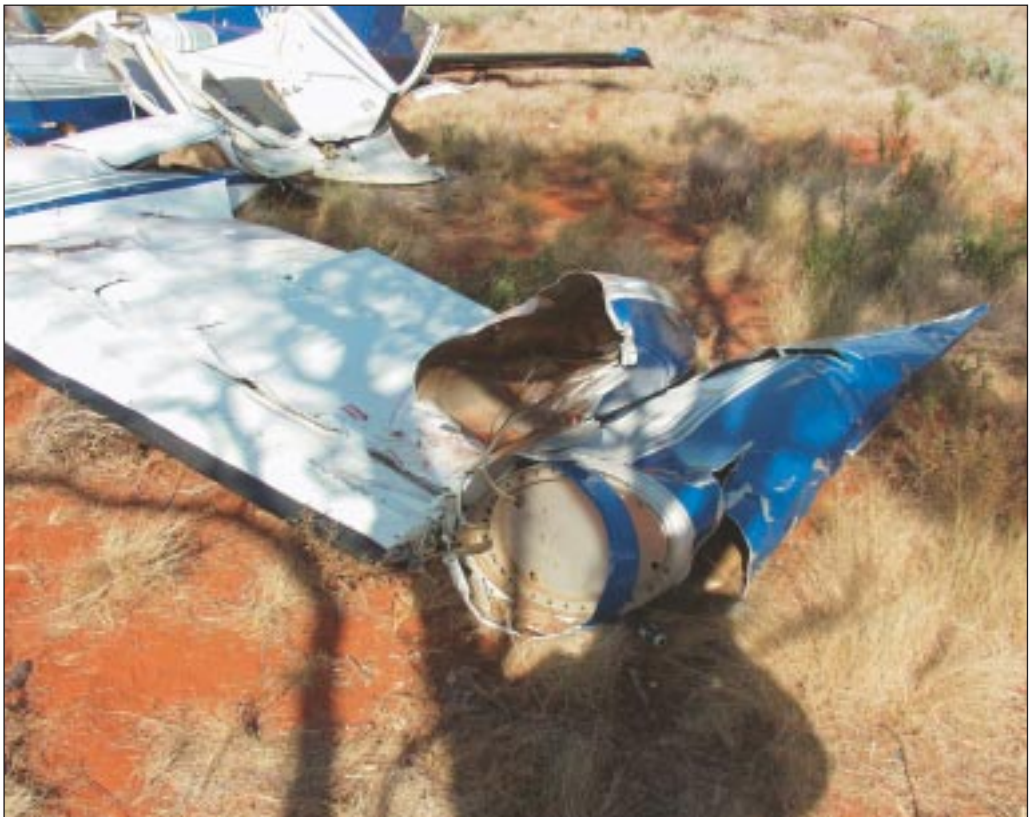
FIGURE 11:
Damage to left main fuel tank

As discussed in section 1.12.3, the left main fuel tank was ruptured and the remaining fuel was exposed to the atmosphere. Testing of the sample obtained from this tank

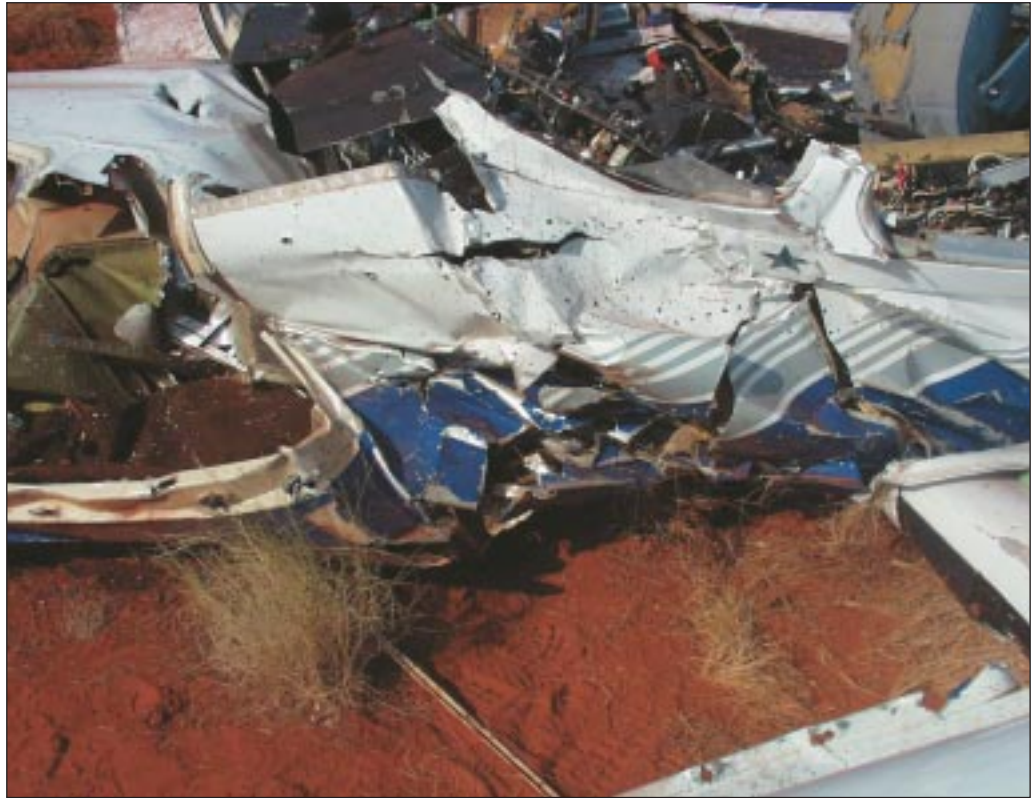
FIGURE 12:
Crush damage to forward fuselage section

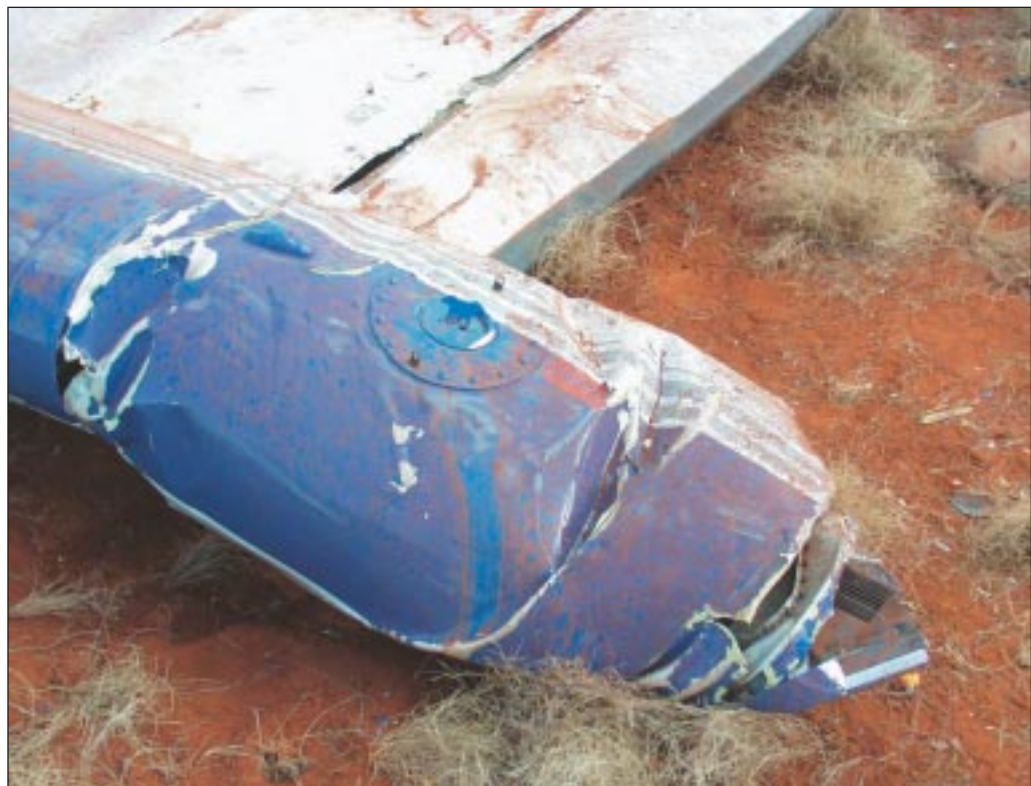
The right main fuel tank was significantly damaged on impact. There were some holes and compression damage to the forward part of the tank structure, although the rear part of the tank remained substantially intact.

FIGURE 13:
Impact damage to right main fuel tank (note fuel cap previously disturbed by emergency services personnel prior to arrival of ATSB investigators)
