MARINE SAFETY INVESTIGATION
REPORT 183

Independent investigation into the fire in the hold of
the Netherlands flag general cargo vessel

Marion Green

Report No 183
November 2003

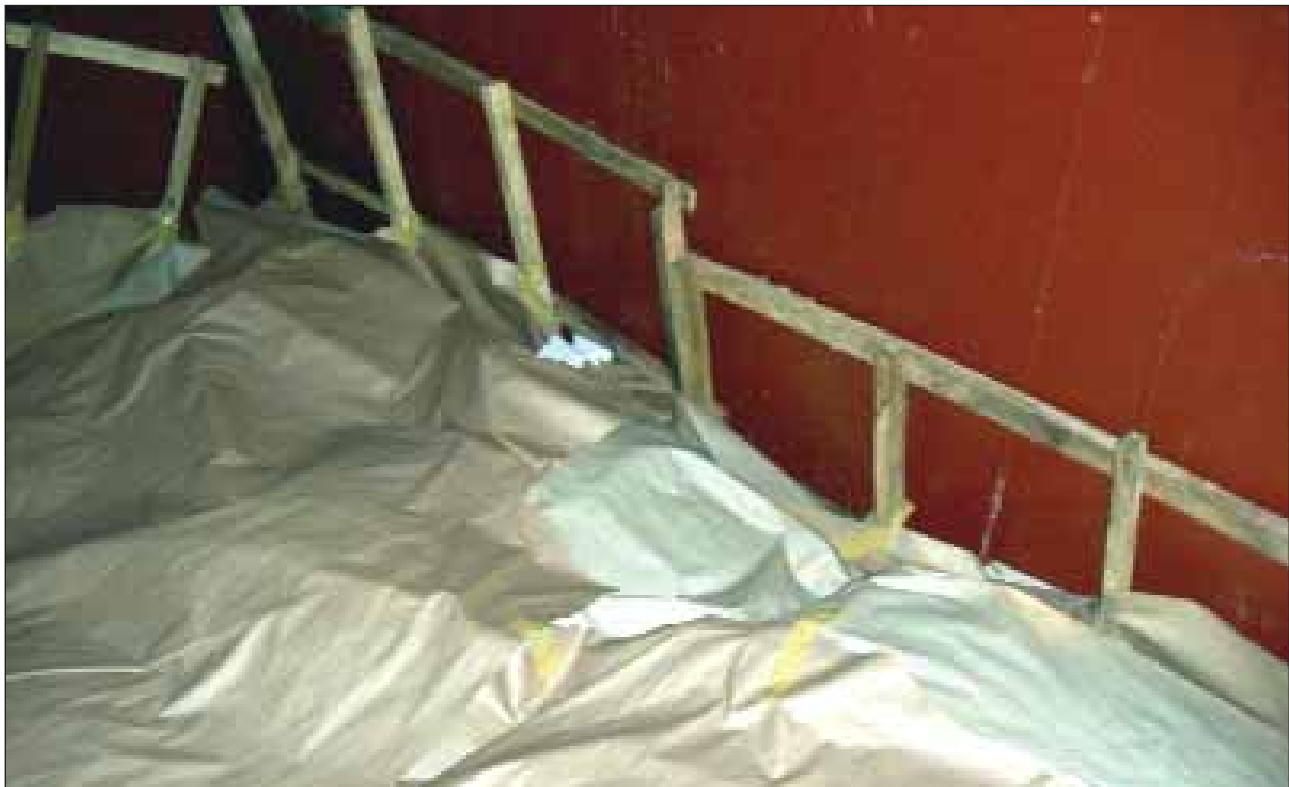
FIGURE 3:
Cargo in No. 1 hold, covered with Kraft paper and showing timber dunnage and fumigation sachets of aluminium phosphide

On completion of loading of the cocoa bean cargo at Makassar, sufficient aluminium phosphide, in the form of sachets, to provide for five days 'in transit' fumigation was scattered randomly across the top layer of the cargo in each hold. In No. 1 hold, some of these sachets could be observed to have fallen down into the ventilation channels provided between the stacks of bags.

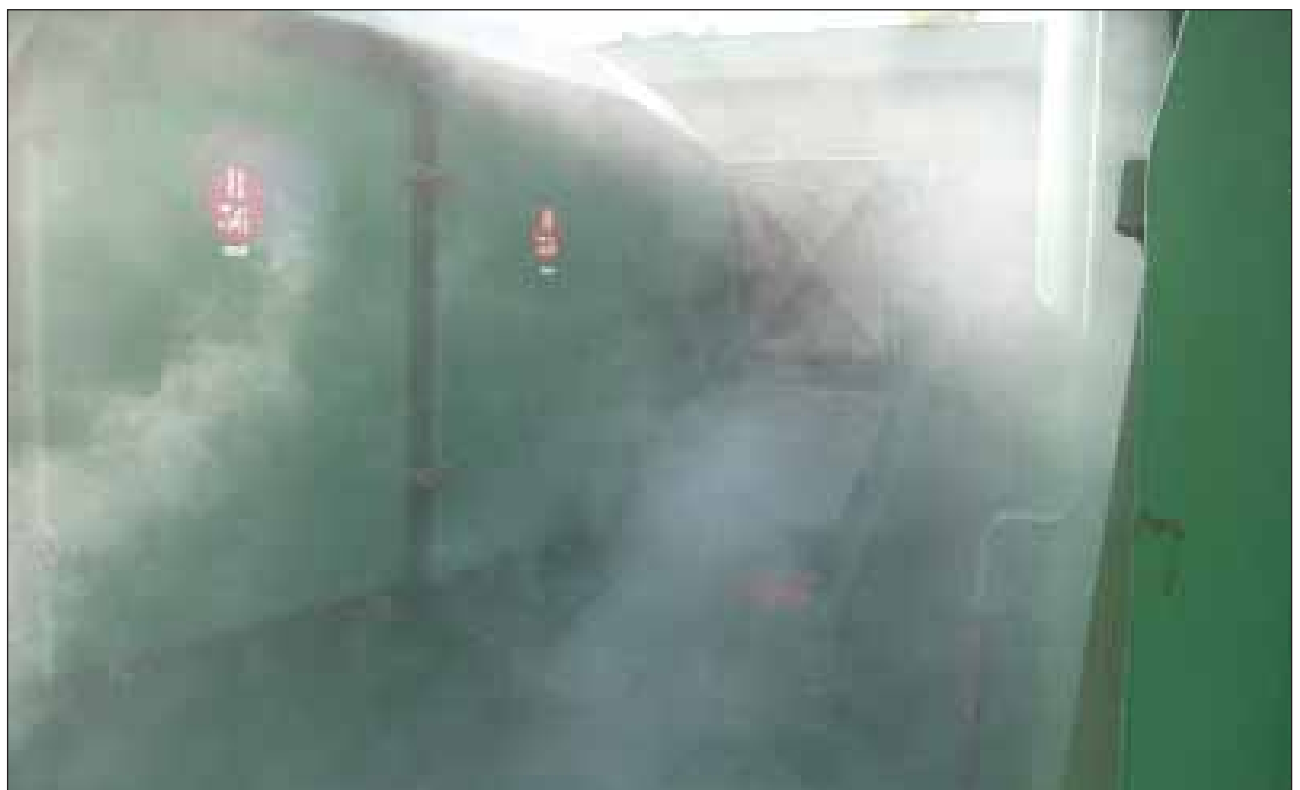
FIGURE 4:
Smoke issuing from No. 2 hold access hatch

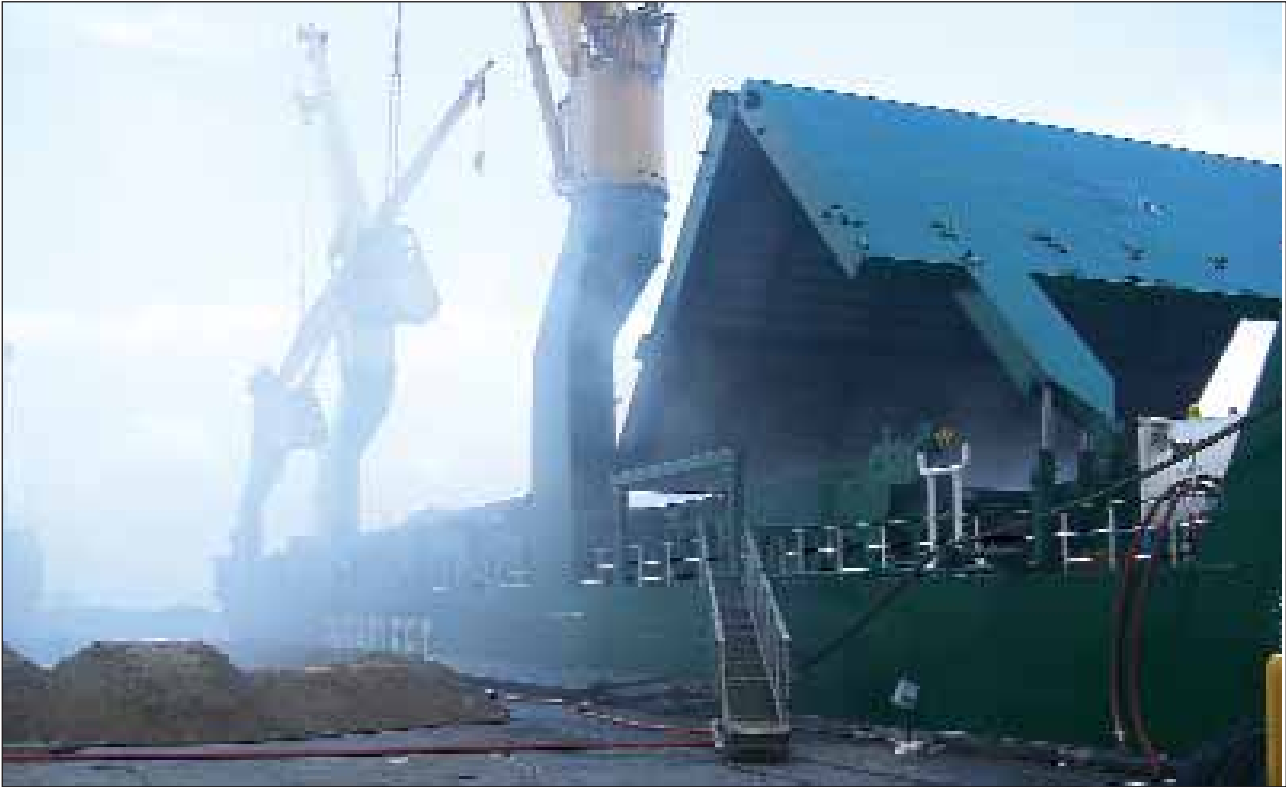
FIGURE 6:
No. 2 hold aft hatch panels partially opened

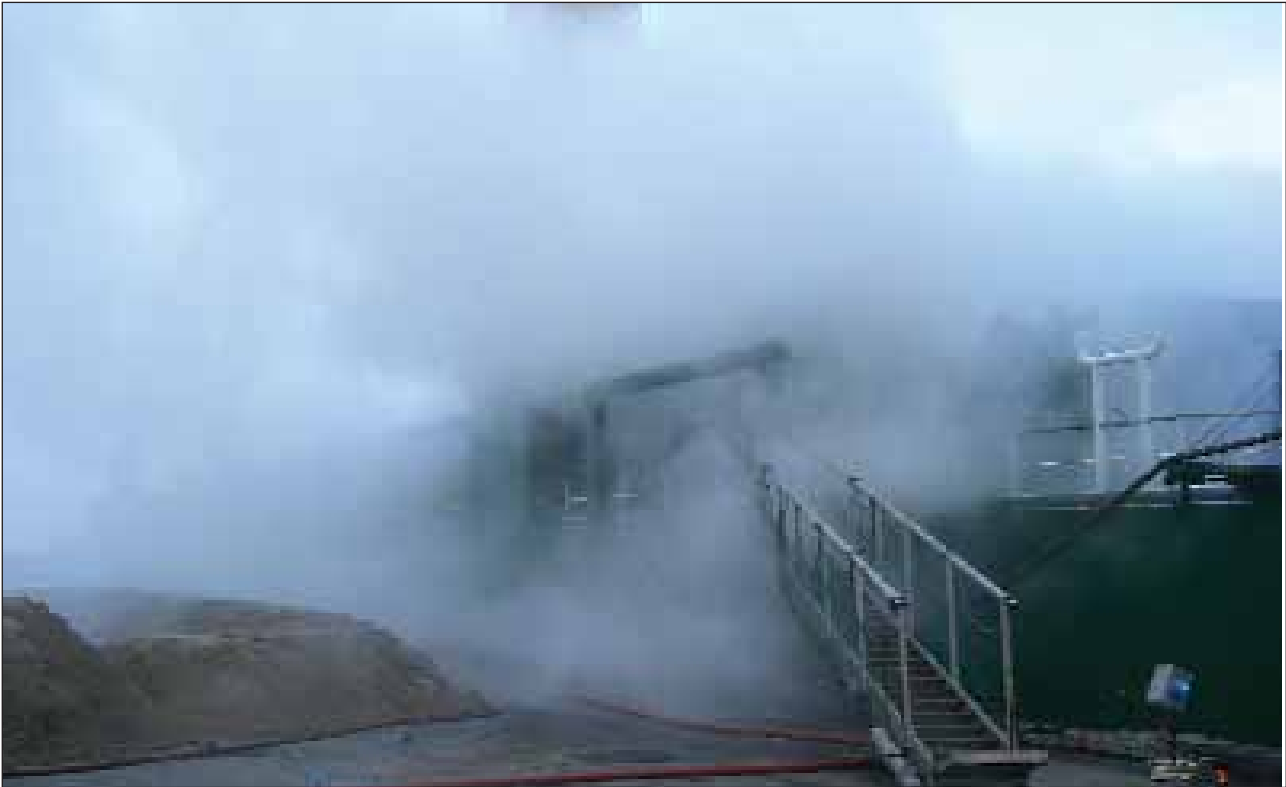
FIGURE 7:
Smoke from No. 2 hold after opening the hatches

At 0930, the access hatch was opened, followed by the two aft panels of the cargo hatch cover which were lifted into a partially open position. Much smoke issued from the hold and some flames were observed through the thick smoke on top of the cargo. The fire brigade started hosing down the top layers of bags of cocoa beans and the flames were eventually extinguished. After a short period with no more flames appearing, the hatch covers were fully opened.

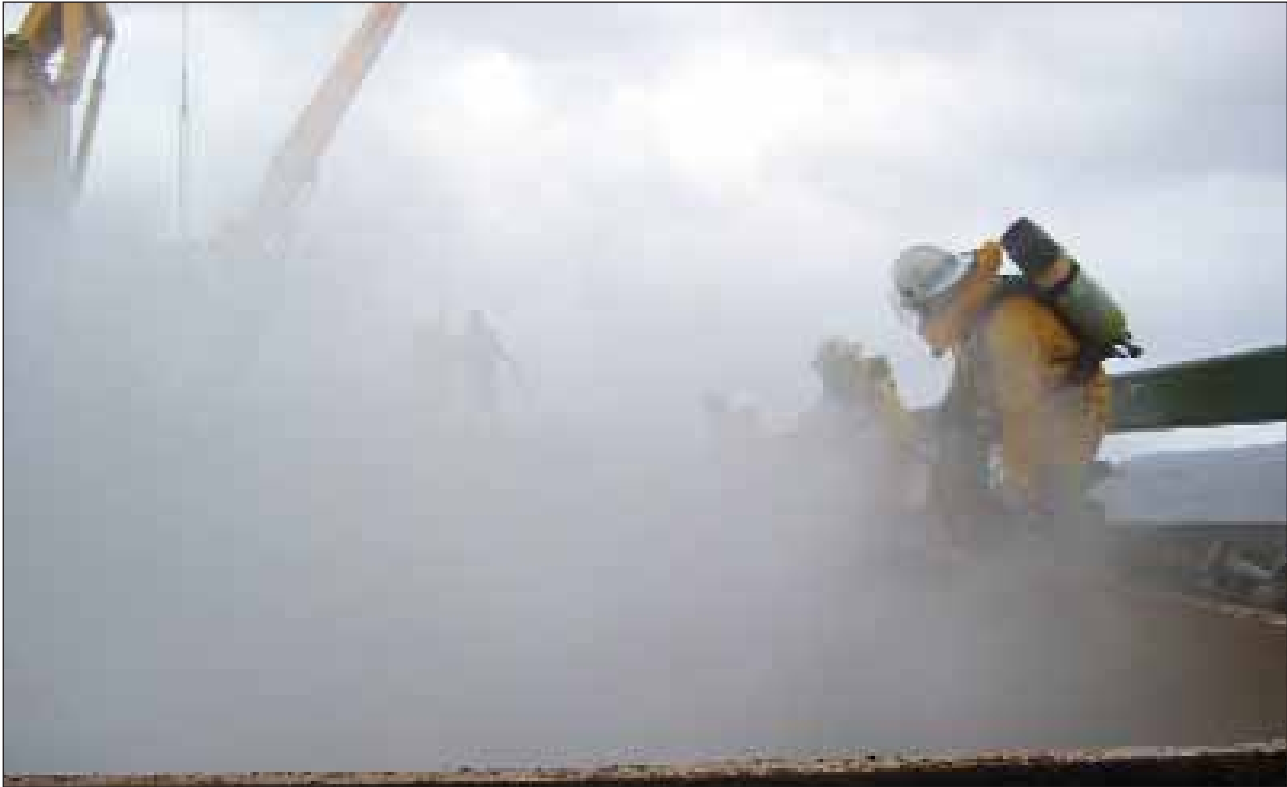
FIGURE 8:
Albany fire brigade tackling fire in no.2 hold

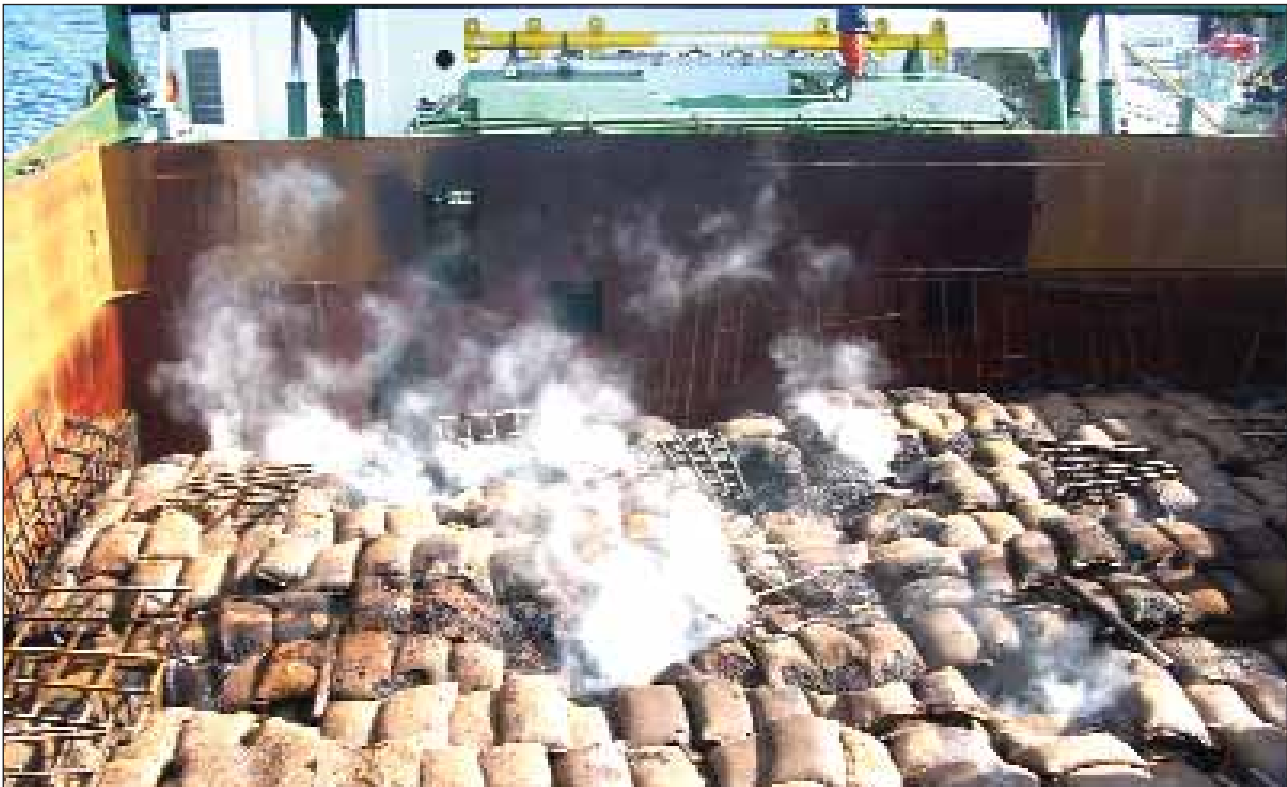
FIGURE 9:
Smouldering cargo at aft end of no.2 hold showing burned cavities and channels

corner of the hold. The way that the fire had burned slowly up towards the top layers of cargo, and then also spread along the bottom of the hold to the forward end would be consistent with smouldering, or slow combustion, having taken place during the five day passage between Makassar and Fremantle. It continued in this manner, albeit accelerated, after the vessel arrived at Albany.

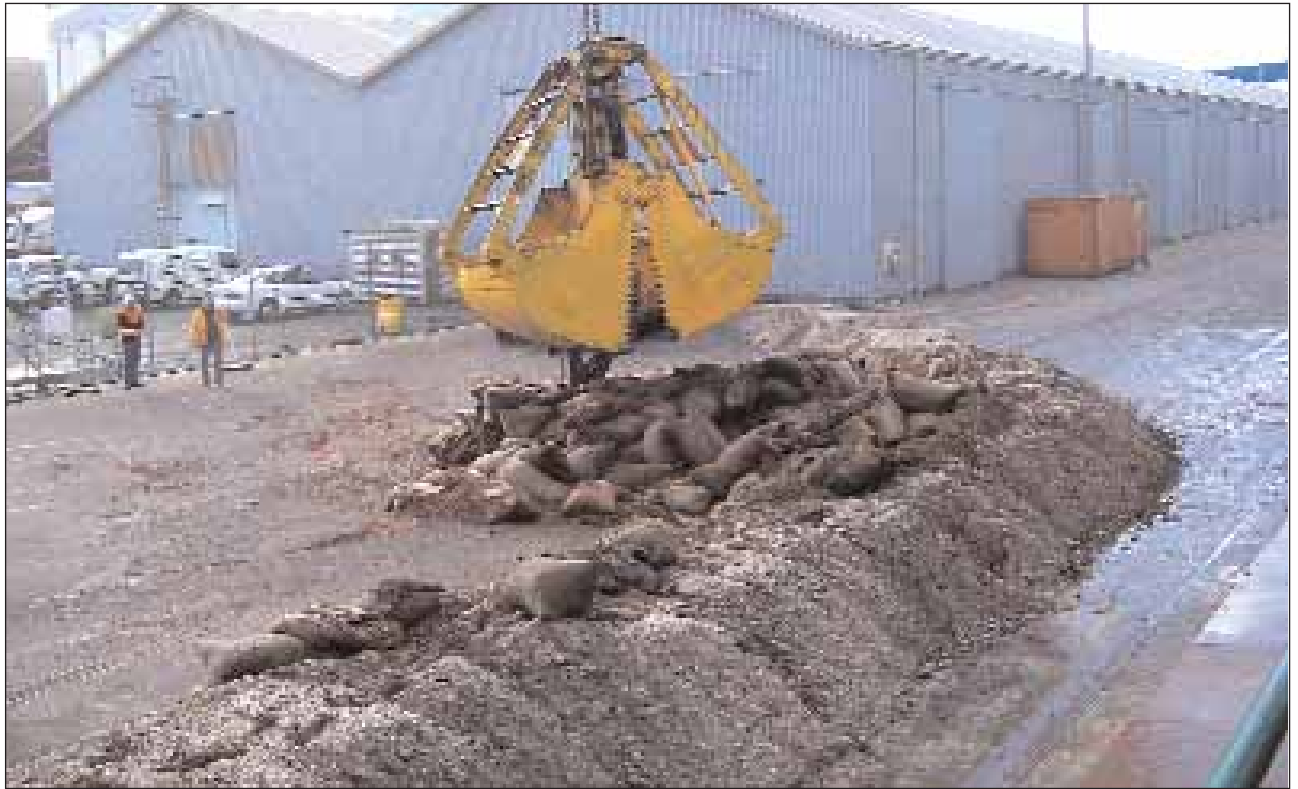
FIGURE 10:
Discharging damaged cargo onto the wharf

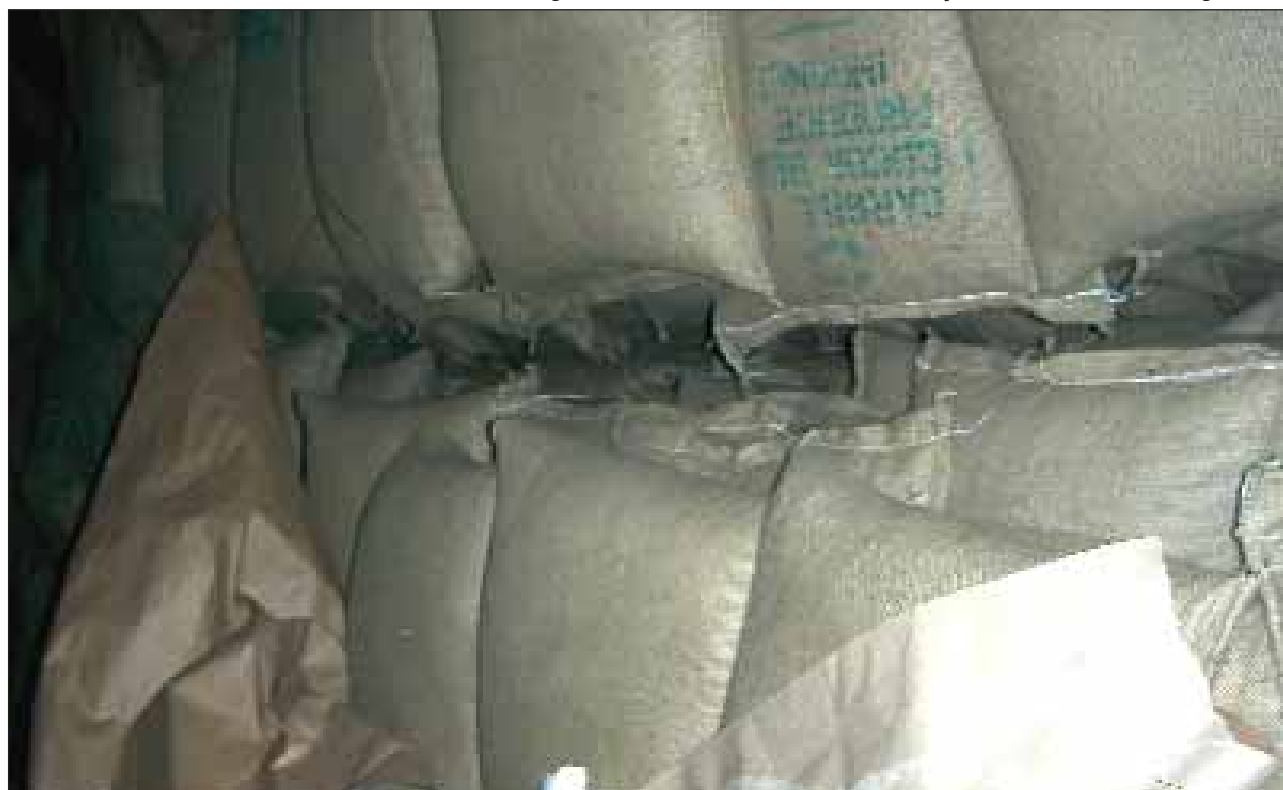
During the investigation, the stowage of the cargo in No. 1 hold was assessed. It was observed that the width of the ventilation channels in many areas was considerably less than 300 mm and, indeed, in some spots had closed up completely, due either to improper stowage on loading, or to subsequent movement of the cargo. It was also noted that the Kraft paper, covering the top layer of cargo, also covered the ventilation channels, hence

FIGURE 11:
Narrow ventilation channel between stacks of cargo in No. 1 hold. Note that some layers are almost touching

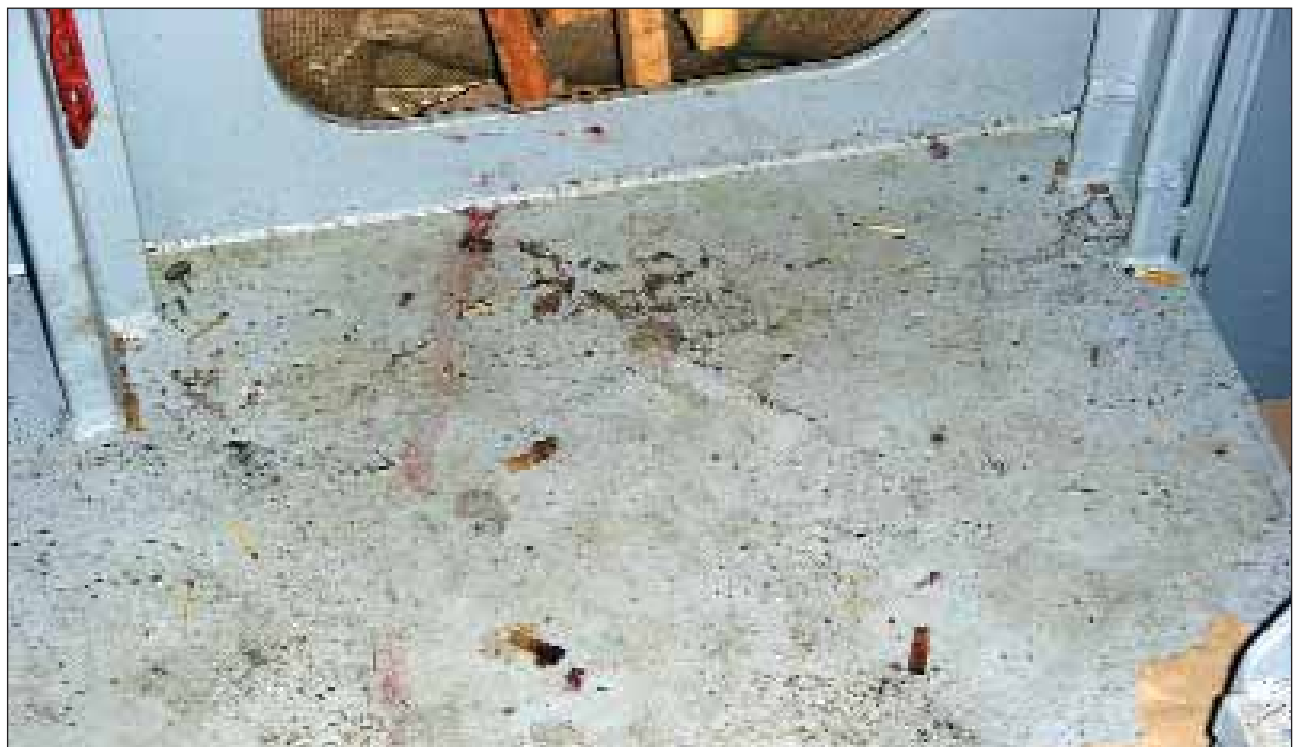
FIGURE 12:
Cigarette ends discarded around No. 1 hold access

the loading of the bagged cocoa beans at Makassar, the deck officers on cargo watch had need, on several occasions, to reprimand certain members of the loading gangs for smoking around the hatches and hold access spaces.

During the investigation, empty Indonesian cigarette packets and numerous butt-ends of cigarettes were found in the accesses to both holds. In addition, it was later reported by the surveyor appointed by the P&I Club, that similar cigarette packets and cigarette ends had been found amongst the cargo from No. 2 hold after it had been discharged ashore.

Smoking materials, discarded in No. 2 hold during the loading of the cargo in Makassar must be regarded as another possible cause of the fire.

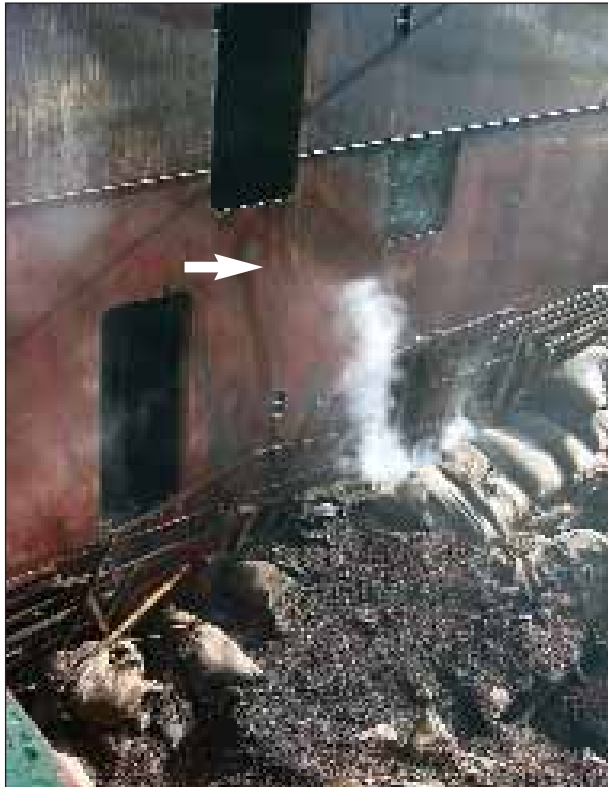
When the after panels of the hatch covers were first opened up on 31 July, it could be seen that an electrical cable was hanging from the upper access at the starboard after corner of No. 2 hold, down into the cargo of bagged beans. This was close to the area where the fire had been first observed and to where it is believed to have originated. See fig. 13.

FIGURE 13:
Electric cable for cargo light hanging into no.2 hold from hold access

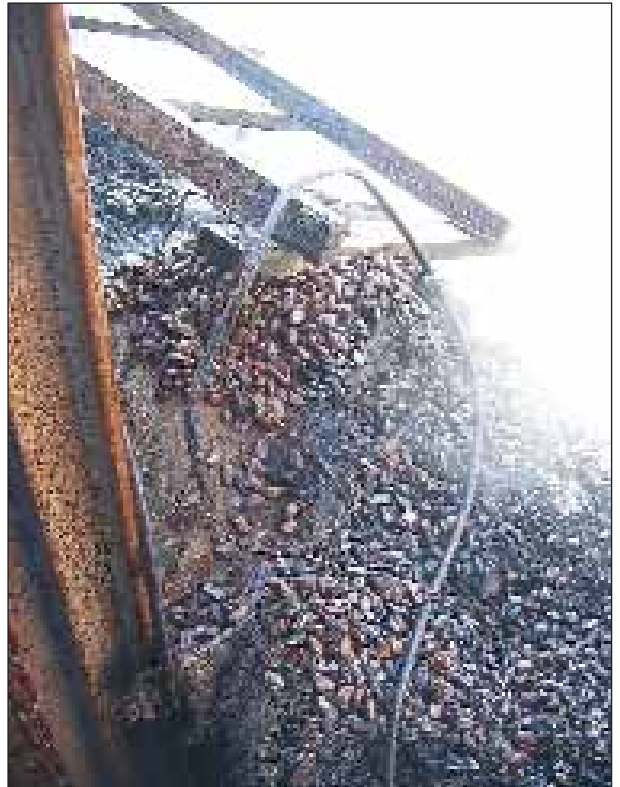
The cable hanging into the hold was the same type as that attached to the cargo lights and the plug on the end had also been removed from its socket. However, the other end, in the hold, was found to have been burned away. Evidence given to the investigation indicated that it had also been attached to a cargo light which, in Makassar, was hanging on one of the timber dunnage frames against the aft bulkhead adjacent to the hold access. This cargo light, however, could not be located during the investigation, neither was it found amongst the cargo either in the hold, or once discharged to the wharf.

FIGURE 14:
Burned end of cargo light cable in no.2 hold
