MARINE SAFETY INVESTIGATION
No. 190

**Independent investigation into
the grounding of the
Maltese registered cargo ship
Tauranga Chief
at Bradleys Head, New South Wales
on 17 January 2003**

December 2004

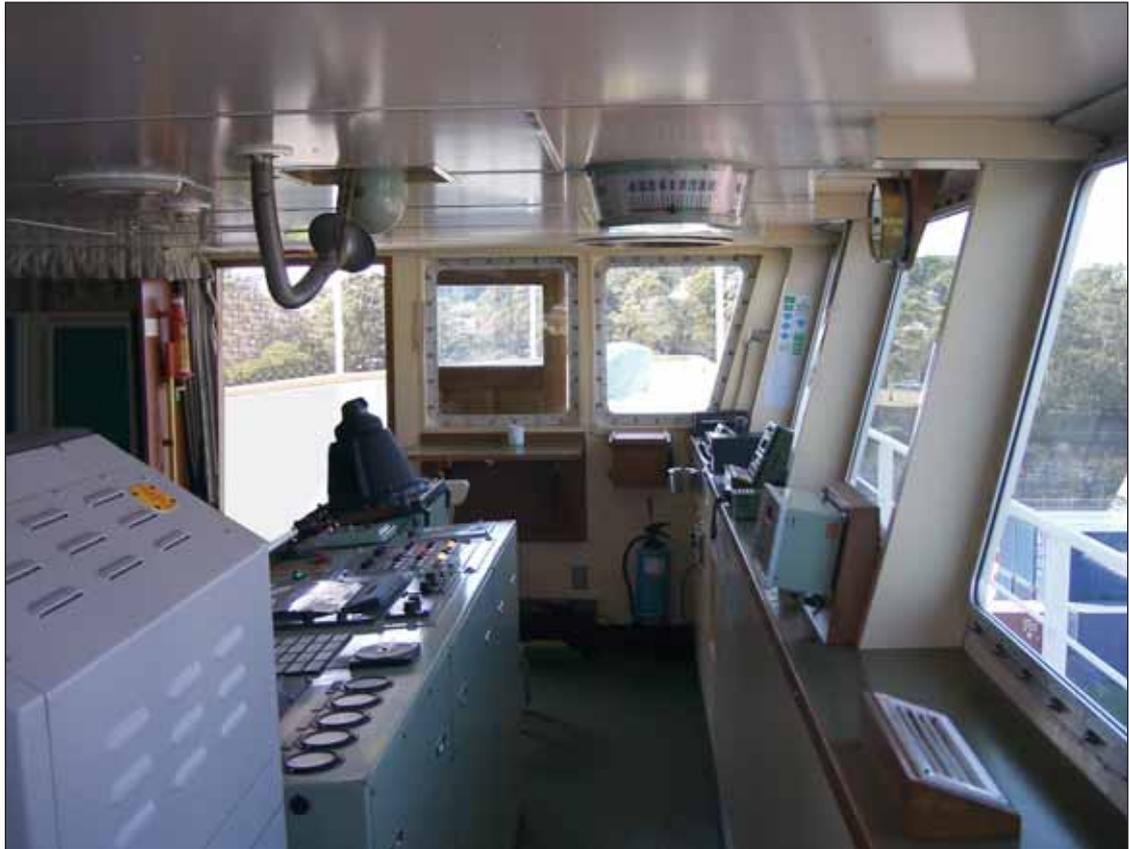
FIGURE 2:
Wheelhouse

The bridge (figure 2) on *Tauranga Chief* is equipped with a Global Positioning System (GPS), an echo sounder and other navigational aids including two radars, a JMA-627-6 to port of the helmsman's position and, to starboard, a Kelvin Hughes Nucleus 3 6000 set. The only rudder angle indicator visible within the wheelhouse is a deckhead mounted, multi-faced type. This display is mounted above the walkway immediately inside the bridge front windows, on the centreline. One display faces aft towards the helmsman for use during pilotage and other hand steering operations and two others face port and starboard respectively. It is illuminated for night use. At the time of the incident, all of the ship's navigation equipment was operating normally.

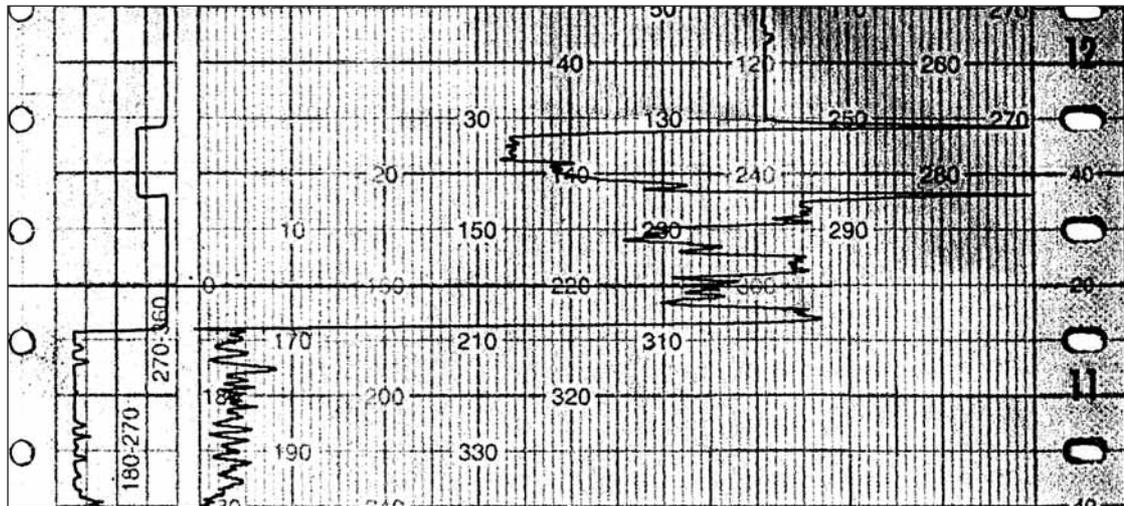
Figure 4:
Tauranga Chiefs course recorder trace

Tauranga Chiefs course recorder trace shows for the northern section of the Western Channel, the ship steered about 219°(G) for two minutes. The next course was about 214°(G) for the 4½ minutes as the ship approached the wheel over position east of Bradleys Head. The next heading was to be about 277° (T), towards Kirribilli Head, an alteration of 63 degrees to starboard.

Analysis of the course recorder trace shows that the ship began to turn at 0336 at an initial rate of 6°/min. About 60 seconds after the ship began to turn to starboard the course recorder trace shows an increase in rate of turn to 30°/min. About 30 seconds later the course recorder indicates reaching a maximum of 40°/min. The ship reached a heading of 277° (G) at 0337:30, 90 seconds after starting to turn. At some stage in the turn the pilot ordered 20° port counter rudder without, apparently, first ordering 'midships'. Despite repeating the order for counter rudder correctly the helmsman increased the rudder angle to starboard.

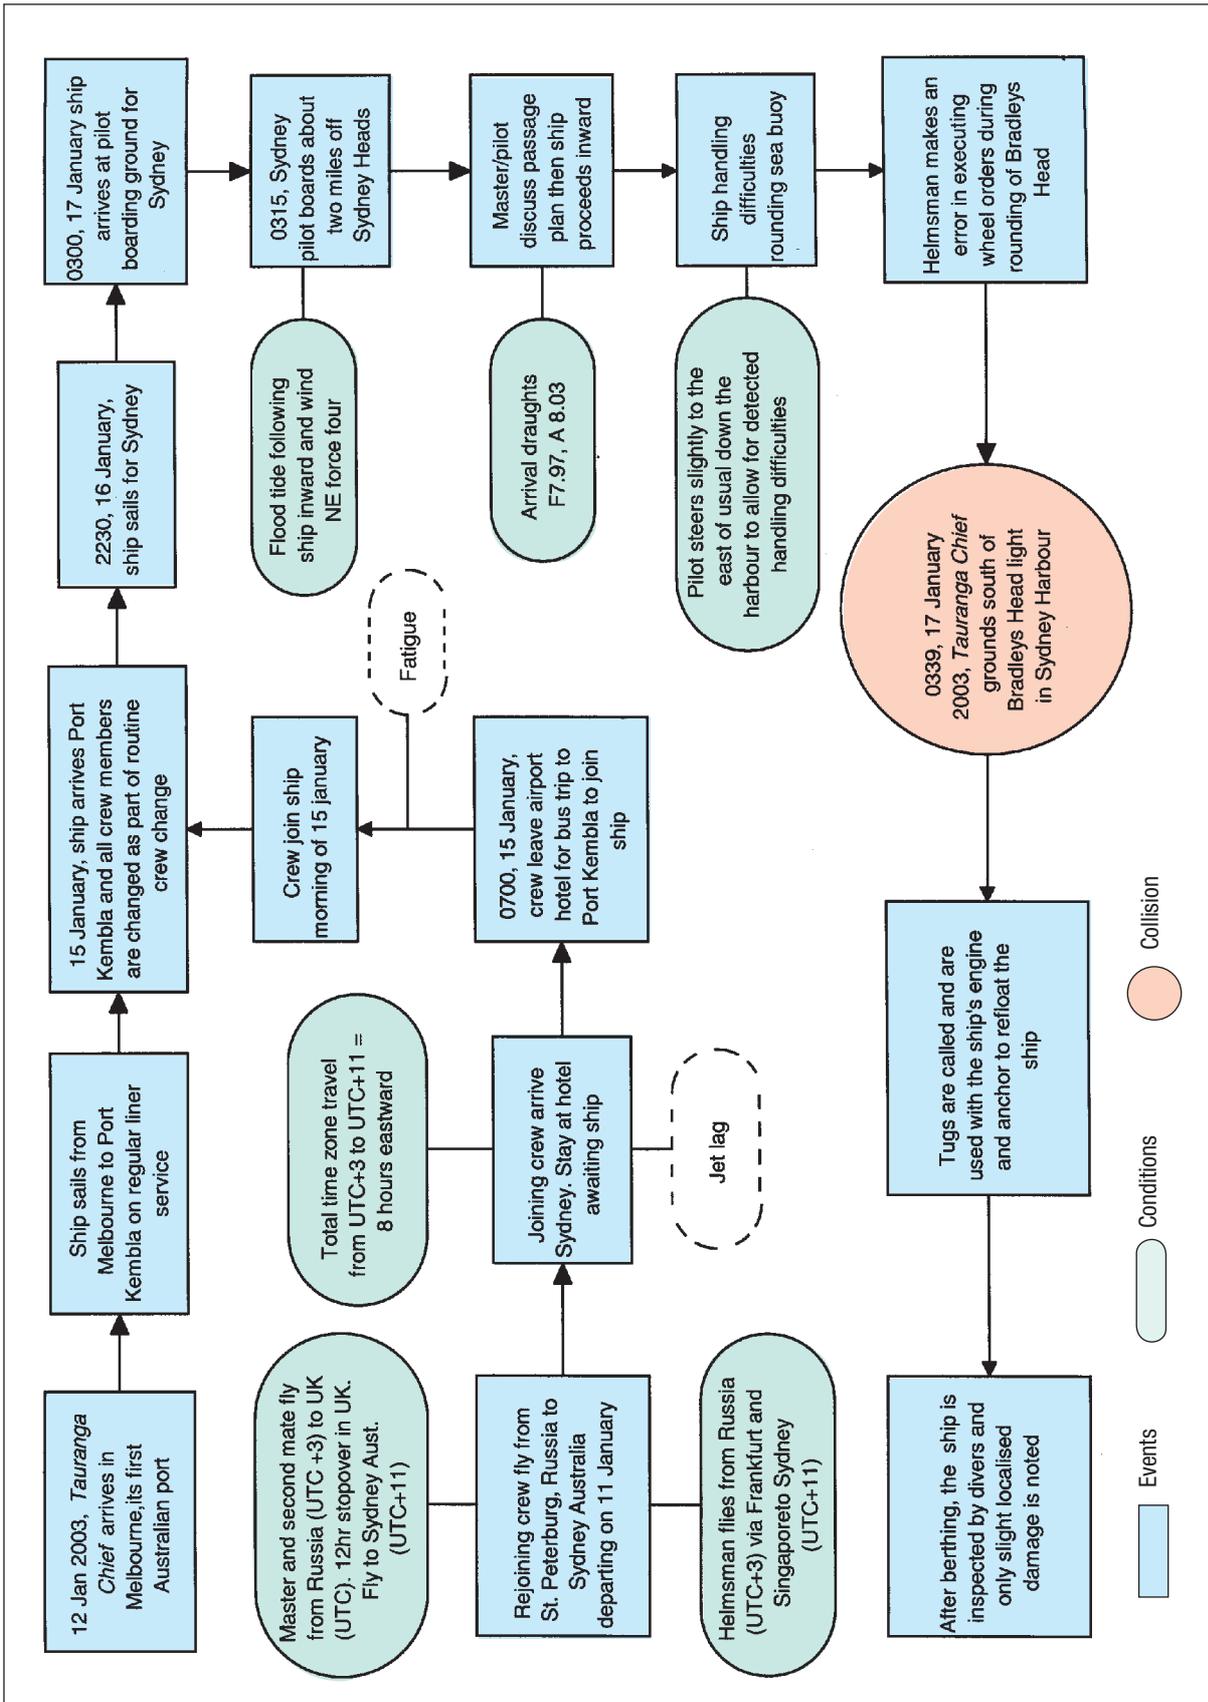
FIGURE 5:
Tauranga Chief: Events and causal factor chart

- The grounding was initiated by an error in the execution of wheel orders during a routine course alteration.
- The pilot did not order midships before ordering counter rudder. This may have contributed to the helmsman's failure to recognise and act upon the change in rudder direction.

- The seaman on the wheel was possibly affected by fatigue, predominantly caused by the circadian low at the time of the incident and compounded by the effects of circadian dysrhythmia (jet lag). The concentration and reaction time of the master and OOW may also have been affected by these effects.

- The handling characteristics of the ship, due to its load and trim at the time of the incident, made the handling of the ship more difficult than usual. The following flood tide and wind on the passage down the harbour would have accelerated the rate of turn which reduced the likelihood of success of the attempted corrective actions.

Pilots and bridge teams should ensure the conventions governing helm orders are observed, particularly the use of 'midships' when changing rudder direction and also consider the use of hand signals to supplement verbal steering orders.
