Captain Aysuna: Fire at sea, 8 October 2001

August 2003

Captain Aysuna: Fire at sea, en route to Tasmania

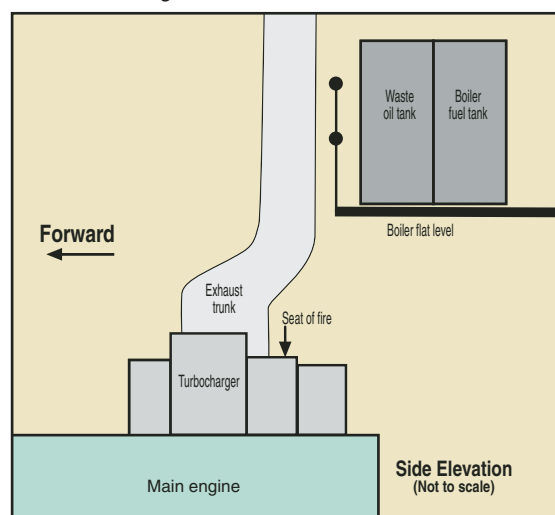
The damage was confined to the engine room and funnel. There was fire damage around the turbocharger on the inlet side and the main exhaust trunking. This damage continued up the starboard outer engine room bulkhead aft of, and above, the turbocharger and under the starboard side of boiler flat above.

FIGURE 1:
Seat of the fire, on top of the turbocharger, directly beneath the edge of the boiler flat

The investigation determined that the seat of the fire was alongside the intake for the turbocharger, directly beneath the edge of the boiler flat on which there were small waste oil and boiler fuel tanks. The surface temperatures here would have been about 350-400° C, sufficient to ignite diesel and other fuels in use in the engine room. Safety data sheets for diesel fuels suggest a minimum auto-ignition temperature of 250° C. Typical auto-ignition temperatures for diesel fuels are in the order of 300-350° C.

Ships' personnel should be made fully aware of the precautions necessary to prevent fires in machinery spaces – in particular, the maintenance of clean conditions, the prevention of oil leakage and the removal of all combustible materials from vulnerable positions.

Ships' personnel should note that wood, paints, spirits and tins or containers of oil should not be kept in boiler rooms or machinery spaces.

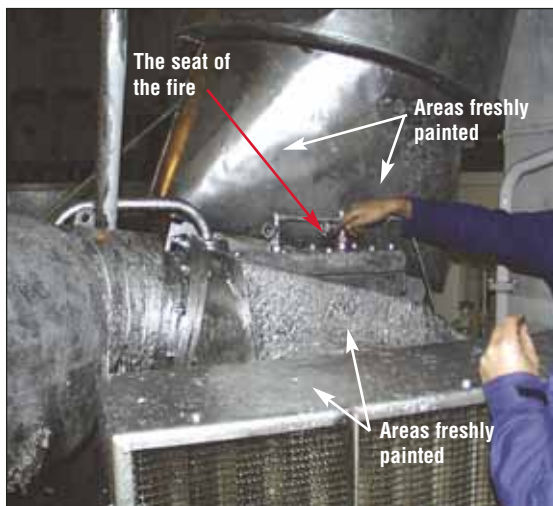
FIGURE 2:
Photograph of seat of fire

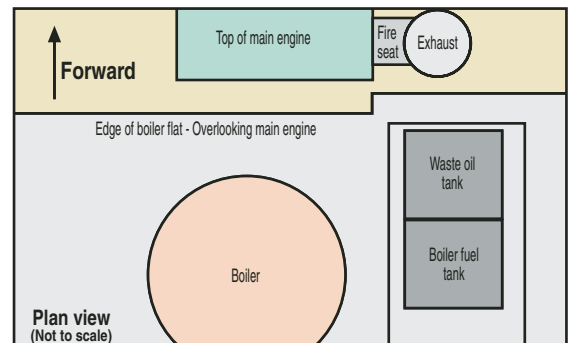
Heat and smoke damage was evident around the forward areas of the waste oil and boiler fuel tanks, where the polycarbonate sight glass of the overflow pipe for the waste oil tank had melted.

Attempts to identify the source and type of fuel were unsuccessful. The indication is that the fuel was most probably diesel from the smell, volume and density of the smoke produced during the fire. There was diesel fuel in the boiler fuel tank on the boiler flat level, but the level in this tank and the waste oil tank, based on internal inspections and records, was the same before and after the fire.

FIGURE 3:
The waste oil and boiler fuel tanks and the boiler flat overlooking the main engine and turbocharger

A crew member was known to have been working on some machinery on the deck above the seat of the fire. Typically, a cleaning fluid, such as diesel oil, is used to assist with such work. It seems unlikely that any oil from the boiler fuel or waste oil tanks had spilled onto the hot surface near the intake for the turbocharger. The possibility that the diesel oil being used for cleaning purposes spilled from a container on the deck directly above onto this surface and ignited would appear to be logical. The temperature of the surfaces here would be high enough to cause auto-ignition of such oil.

It is probable that the fire was caused by spillage of a small amount of fuel from a container left at the forward edge of the boiler flat. The fuel, probably being used as a cleaning medium, could have spilled as a result of movement of the ship in rough seas. It is likely that this fuel was diesel oil.
