MARINE SAFETY INVESTIGATION
No. 193

**Independent investigation into
the equipment failure aboard the Australian
flag roll-on/roll-off cargo vessel
Searoad Mersey
in Bass Strait
on 21 March 2003**

December 2004

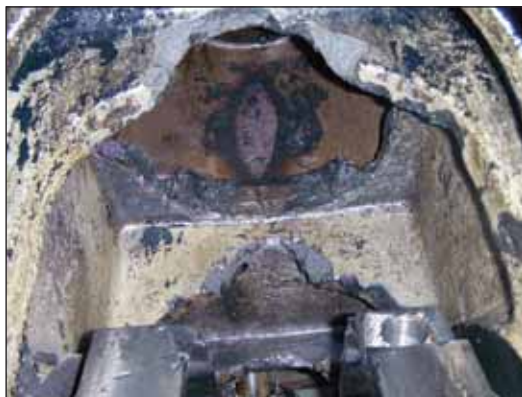
FIGURE 3:
No.1 unit PME water jacket space

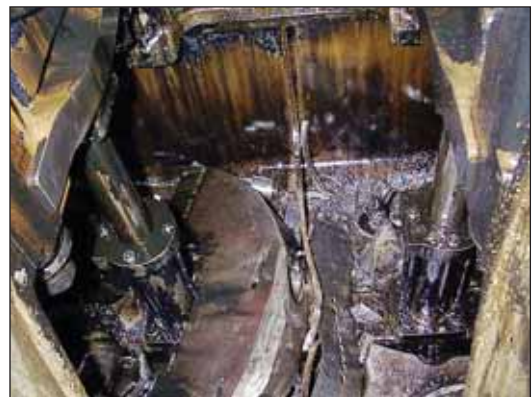
FIGURE 4:
Debris in crankcase

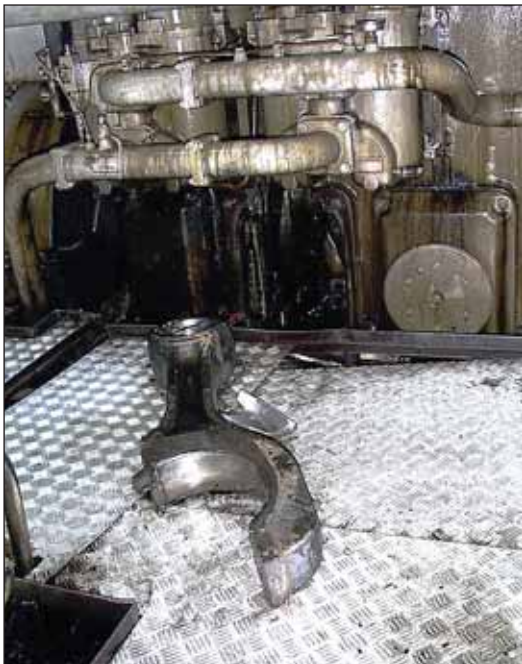
During his inspection, the second engineer found a main engine connecting rod lying on the deck on the inboard side of the port main engine. The port main engine had stopped. There was oil lying all over the floor plates, on and around the engine, and on the deck head above the engine. He also found a solitary inlet valve lying on the floor plates. He returned to the control room to report the situation to the bridge. On finding the bridge telephone engaged, he used his hand held radio to report that he thought that the port main engine had experienced a crankcase explosion.

FIGURE 5:
Con-rod lying on floor plates as found

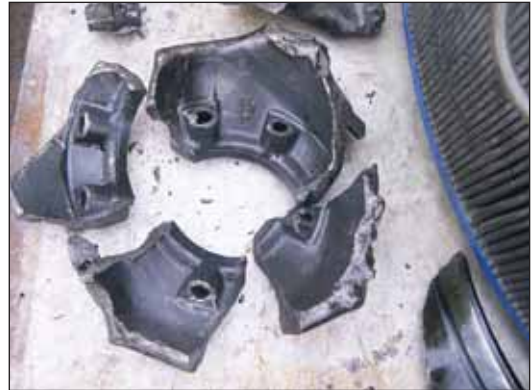
FIGURE 6:
Pieces of piston skirt

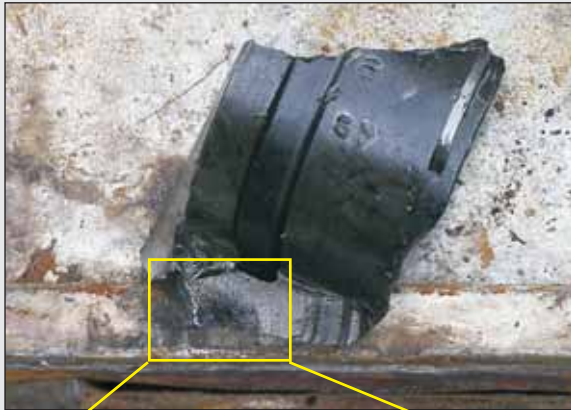
Well developed fatigue growth fronts were observed on the web section of one gudgeon socket (see Figures 7 & 8) while less well defined fatigue crack growth fronts were observed at a similar location in the second gudgeon of the piston. In both instances, the cracking was associated with the central region of the two webs at the casting 'flash' at the web/gudgeon socket transition.

FIGURE 7:
Section of piston skirt showing fatigue crack on gudgeon pin socket web section

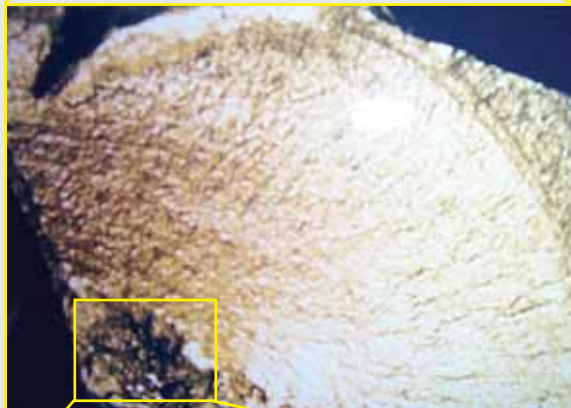
Examination near the surface, which coincided with the casting flash region, revealed the presence of a large casting defect in the form of entrapped dross/shrinkage...

FIGURE 8:
Fatigue crack in detail showing casting defect

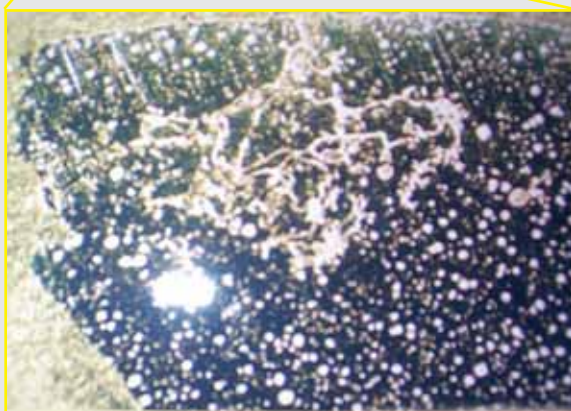
FIGURE 9:
Fatigue crack magnified 25X showing area of dross (black)

Searoad Mersey's port main engine failed catastrophically when the piston assembly fitted to number one unit failed. It is likely that the casting inclusion found by ETRS in the piston skirt initiated the formation of the fatigue crack adjacent to the gudgeon pin socket with the evidence suggesting that the crack had grown over a period of time.

Operators of Wartsila Vasa 32 engines ensure that they comply with the manufacturer's recommendations in respect of the overhaul and replacement of piston assemblies at the operating hours stipulated.
