MARINE SAFETY INVESTIGATION  
No. 192

**Independent investigation into the  
grounding of the Liberian registered  
bulk carrier  
*Pactrader*  
in the port of Thevenard, South Australia  
on 1 March 2003**

June 2004

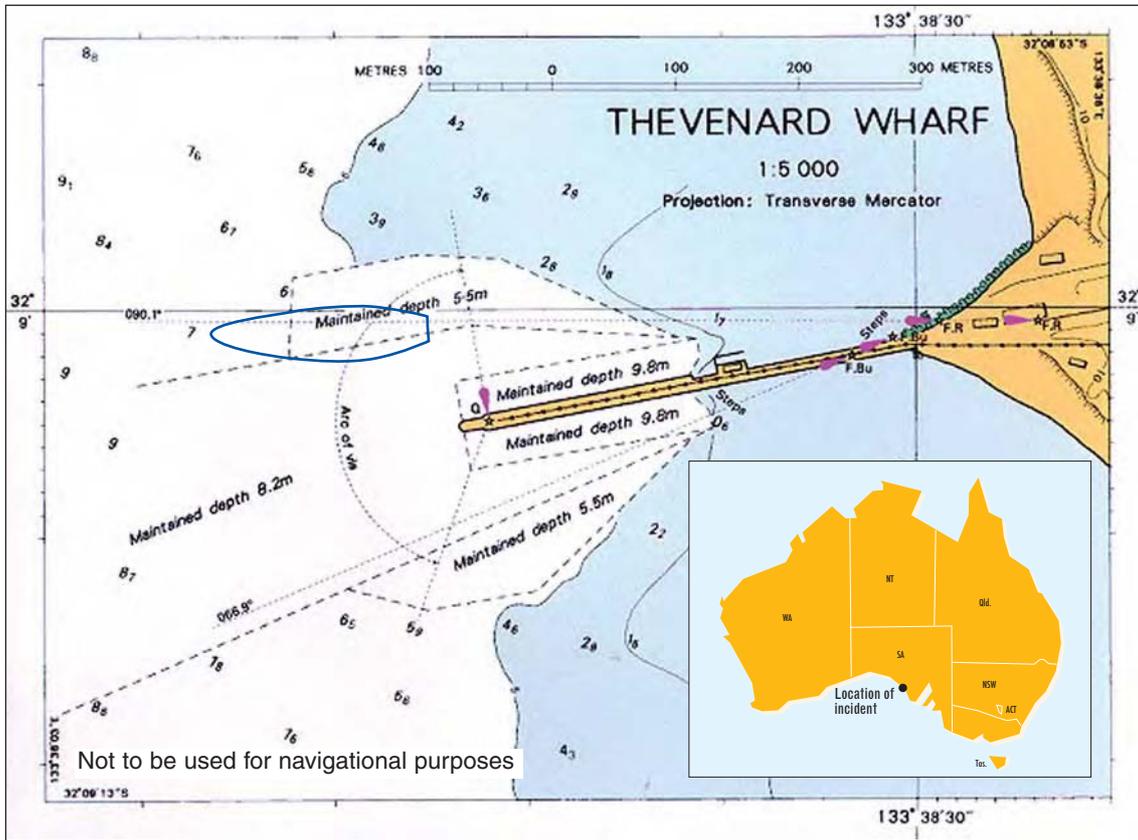
**FIGURE 1:**  
**Insert from Chart Aus 120 showing approximate grounding position of *Pactrader***

The maintained depths around the jetty area (see figure 1) allow vessels in ballast a guaranteed safe area to manoeuvre when berthing. For loaded ships, sailing at draughts greater than 5.5 m, the available water north and south of the jetty is more restricted. To the north the width of unrestricted water is about 70 m.

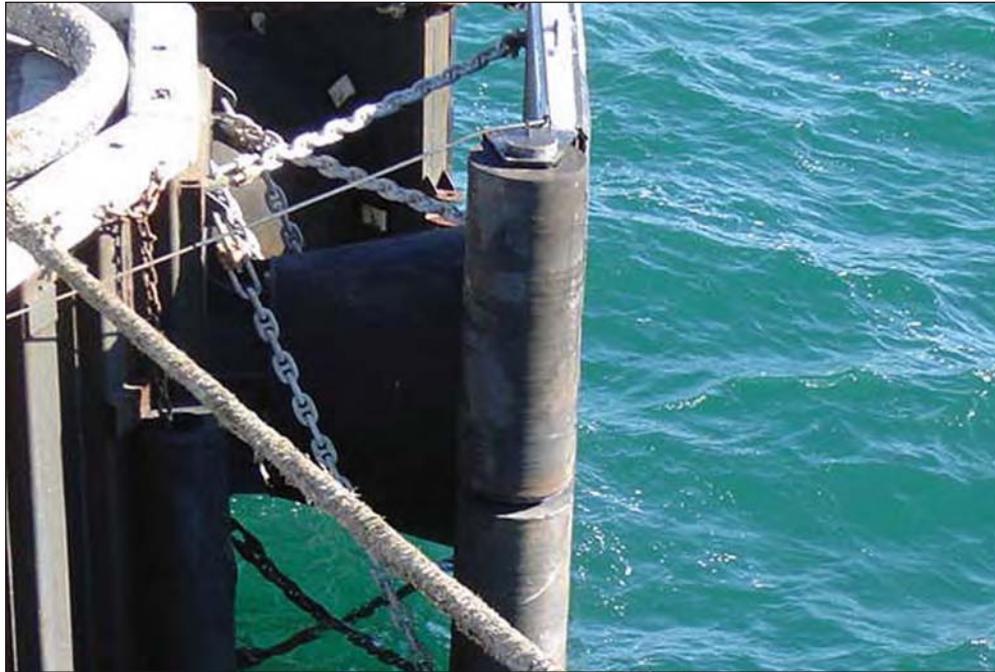
**FIGURE 4:**  
**Rollers at 'soft nose'**

The pilot's options for sailing were also limited, to a degree, by the design of the wharf fenders. The outer end of the wharf consisted of a 'soft nose' designed to protect the end of the wharf as a ship berths. The fendering is proud of the line of the jetty. The 'soft nose' fender is seen as being vulnerable if contacted by a ship leaving the jetty (see figure 3). An incident involving previous damage to the outer end of the wharf was a factor the pilot took into account. The tendency was to ensure that ships sailing from the berth did not contact this fendering. The pilot, therefore, did not consider the option of warping the ship along the jetty, or staying very close to the jetty on departure. His main concerns in conning the ship, as he perceived it, were on his port side. The pilot remained on the port bridge wing as *Pactrader* cleared the berth.

Flinders Ports have, since this incident, made some alterations to the soft nose at Thevenard wharf. These alterations – the addition of rollers at the wharf face end of the system - will allow pilots to stay closer to the wharf without fear of damage during berthing/un-berthing operations. See photo below.
