In-flight cargo door separation 28km NW Sunshine Coast Airport 1 December 2009

Abstract

On 1 December 2009 at approximately 0730 EST, the forward, left-side cargo door of a Eurocopter AS350D helicopter (registered VH-PIH) separated from the helicopter fuselage during fire-fighting operations near Maryborough, Queensland. The helicopter subsequently landed safely and there were no injuries.

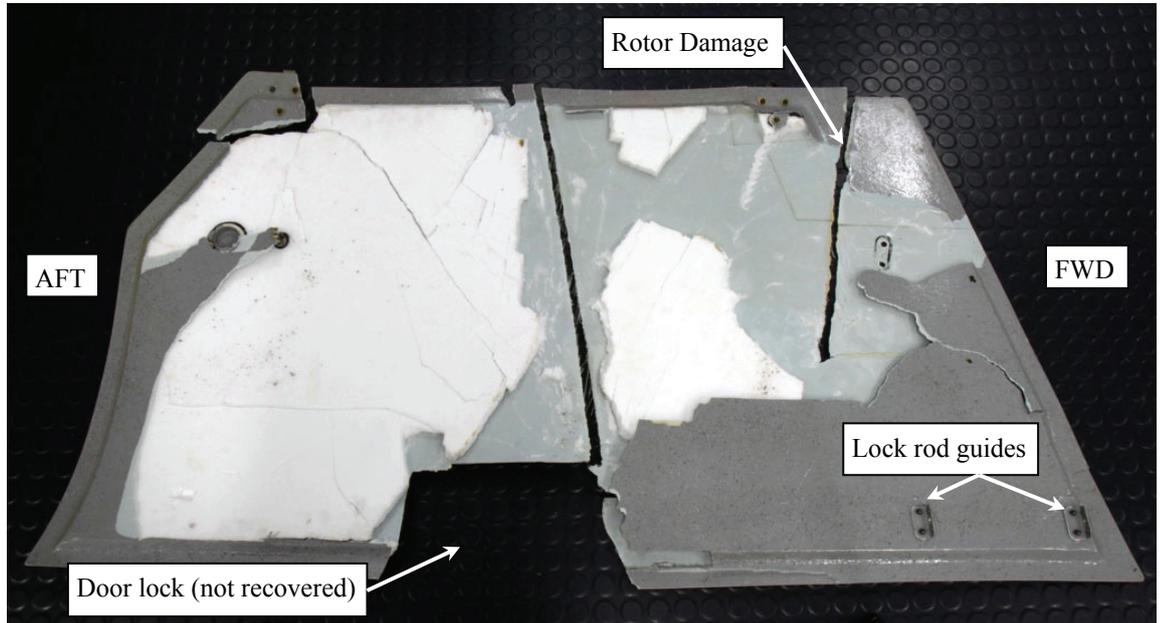
Figure 2: VH-PIH Left cargo door interior

It was probable that separation of the cargo door occurred as a consequence of replacement of the door seal during a recent overhaul. That replacement resulted in the door sitting proud of the mating surfaces when closed and latched. Elevated air loads acting on the door as a product of its overly proud position would subsequently have led to its fracture.

The cargo door was received as shown in Figure 2, having sustained significant fractures in two

locations. The forward fracture was consistent with passage of a main rotor blade. The blade passed through the location of the brace strut, which was not present and was not recovered with the door sections. The fracture through the centre of the door was dissimilar to the forward rotor slice and was probably the result of the door fracturing in two as it separated from the airframe.

The door had fractured around the lock mechanism during the occurrence and the mechanism was not recovered. However, two lock rod guides remained attached to the inside surface. Brittle fracture of the exterior paint adjacent to the location of the lock was indicative of a rapid failure event.

The most probable scenario for the door separation involved the replacement door seals holding the door proud of the airframe, as was reported. As such, the protruding door may have experienced higher than normal air loads or buffeting during cruise flight – those loads acting to pull the door out and away from its closed position. This action may have subsequently

caused the front lock rod to disengage, ultimately resulting in the fracture and separation of the door from the airframe.

Considering this scenario, the installation of improved door locks per SB 52.00.25 and SB 52.00.26 would significantly reduce the likelihood of a future AS350 cargo door separation event, by reducing the protrusion of the door from the airframe and increasing the security between the door and surround.

As a result of this occurrence, the cargo door lock modifications detailed in SB 52.00.25 and SB 52.00.26 were applied to the new door installed on VH-PIH.

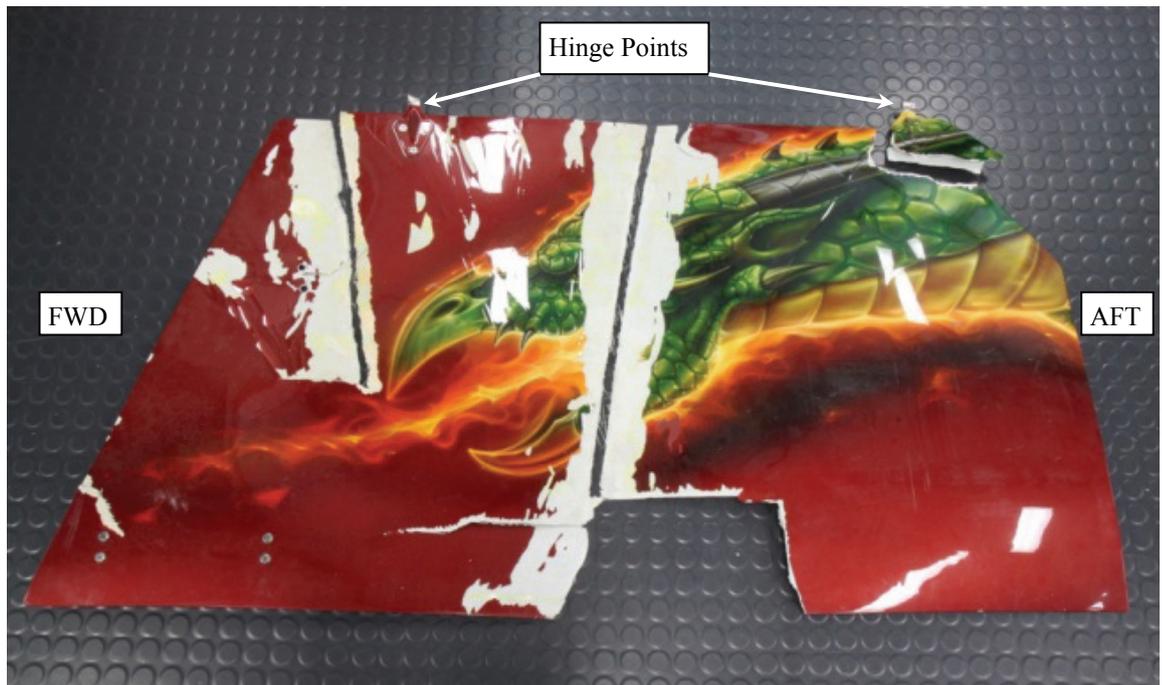
Figure 3: VH-PIH Left cargo door exterior

The forward door hinge was plastically deformed, and the corner section of door containing the rear hinge had fractured as the door separated from the airframe (Figure 3)
