Department of Transport
Bureau of Air Safety Investigation

INVESTIGATION REPORT
B/921/1032

Boeing 727-277 VH-ANA
Brisbane Qld
4 July 1992

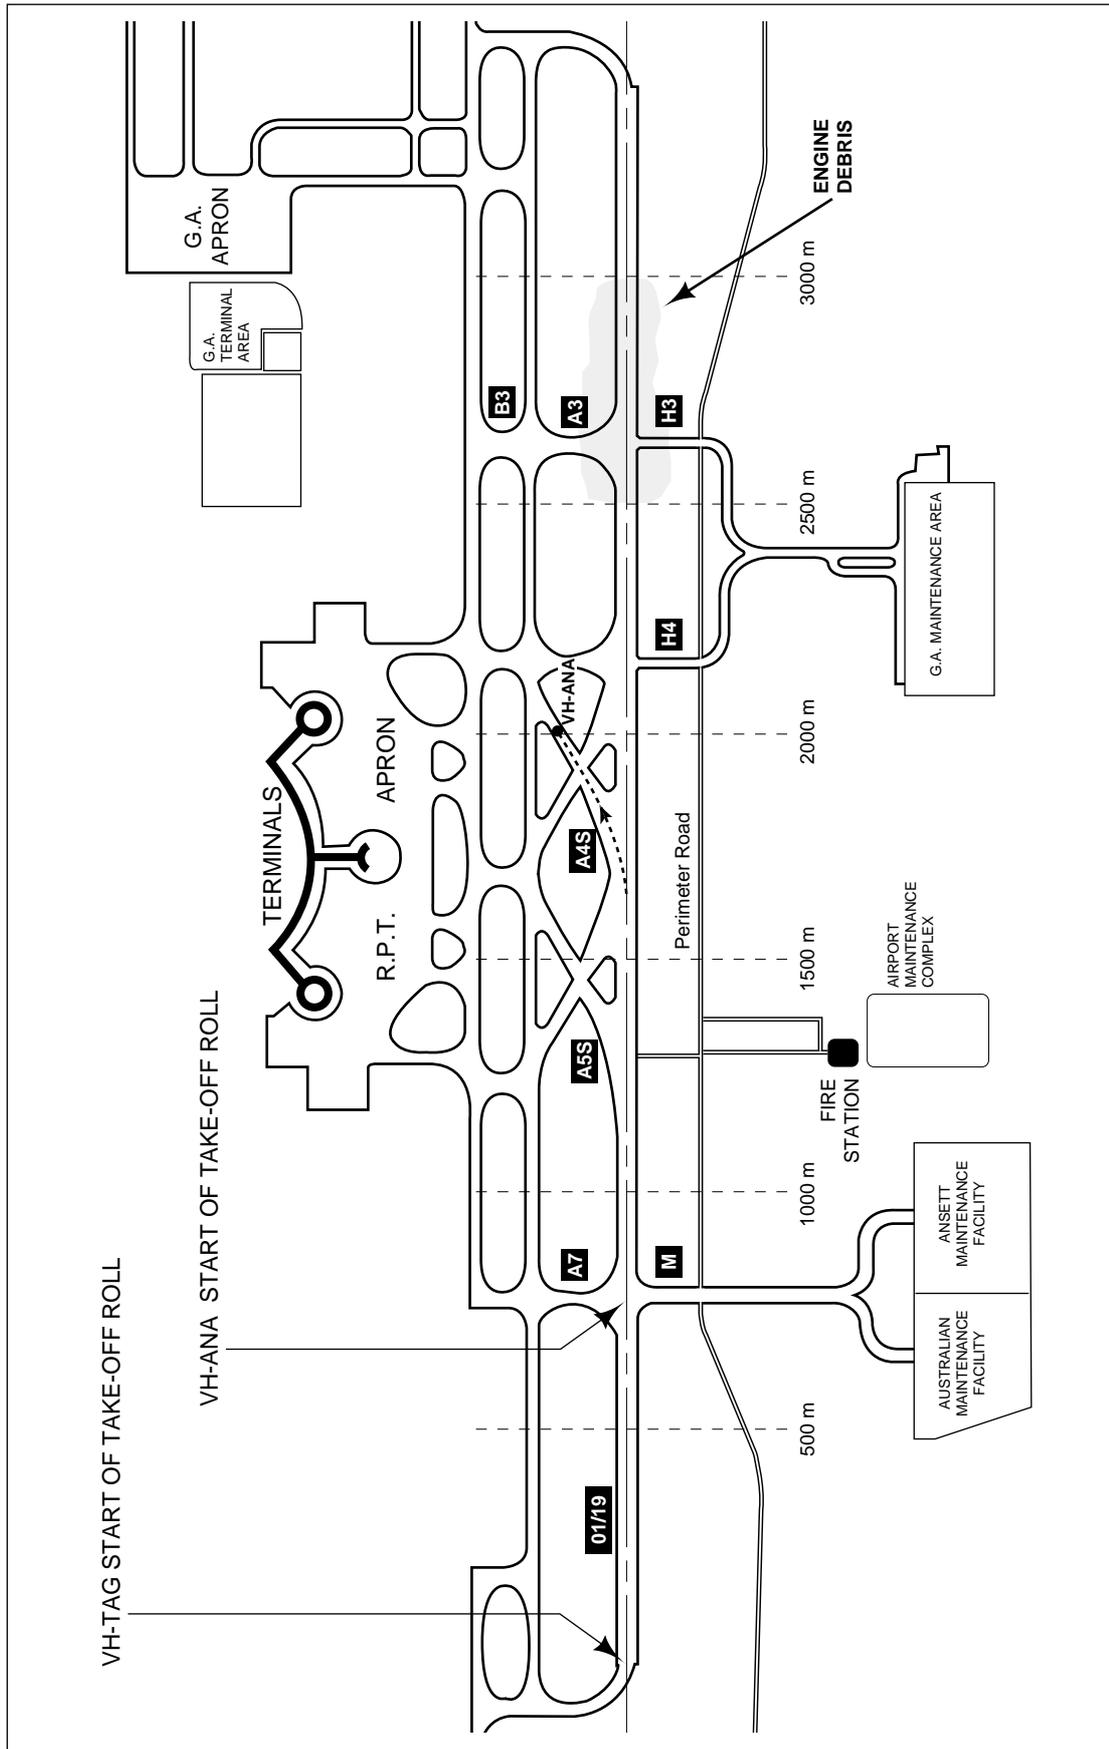
Figure 2

There are a significant number of drainage ditches on the Brisbane aerodrome surface adjacent to taxiways but outside the taxiway strips. The ditches vary in size from about 4 m wide and 1.5 m deep to 2 m wide and 0.5 m deep and have grasses and reeds growing in them. These characteristics make the ditches difficult to distinguish from their surrounds in daylight conditions and more so in reduced visibility conditions. There are no markings along the ditches or at their extremities.

The position of the ditches meets International Civil Aviation Organisation (ICAO) aerodrome standards. These standards contain no requirement for such ditches to be marked.

3. The FAC, regardless of the ICAO Annex 14 standard in respect to marking of ditches, further consider the introduction of ditch and hazard marking for Australian domestic and international airports.

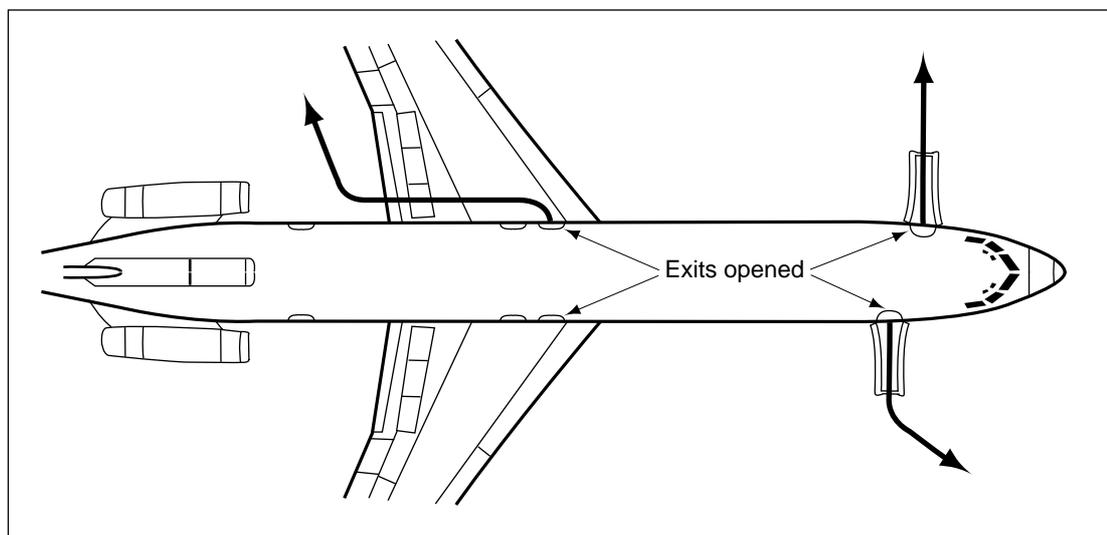
The right forward escape slide was damaged during the evacuation. Damage consisted of a split in the fabric covering the inflation tubes, although the tubes themselves remained intact. The split ran for most of the length of the slide. It was later learned that a passenger had lost the heel from one of his shoes during the evacuation, thereby exposing a number of small tacks on the base of the shoe.

The passengers exited the aircraft in an orderly manner with only a small number attempting to retrieve hand baggage. There was little congestion at the exits. Flight attendants at the forward exits told passengers to 'jump and sit', whilst the flight attendant at the left overwing exit was required to modify his command to include the instruction to 'follow the arrows' when passengers ran along the wing towards the wingtip instead of moving towards the trailing edge of the wing. On the forward exits, the flight attendants did not designate passengers to stabilise the bottom of the slides and assist other passengers. This instruction is not required by company procedures. Figure 3 shows the exits used and the arrows show the direction of evacuation.

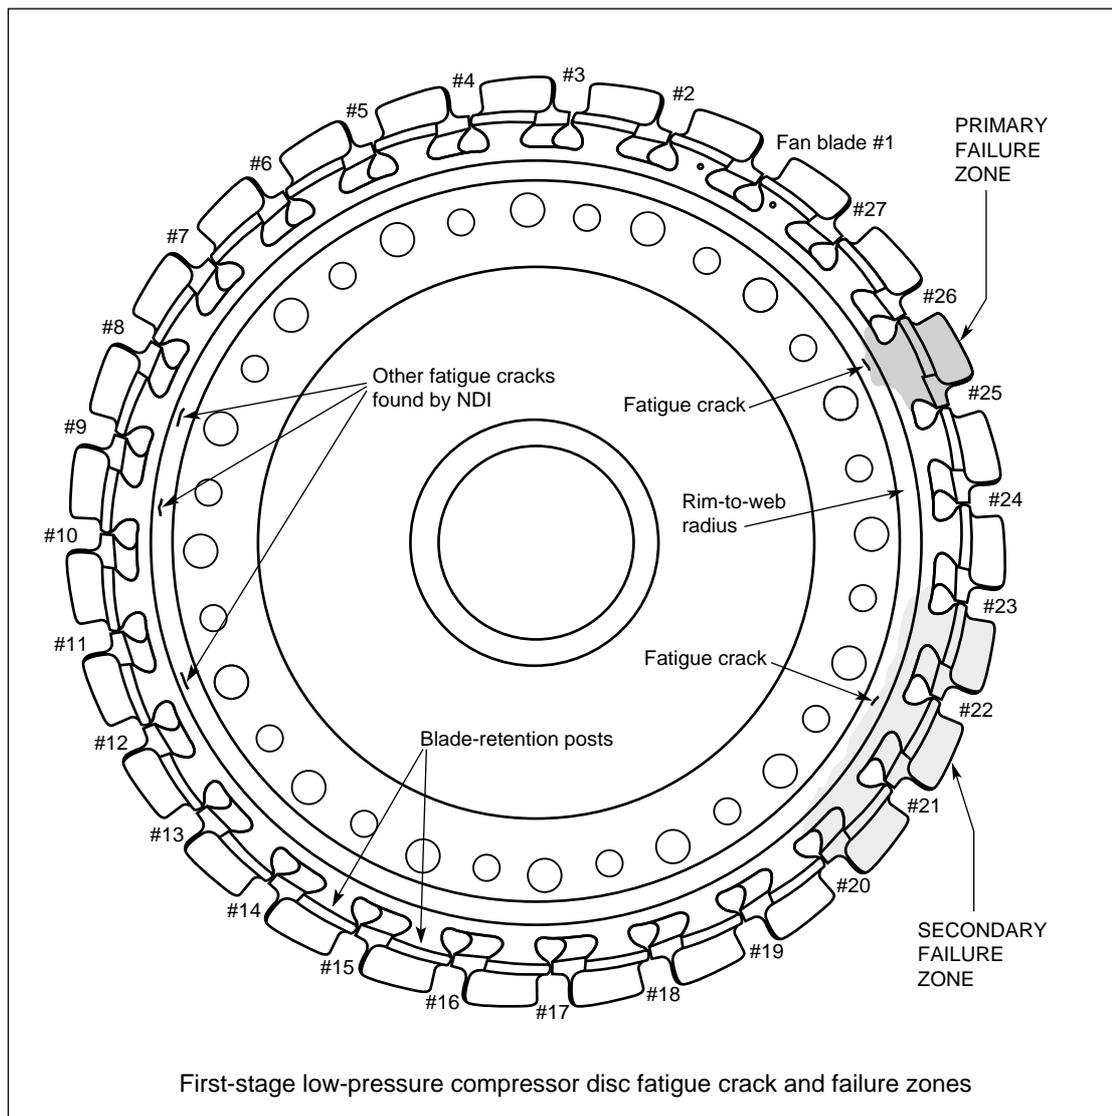
Figure 4

The failed first-stage fan disc was subjected to metallurgical examination. The examination revealed that fatigue cracking had occurred in the rim-to-web radius of the forward side of the disc which resulted in the release of a blade-retention post and two fan blades (primary failure zone, figure 4). Crack growth at the site of the primary fracture occurred over a period of approximately 700–800 engine cycles. A further three blade-retention posts and four fan blades were released as a result of a fracture under abnormal loading conditions and in the presence of a smaller pre-existing crack on the forward rim-to-surface radius under the blade-retention posts between blade numbers 21 and 22 (see figure 4 below). Non-destructive inspection of both the forward and aft rim-to-web radii found another three cracks in the forward radius.

The forward radius was then subjected to a detailed examination which revealed that the fatigue cracking initiation was associated with surface damage resulting from abrasive hand machining which attempted to polish the radius. Evidence of the abrasive process included sharp bottomed scratches formed by abrasive particles ploughing and tearing the surface, and embedded silicon carbide particles at the ends of the scratches.

It was apparent that the abrasive hand machining process had not been as a result of any rework during the operational life of the disc, but had occurred during manufacture.

The metallurgical examination concluded that the engine failed as a result of the failure of the first-stage fan disc. The failure of the disc was the result of a fatigue crack initiated at a 'V'-bottomed scratch in the forward rim-to-web radius. It is probable that this scratch was caused during the finishing process of manufacture. Any inspection carried out following this process did not find a fault in the surface finish.

5. Fatigue cracking in the first-stage fan disc initiated at 'V'-bottomed scratches in the forward rim-to-web radius and propagated under the blade posts.

6. The scratches were created during the initial rough polishing of the rim-to-web radius during manufacture.
7. Subsequent finish polishing of the radius had not removed all the surface damage created during the initial rough polishing process.

- (a) Airworthiness directive AD/JT8D/27, dated December 1992 has been issued, requiring mandatory inspection of all JT8D-9 through 17AR engines in the Australian fleet [see final recommendation 2].
- (b) A review of auditing and surveillance procedures for all airports is being carried out, taking into account the problems identified at Brisbane Airport.
- (c) Further emphasis is being placed on the requirements in relation to airport topography

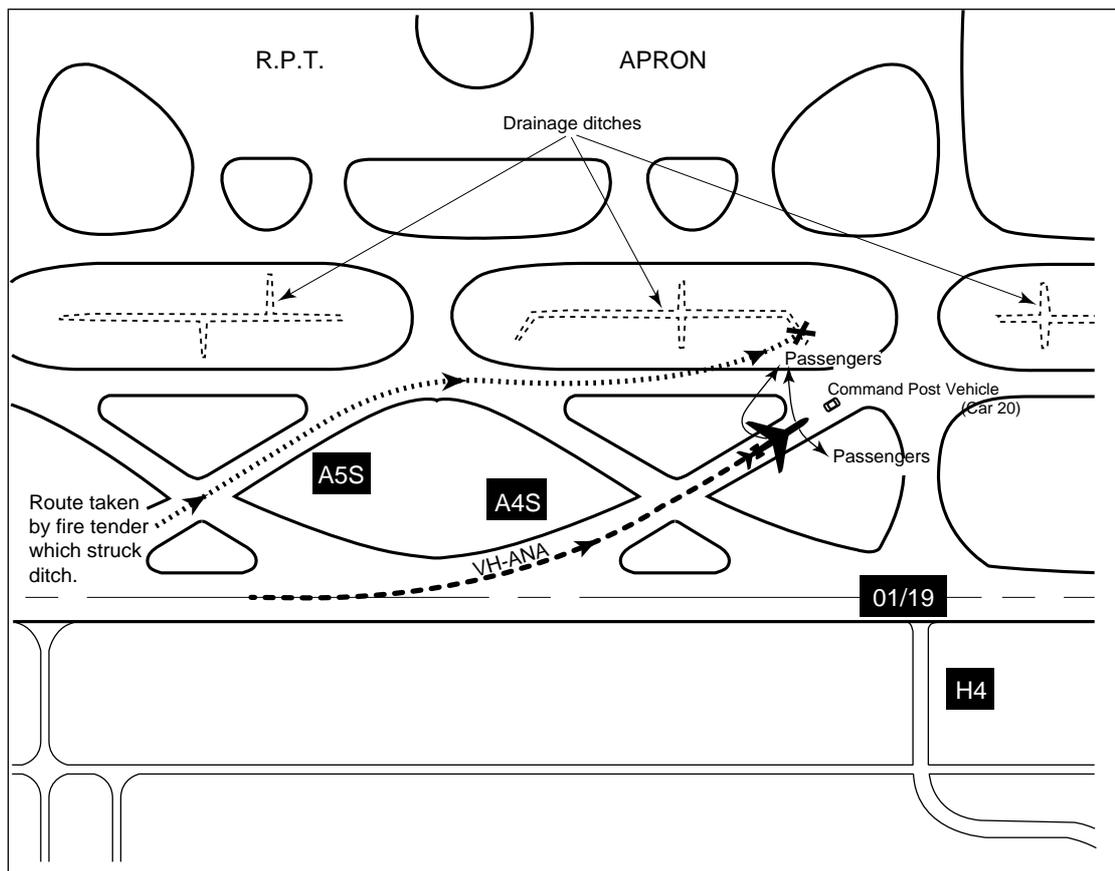
Figure 5

In accordance with the RFFS tactical plans, the driver of Tender 3 intended to position his vehicle at the nose of the aircraft. Because of the large turning circle of the ULFV, he elected to leave the runway at taxiway A5S to allow a more favourable approach to the aircraft via a grass verge. As the vehicle manoeuvred across the grass at about 20 km/h, the driver's attention was directed to the aircraft and the evacuating passengers. Neither the driver nor the other occupant of the vehicle noticed the presence of a ditch until the vehicle was about 5 m from it. At that late stage a collision with the ditch could not be avoided (see figure 5).

Investigation revealed the level of RFFS knowledge of the drainage system on the airport to be superficial. All on-airport driver training was limited to sealed surfaces, and topography training focused mainly on the location of buildings and hardstandings. Knowledge of the airport drainage system was limited mainly to an awareness of its general layout with little knowledge of the exact position of spoon, finger, or lateral drains.

7. The FAC review and update the Brisbane Airport emergency plan to conform with the requirements of the CARs.
8. The CAA review its emergency/rescue vehicle driver training syllabus to include a segment which specifically identifies the location of airfield hazards.
