Collision with terrain, VH-RPN

257 km ENE Derby, Western Australia

13 June 2010

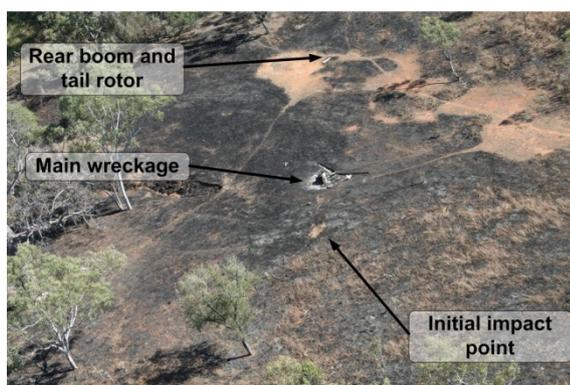
Figure 1: Aerial view of the accident site

The accident site was located at an elevation of about 1,300 ft (400 m) on flat, clear terrain close to a small creek (Figure 1). The terrain surrounding the accident site was slightly undulating with numerous trees and saplings. There was no evidence to indicate that the helicopter struck any of those trees or saplings prior to the impact with the ground.

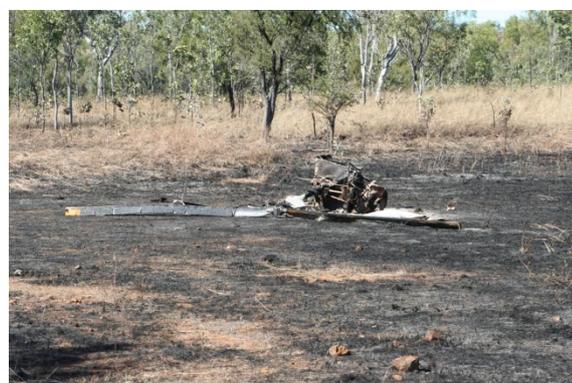
Figure 2: Helicopter main wreckage

The main wreckage was along the approximate direction of flight, about 10 m from the point of initial ground contact. An intense post-impact fire, the intensity of which was consistent with a significant quantity of fuel being on board the helicopter, consumed the main wreckage.

The helicopter's main rotor blades were intact, securely attached to the main rotor hub and with the main wreckage (Figure 2). Damage to both blades was consistent with impact forces and the effects of the post-impact fire. There was no evidence of the main rotor blades striking any foliage, terrain or other objects prior to the accident, or of pre-accident skin delamination on either blade. There was no evidence of 'coning'⁴.

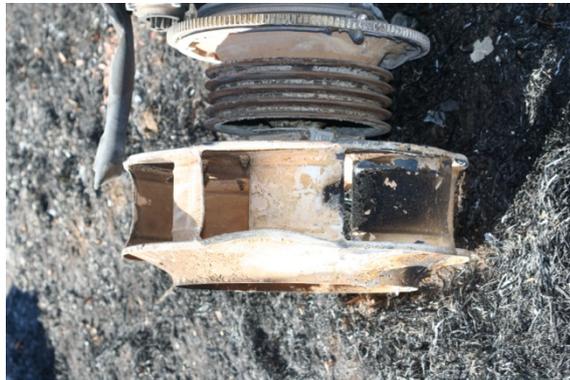
Figure 3: Damage to the engine cooling fan vanes

All of the engine cooling fan vanes were damaged through 360° of rotation from ground contact, which was consistent with engine rotation at impact (Figure 3).

The damage to the engine cooling fan vanes was consistent with the engine rotating at the time of impact, and was a strong indicator of substantial engine power being available at that time. Also, there was no evidence of a mechanical failure to the main rotor drive system. While the impact and fire damage precluded a conclusive assessment of engine power capability and main rotor drive system continuity, a significant loss of main rotor torque as a contributor to the accident, was considered unlikely.
