ATSB-May11/ATSB56

Loss of separation assurance

222 km NW of Tennant Creek, Northern Territory

22 December 2009

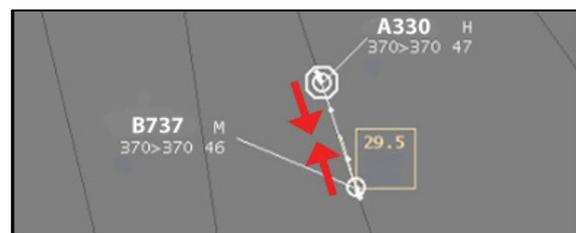
Figure 2: Proximity of the aircraft at 0252:05

At 0252:05, the controller was accepting voice coordination from another ATC sector controller, via an intercom line, when the flight crew of the A330 requested information on the opposite

direction traffic at the same level as their aircraft. The flight crew had identified that traffic via their onboard Traffic Alert and Collision Avoidance System (TCAS). The aircraft were 29.5 NM (55 km) and about 2 minutes flight time apart at that time (Figure 2).

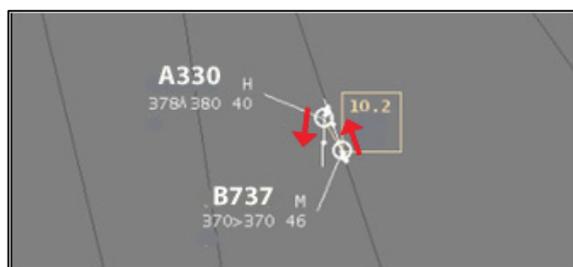
Figure 3: Proximity of the aircraft at 0253:23

At 0253:23, the flight crew of the A330 reported maintaining FL 380⁸, and that they were resuming track, following the deviation right of track. The radar data indicated that the aircraft were 10.2 NM (19 km) apart at that time (Figure 3).
