INVESTIGATION REPORT  
9703719

**De Havilland Canada DHC-6 Series 320, VH-HPY  
9 km SW of Simbai, Bismarck Ranges,  
Papua New Guinea  
9 November 1997**

**Bureau of Air Safety Investigation**

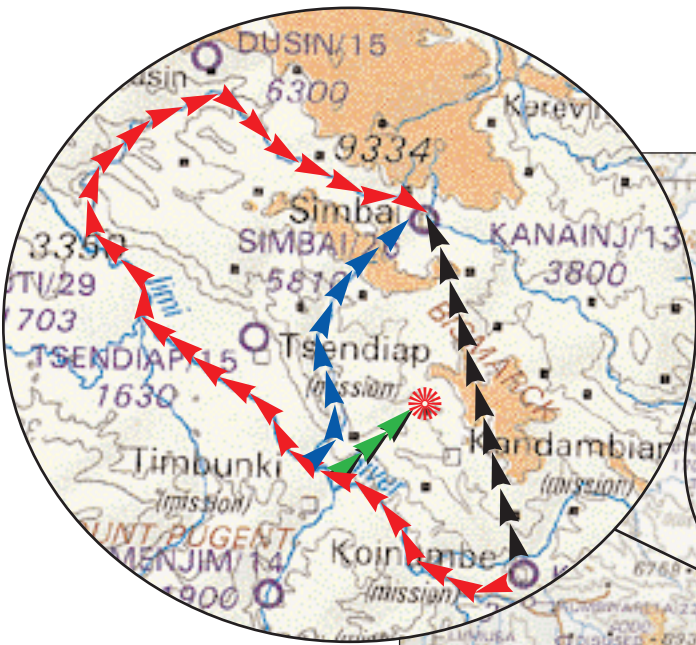
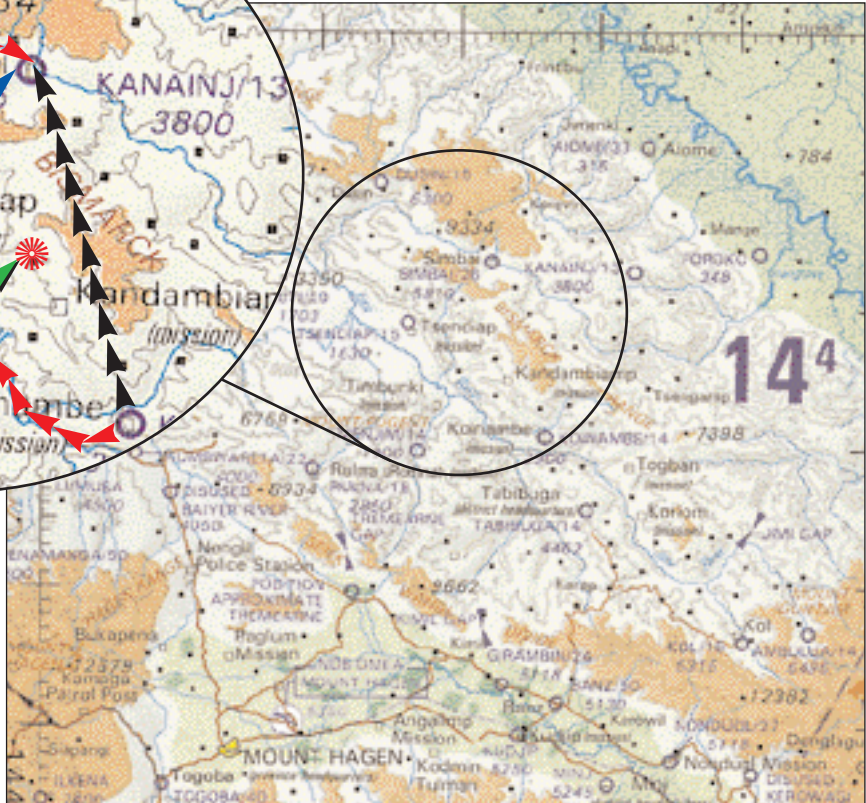
1:1,000,000 Operational navigation chart (ONC)

It was subsequently established that when the crew turned from the Jimi River, they entered the wrong valley. Calculations based on the manufacturer's performance data showed that the aircraft did not have sufficient performance to outclimb the increase in terrain elevation from the Jimi River valley to cross the Bismarck Ranges via this valley.

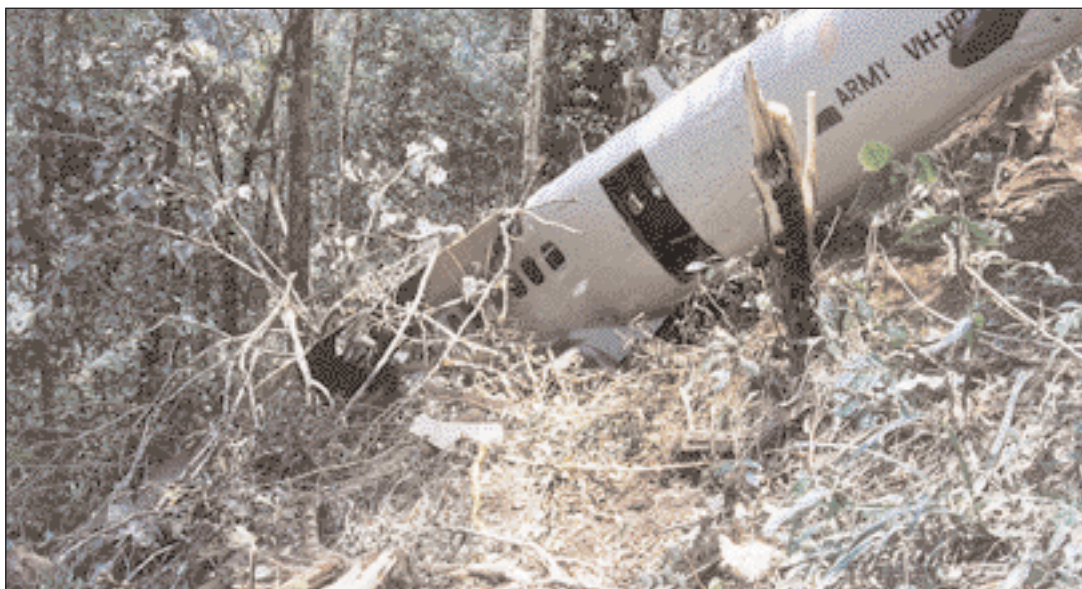
The aircraft entered the forest canopy at an angle of bank of about 90° left. The initial impact with the trees severed the left outer wing section. The fuselage then pivoted around the remaining section of the left wing so that it was heading about 90° left of the initial direction of travel. The fuselage struck the ground at an attitude of about 75° nose down. However, the terrain in the area sloped about 55° down in the direction the fuselage was travelling at impact. This effectively reduced the ground impact angle to less than 20°.

The nose section struck the ground first and folded back under the fuselage as the aircraft slid forward for about 5 m, before coming to rest against a tree. This prevented further movement down the slope.
