Collision between freight train 7SP3 and a track mounted excavator near Jaurdi, WA

28 March 2011

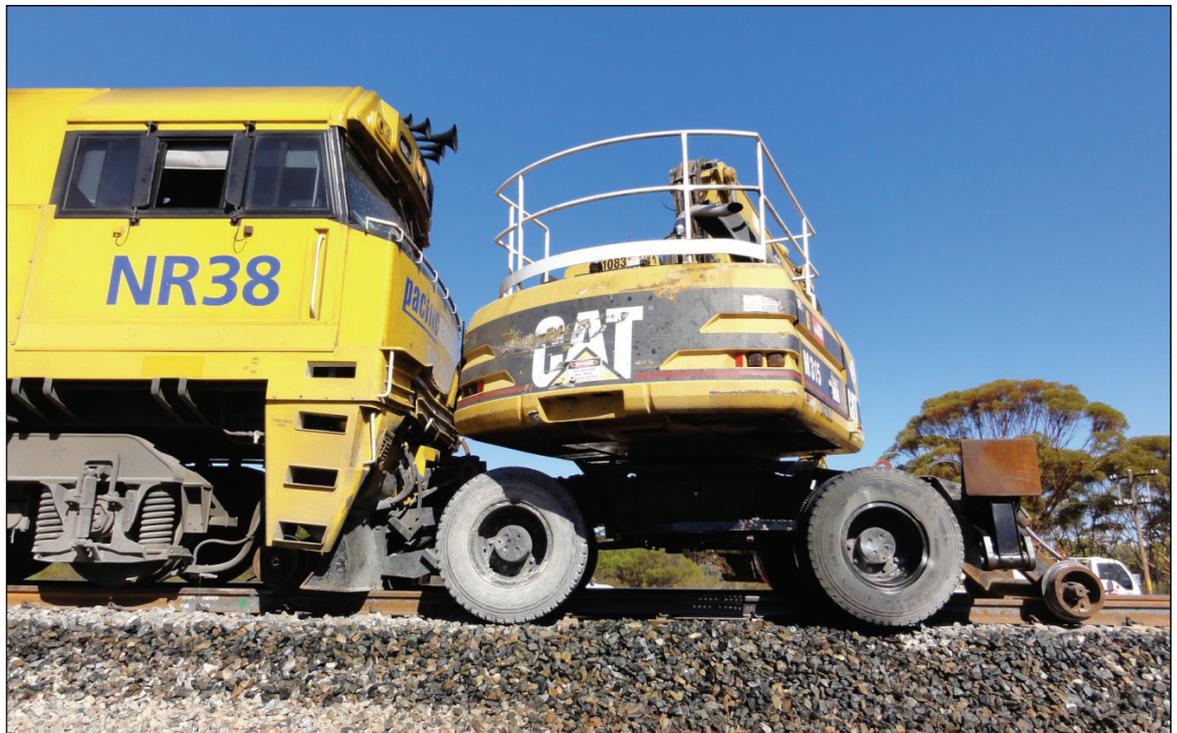
Figure 1: Train 7SP3 and track mounted excavator following the collision

The train driver sustained a minor injury. There was moderate damage to the lead locomotive and the excavator, and minor damage to the track as a result of the incident.

Train 7SP3 was travelling at 67 km/h when it collided with the excavator. The front of the locomotive rode up onto, and became wedged on, the trailing components of the excavator. The now interlocked excavator and locomotive continued along the track finally coming to a stop 290 m and 34 seconds after the point of impact.
