AVIATION SAFETY INVESTIGATION REPORT
200202710

Runway overrun at Darwin International Airport

Boeing 737-800, VH-VOE
11 June 2002

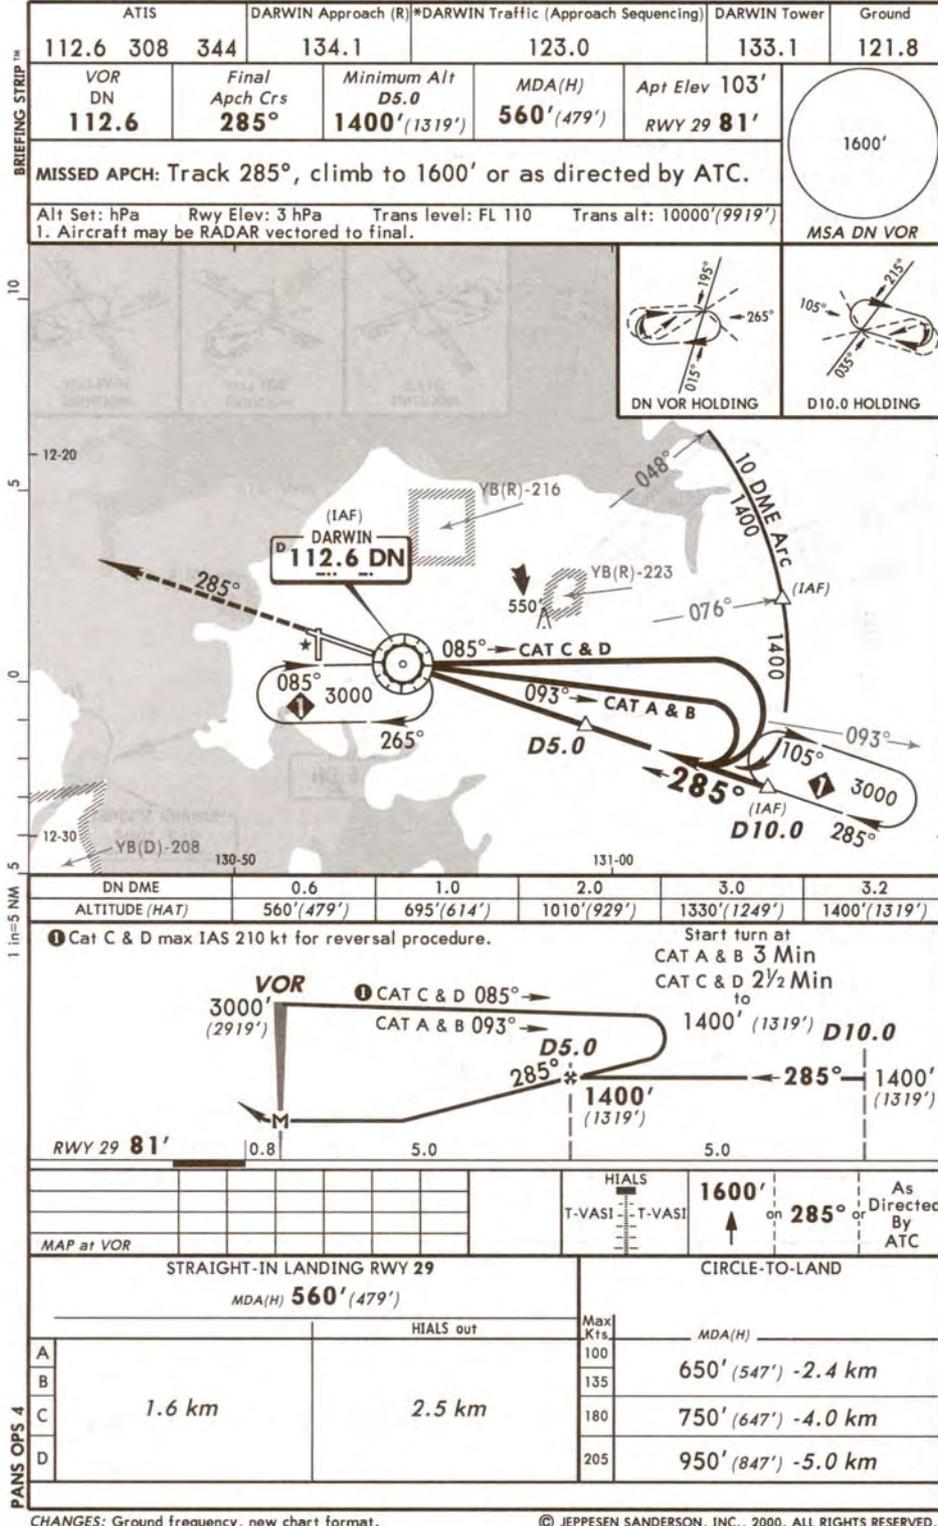
Figure 1. Darwin, NT (YPDN) Runway 29 VOR or VOR/DME Approach³.

Due to works-in-progress on the eastern end of the runway, the landing threshold was temporarily displaced 1,173 m beyond the permanent threshold, resulting in a reduced Landing Distance Available¹ (LDA) of 2,181 m. The temporary threshold was equipped with threshold lights and approach slope guidance was provided by a portable Precision Approach Path Indicator (PAPI). Because of the presence of the temporarily displaced threshold, ATC cleared the aircraft for an ILS approach to the circling minima, by which time it was expected that the crew would visually acquire the displaced threshold and complete the approach with the aid of the temporary PAPI. The pilot in command elected to conduct a VOR/DME approach to runway 29, depicted at figure 1.
