Collision with terrain, VH-DSD

85 km NW of Julia Creek, Queensland

9 May 2011

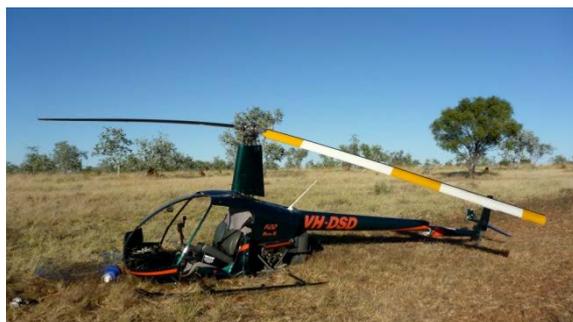
Figure 2: Aircraft wreckage

There was no fire and, although seriously damaged², the aircraft was largely intact (Figure 2).

The tail boom had been severed about 1 m from the tailrotor; however, the tailrotor pitch control and drive train remained intact.

The fuel system was ruptured and fuel was reported to have leaked onto the battery until the fuel shutoff valve was closed. The trailing edge of

one main rotor blade was kinked in two places, but the main rotor blades were otherwise undamaged.

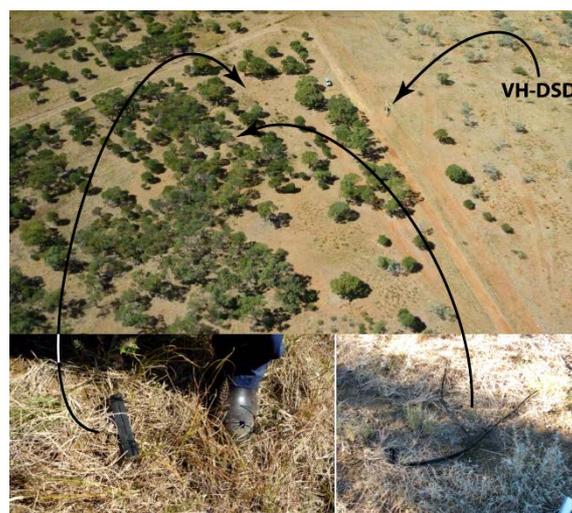
Figure 3: Location of the two belt fragments relative to the main wreckage

Examination of the wreckage revealed that a drive belt had broken. Two belt fragments were found about 60 m from the main wreckage.

Two fragments of the rubber drive belt system that drives the main and tail rotors were found on the ground about 60 m from the main wreckage (Figure 3).

- **Drive belts.** Check for defects or damage such as blistering, cracking or delamination.
- **Drive sheaves.** Check for incorrect alignment, poor sheave surface condition and/or uneven groove wear patterns.
- **Clutch actuator.** Check for incorrect tension, such as indicated by rotor engagement during engine start.

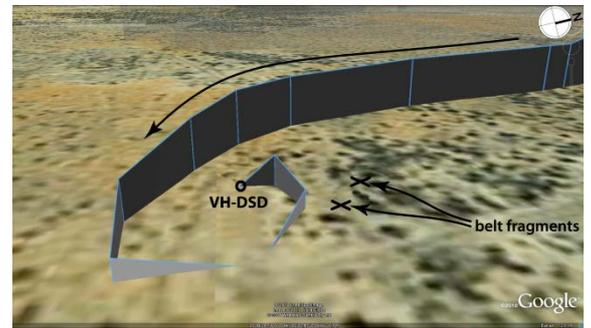
Figure 5: Final flightpath of DSD and the location of the drive belt fragments

A Garmin GPSmap 76CSx handheld Global Positioning System (GPS) unit was on board the helicopter during the accident flight. That unit had been recording GPS positional information throughout the day's flying and the recorded data was downloaded at the Australian Transport Safety Bureau's (ATSB) technical facilities in Canberra. Figure 5 displays the helicopter's final flightpath, derived from that data.
