INTRODUCTION

On 26 April 1986 at 1735 hours local time the Indian flag bulk carrier Jhansi Ki Rani of 42141 gross tonnes, on a passage from Newcastle, Australia to Higashie Harima, Japan, ran aground on Frederick Reef in position 21° 01.5'S 154° 22'E.

DETAILS OF M.V. JHANSI KI RANI

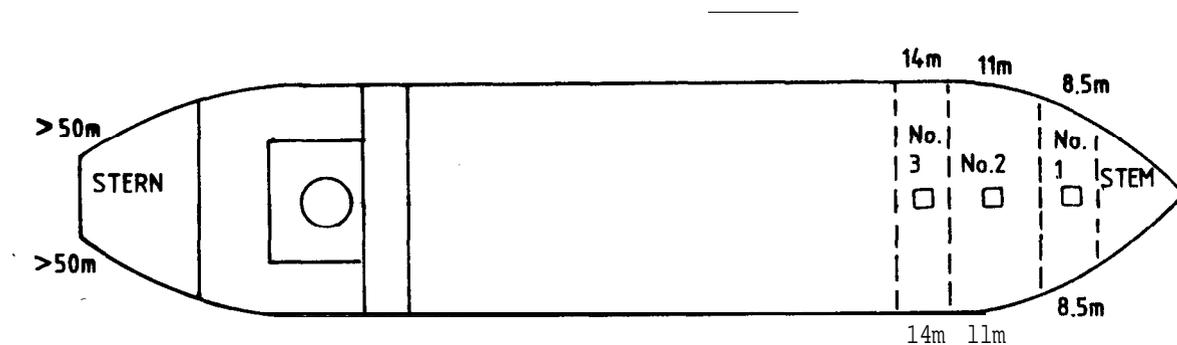
At 1830 hours, the water depth around the ship was sounded with the results shown below. This indicated that the vessel was hard aground from the stem to the after end of No. 2 Hatch.

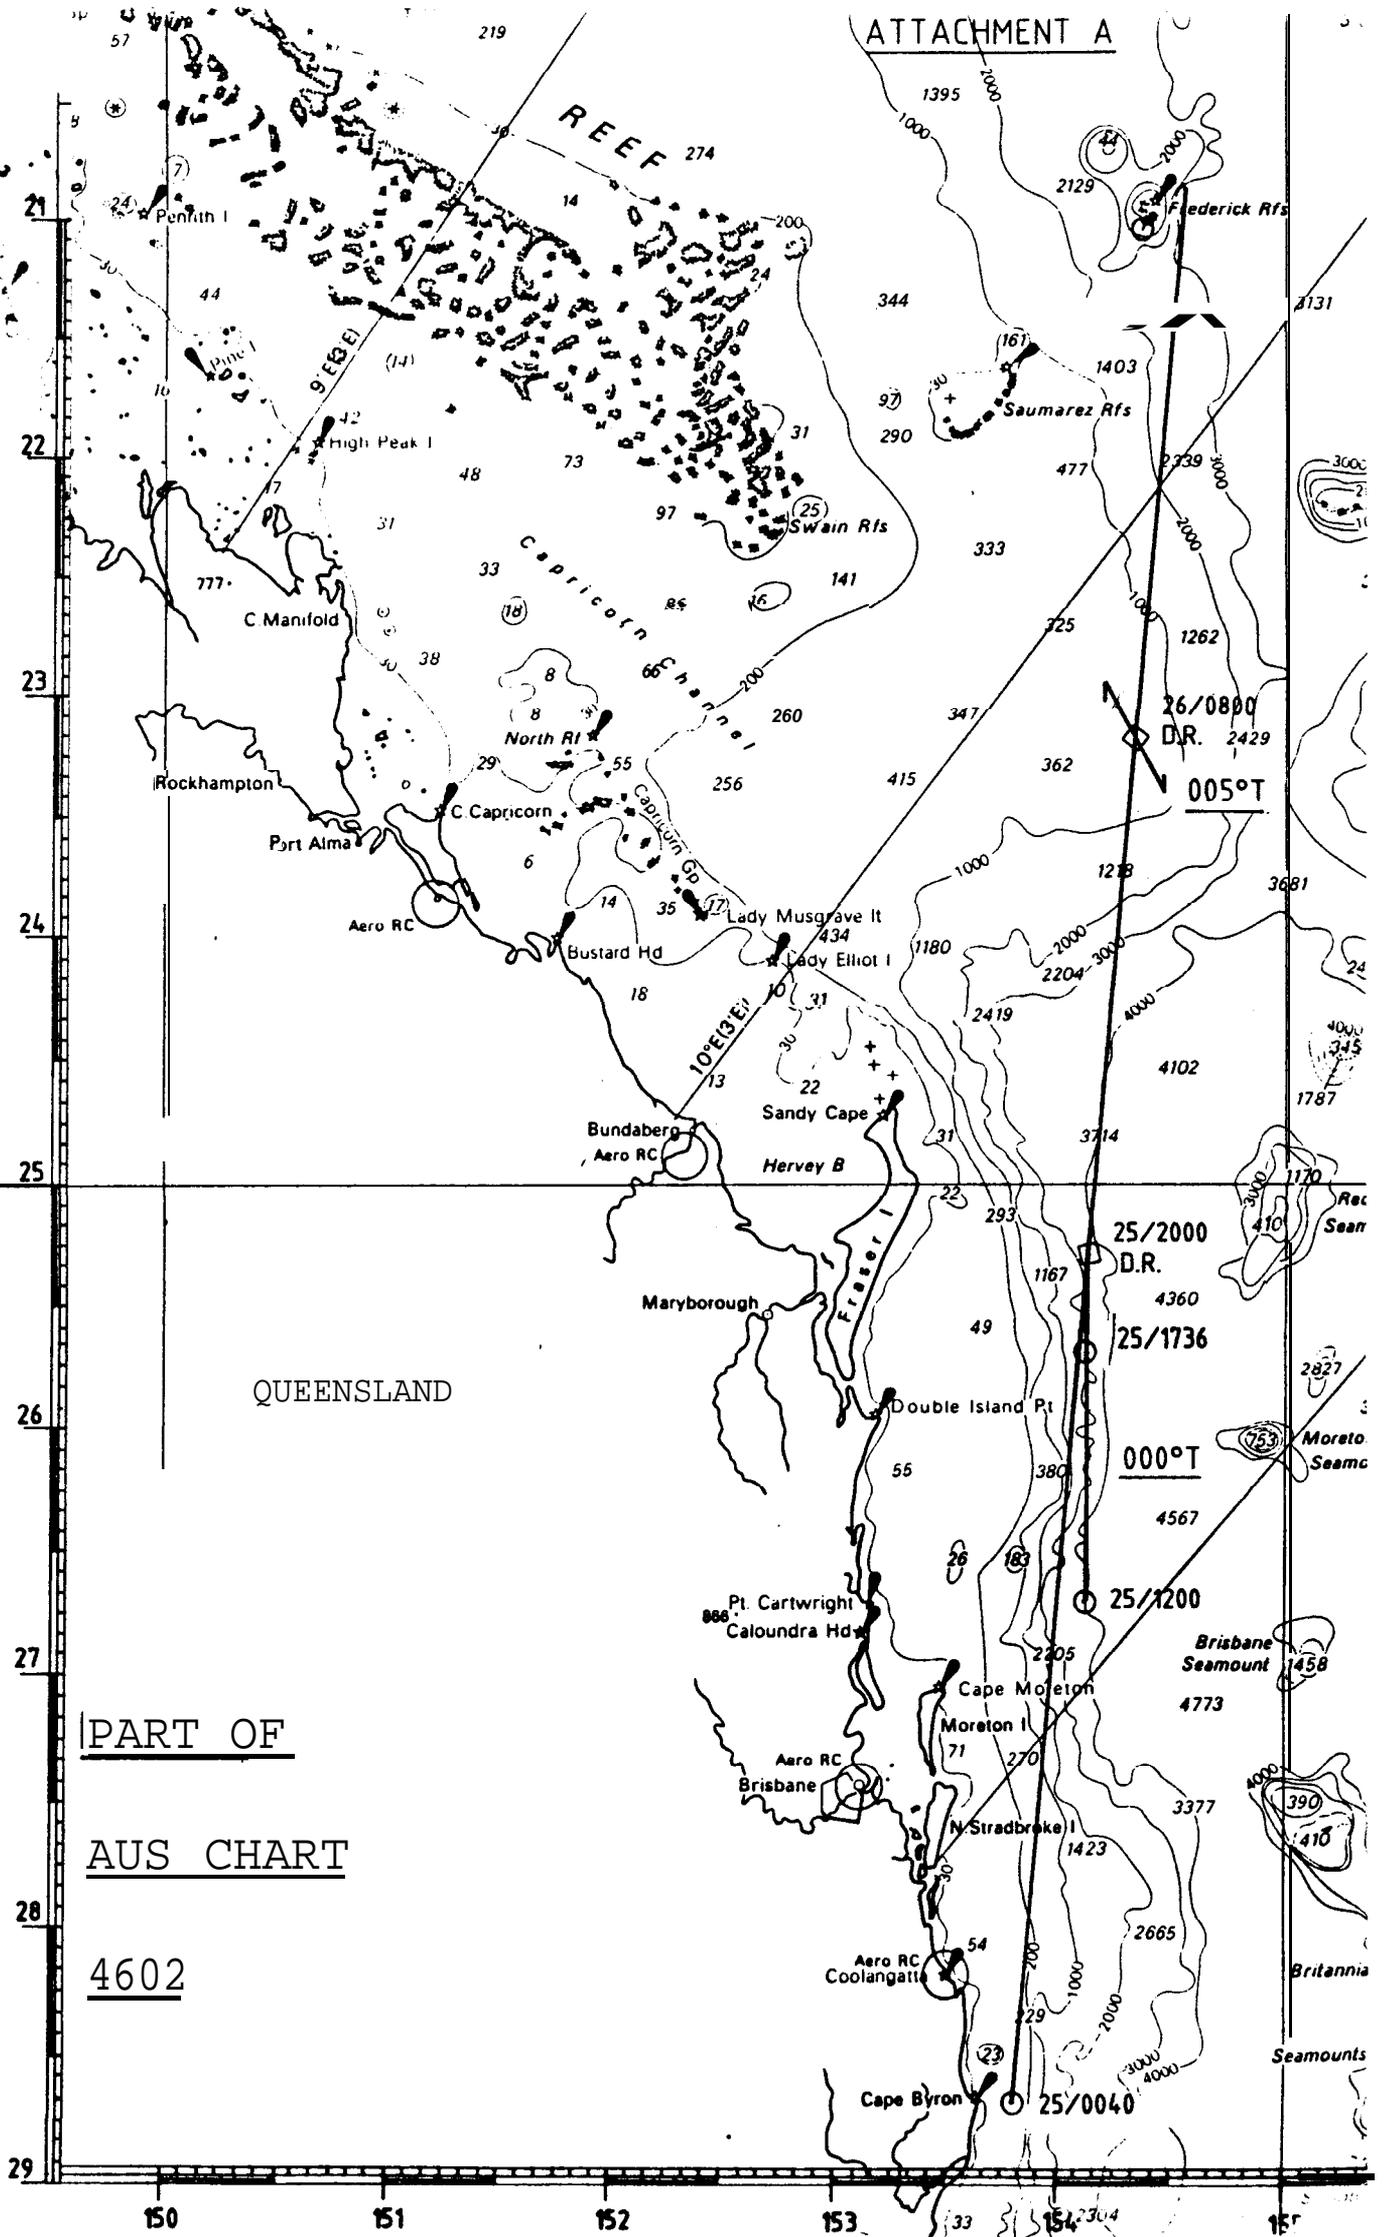
AUS CHART

This adverse current did not eventuate. The distance from the star position at 1736 hours on to the grounding position at 1735 hours on the 26th is 277 miles, which gives the average speed over that distance of 11.54 knots, the service speed of the vessel.

would have been reasonable to assume that any adverse current experienced then, may have dissipated when the vessel was virtually in the open ocean. Had the dead reckoning positions been run up at the vessel's service speed, the solar position line obtained at 0800 hours on the 26th April would have indicated that the vessel was to the west of her intended course.

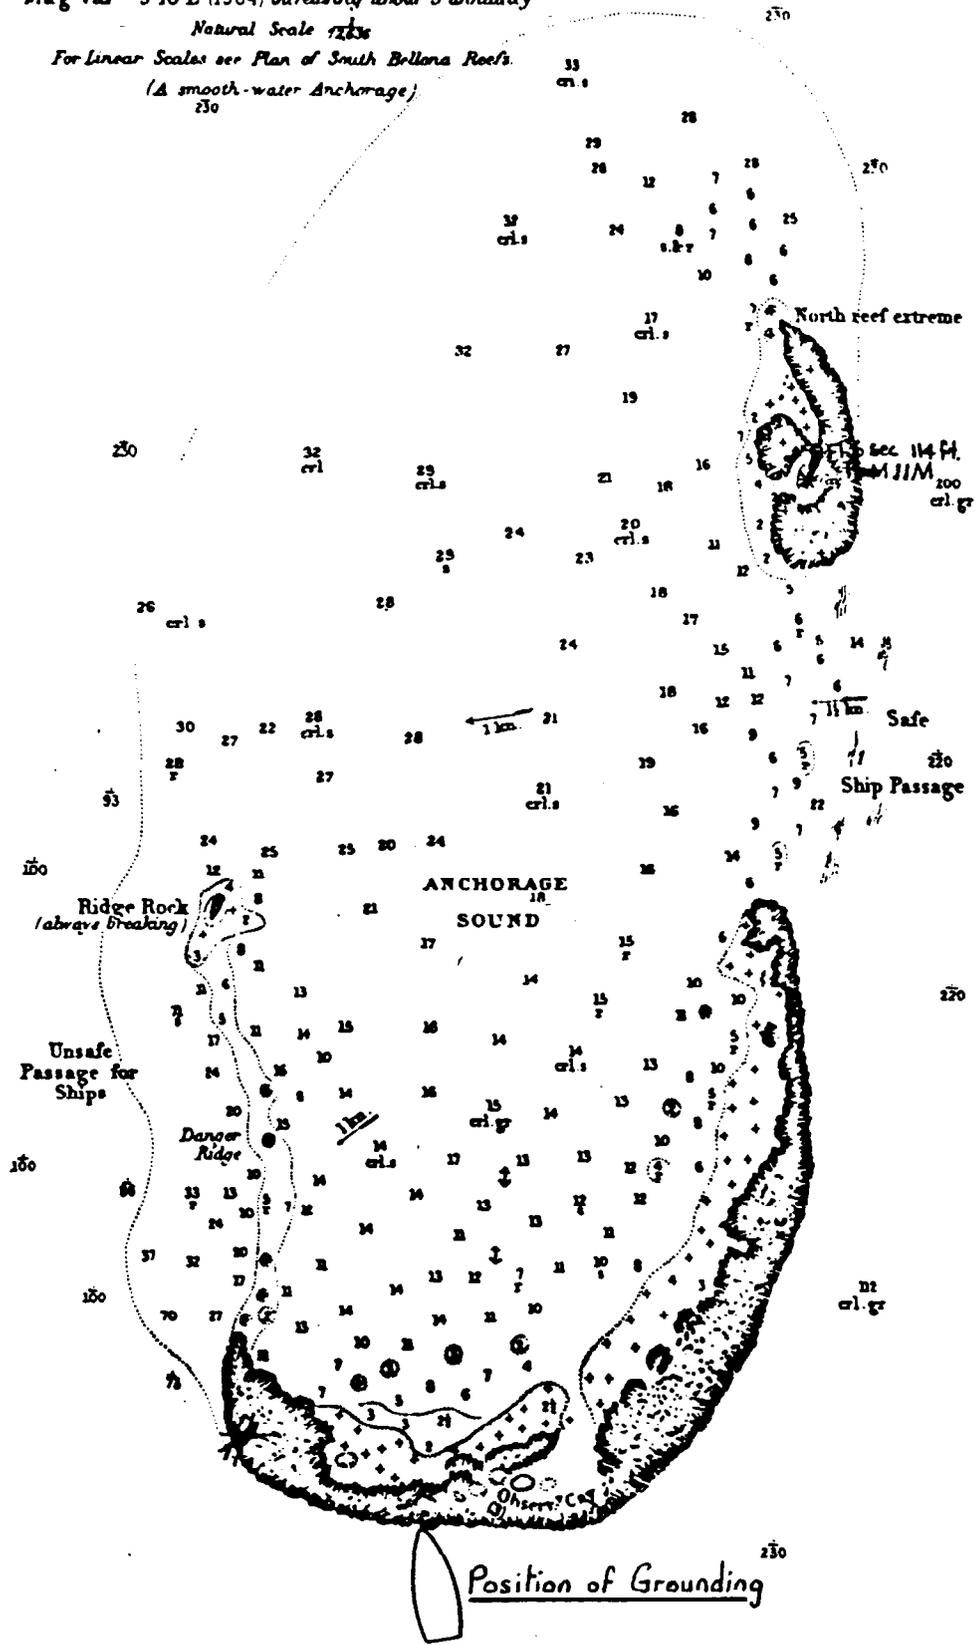
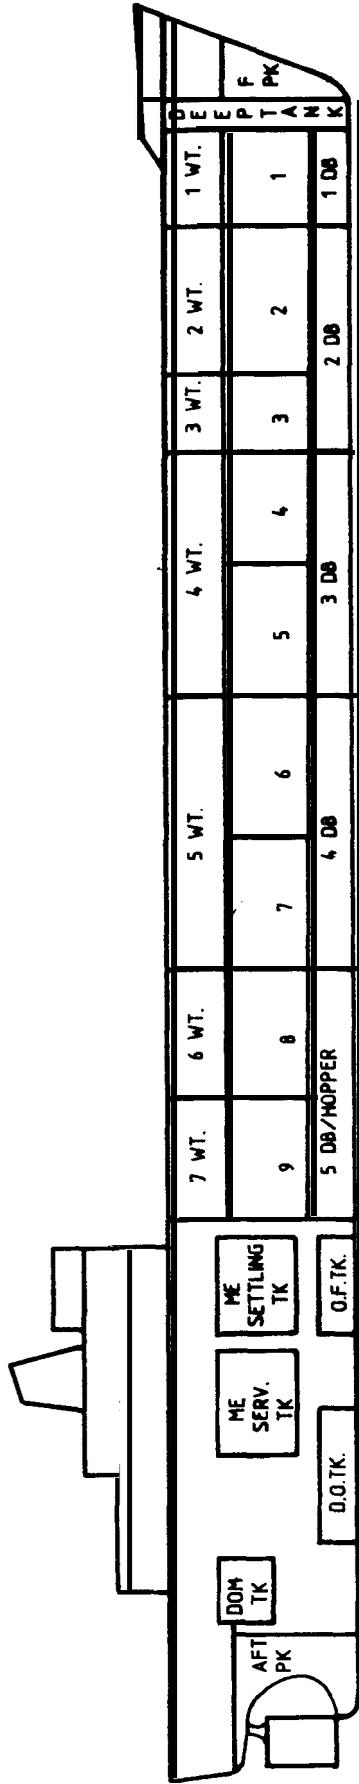
ARRANGEMENT OF SHIP HOLDS AND TANKS

The vessel continued to "work" on the reef, with the bow remaining hard aground. At the time of the investigation, the following compartments were reported to be breached:

'Fore Peak
Deep tank (P&S)
Emergency Fire Pump space forward
No. 1 Hold
No. 1 DB (P&S)
No. 2 DB (S)
No. 2 DB (P) is suspect
No. 2 Hold taking water gradually
No. 3 Hold taking water gradually
The Duct Keel and Engine Room Cofferdam.'

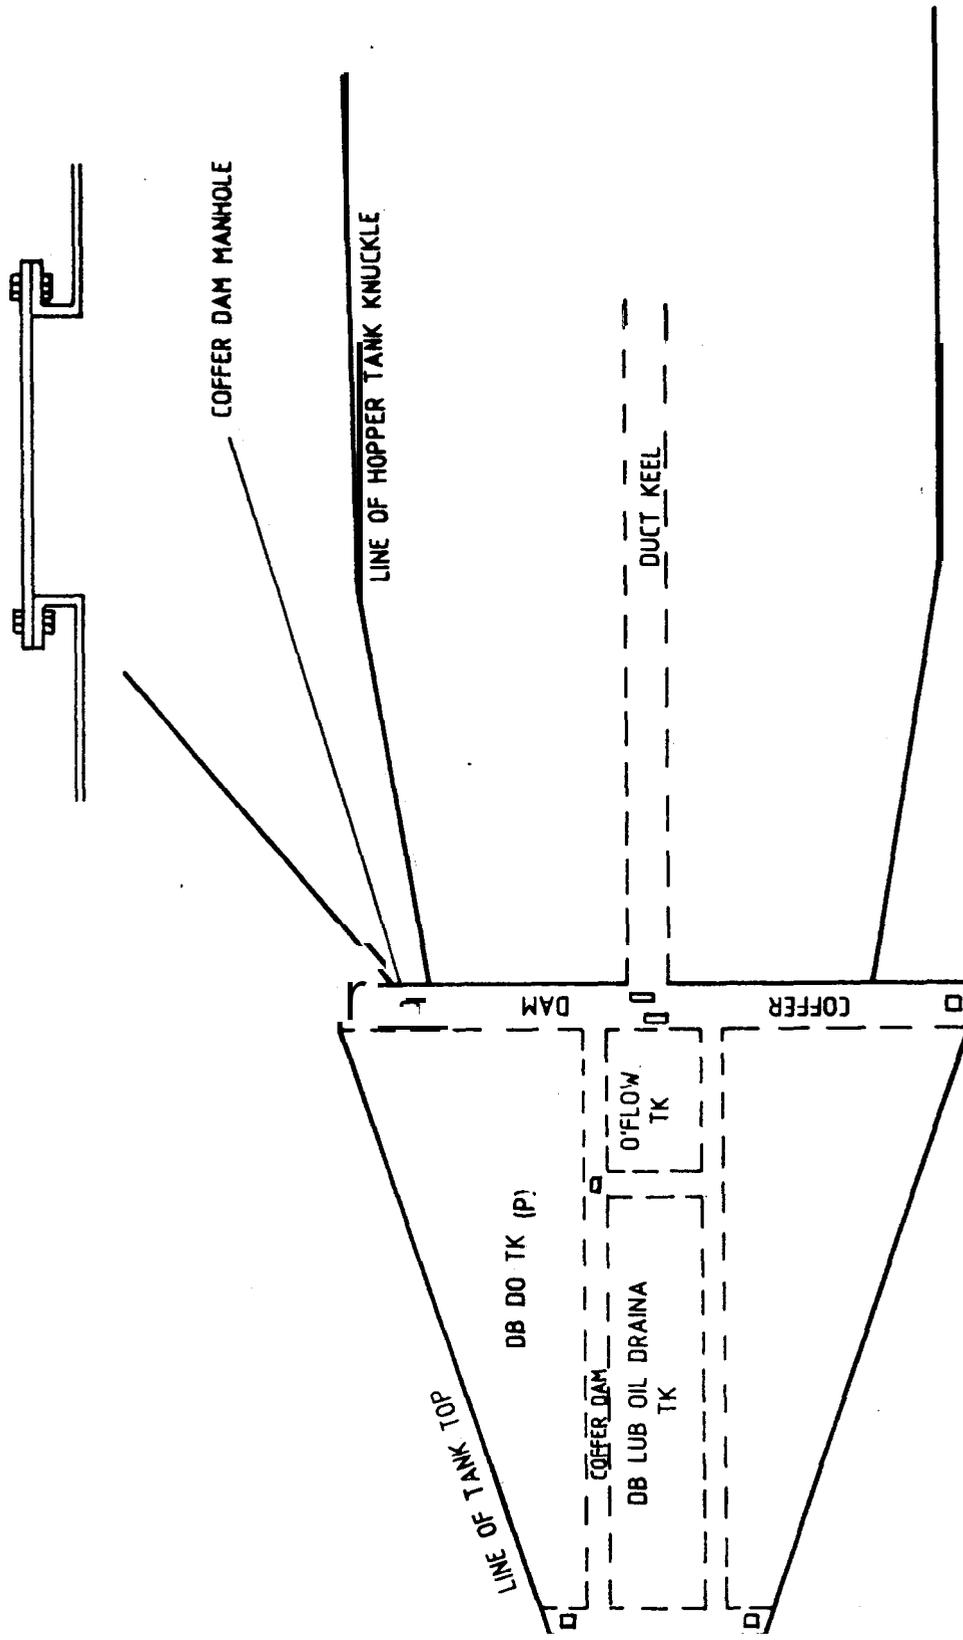
ARRANGEMENT OF COFFER DAM

The arrangement of the duct keel and cofferdam is shown at "Attachment D". On grounding, the duct keel had apparently been breached, allowing water into the engine room cofferdam. There are no watertight bulkheads, doors or plates between the duct keel and cofferdam.

- 8) The design of the duct keel and engine room cofferdam system as an integral unit, with no provision for subdivision, made the engine room vulnerable in the event of bottom damage. Water entered the engine room, from the duct keel and cofferdam, through sounding pipes, the duct keel venting system and leaking manhole covers.
 - 9) The cofferdam sounding pipe caps were left uncapped.
 - 10) There would appear to have been an excessive amount of rags and jute in the engine room bilges which caused the pumps to become blocked.
-
