OUTLINE OF INCIDENT

At 1142 Eastern Standard Time (EST) on 24 1989 July the Cypriot flag liquefied gas carrier "Kouris" anchored off Bate Bay, New South Wales.

The Cypriot liquefied gas carrier "Kouris" came into heavy bottom contact in shoal water off Merries Reef at about 0335 on 25 July 1989, disabling the ship's rudder and sustaining extensive bottom damage. Through being unable to steer and manoeuvre normally as a result of the rudder damage the ship grounded on Cronulla Beach at approximately 0438. The cause of the contact with Merries Reef and the subsequent grounding are as follows:

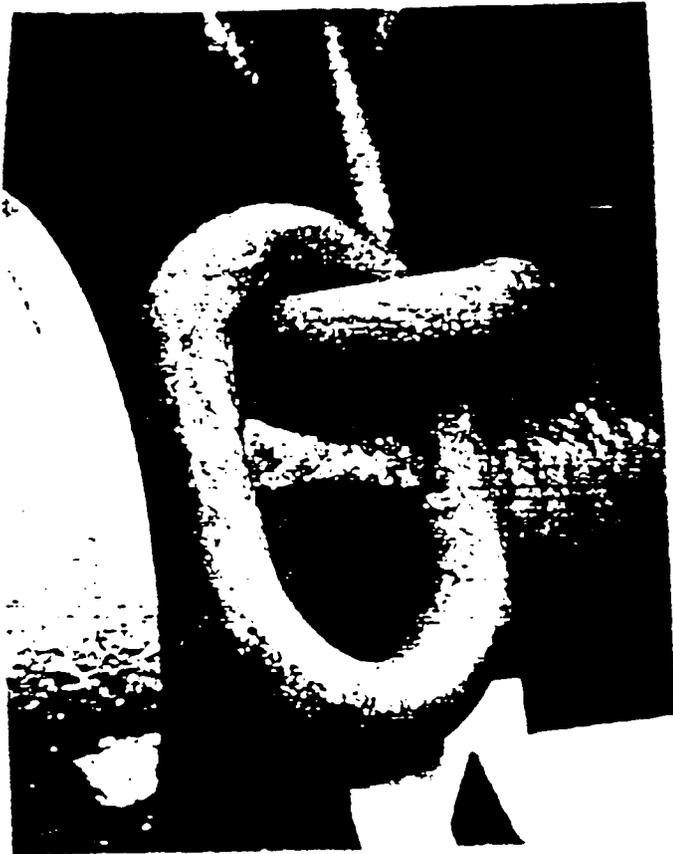
On inspection by the investigating officers the "Kouris" was found to be well maintained. The remaining anchor cable was visually inspected and it was found that both cables had parted at stud links, the starboard cable some 21 metres from the anchor, and the port cable approximately 16 metres from the anchor. The end stud links on each cable showed no undue wear down and did not appear distorted in any way. The remainder of the cable appeared to be in good condition. The chain locker was dry with a minimum amount of mud in the bottom. The windlass appeared to be well maintained.

PORT ANCHOR CABLE
END LINK

STARBOARD ANCHOR
BREAKBAND (A) AND
GYPSY (B)
